# Hackensack Meadowlands Floodplain Management Plan

**The National Flood Insurance Program  
Community Rating System  
Activity 510 Guidelines**

**The New Jersey Meadowlands Commission  
One DeKorte Park Plaza  
Lyndhurst, New Jersey**

**October 24, 2005**

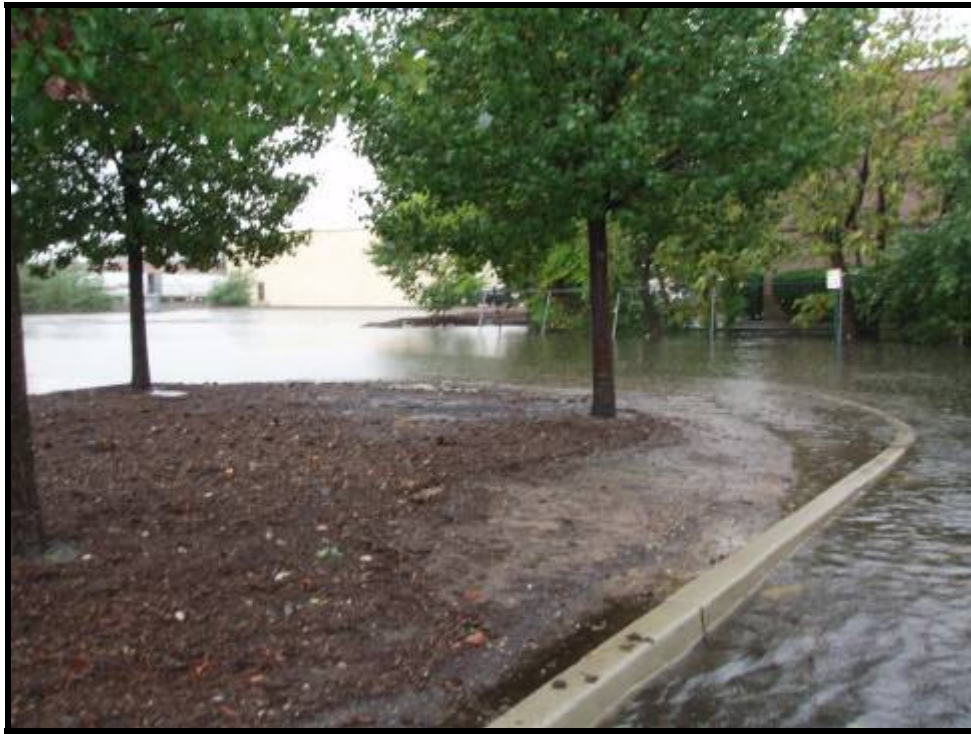
5. View of flooding in the parking lot at 1 Carol Place (10/12/05)

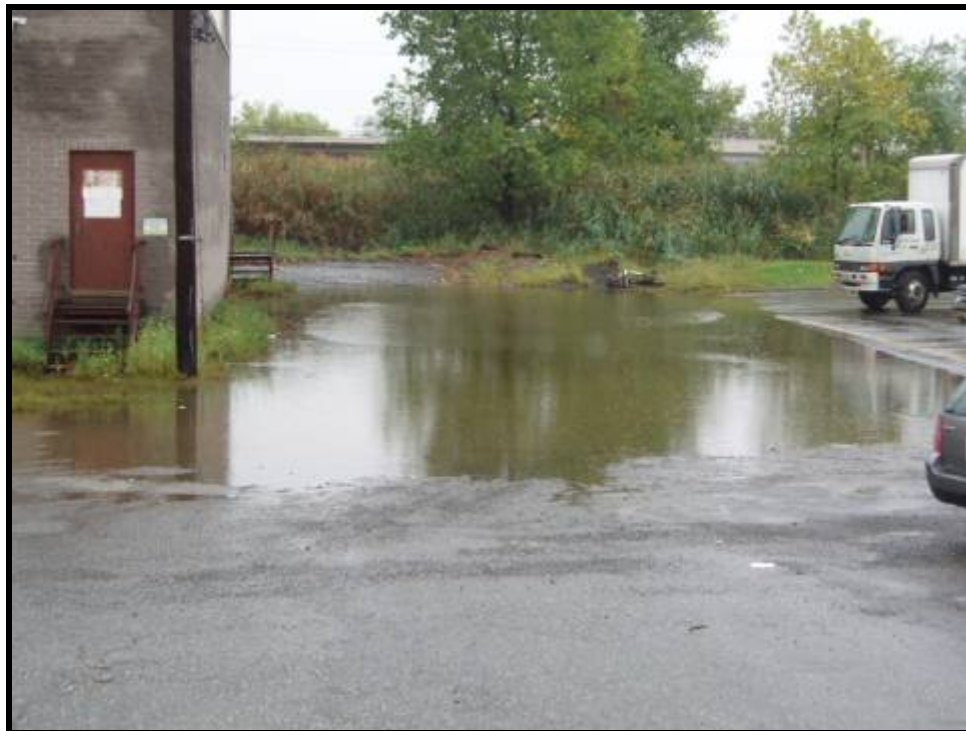
4. Flooding condition at 462 Barell Avenue (10/14/05)

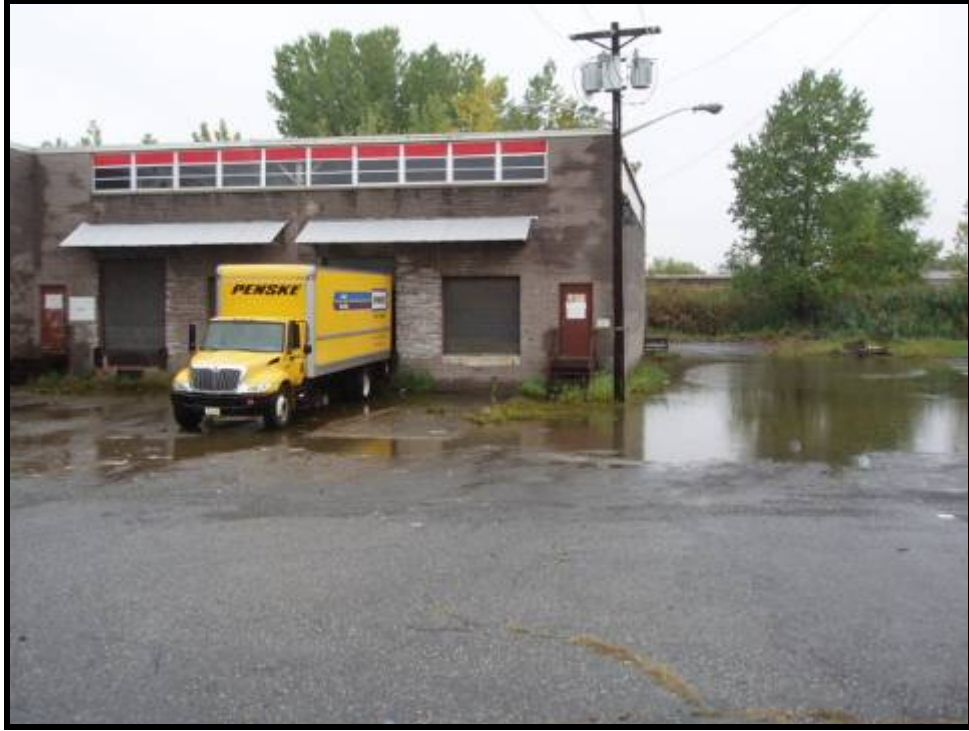
5. Flooding condition at 462 Barell Avenue (10/14/05)

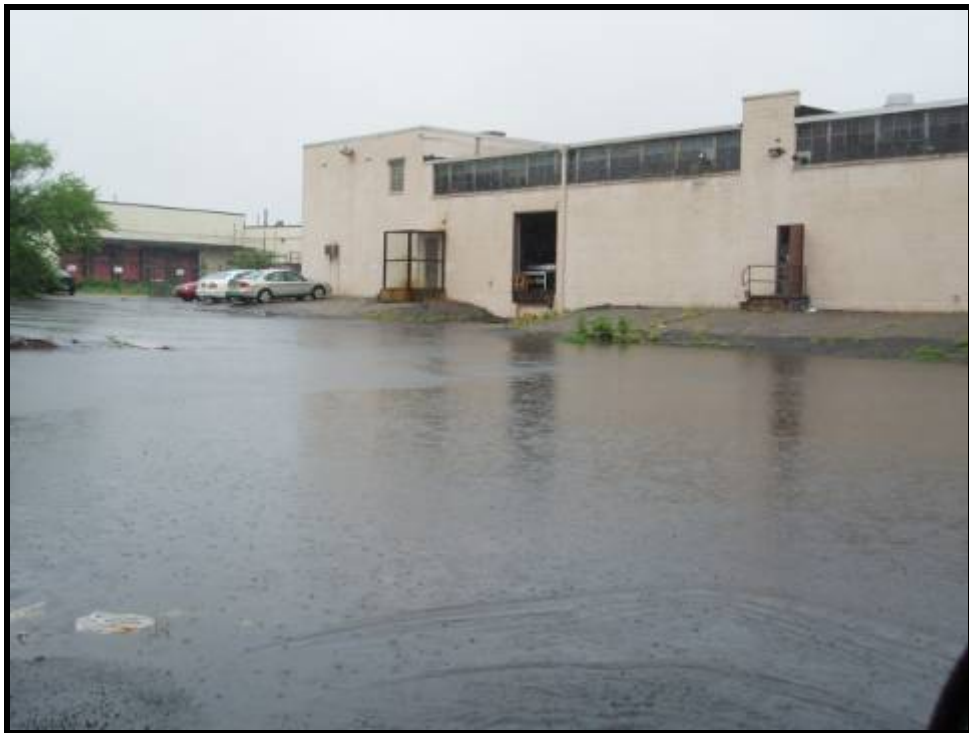
6. Flooding condition behind 705 Commercial Avenue (7/08/05)

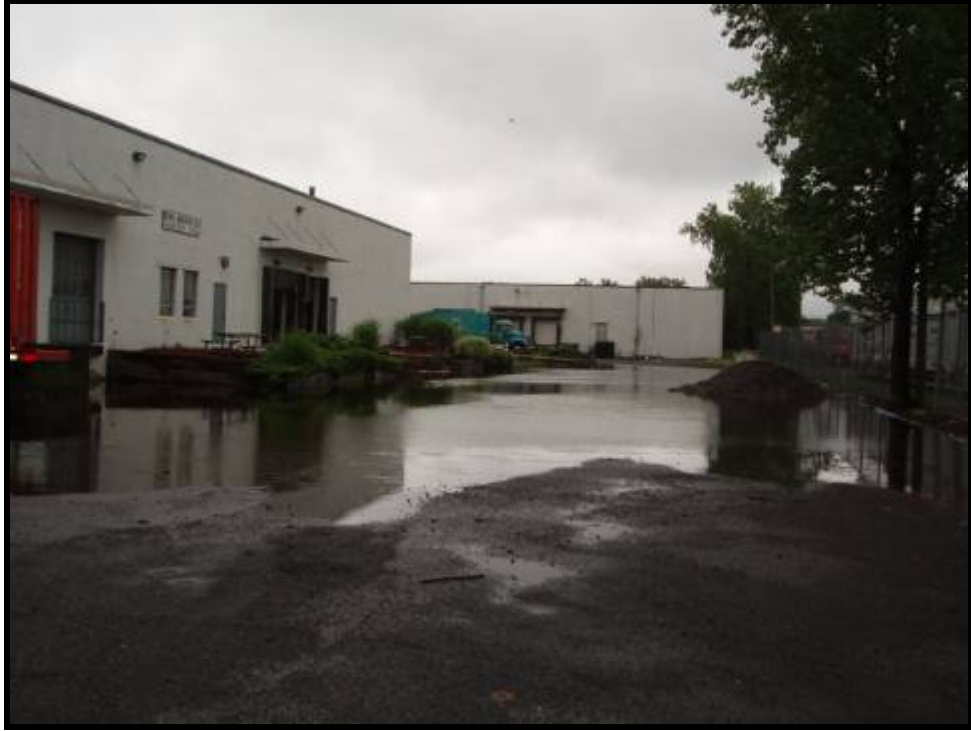
7. Flooding conditions at 745 Gotham Parkway in rear of the property (7/08/05)

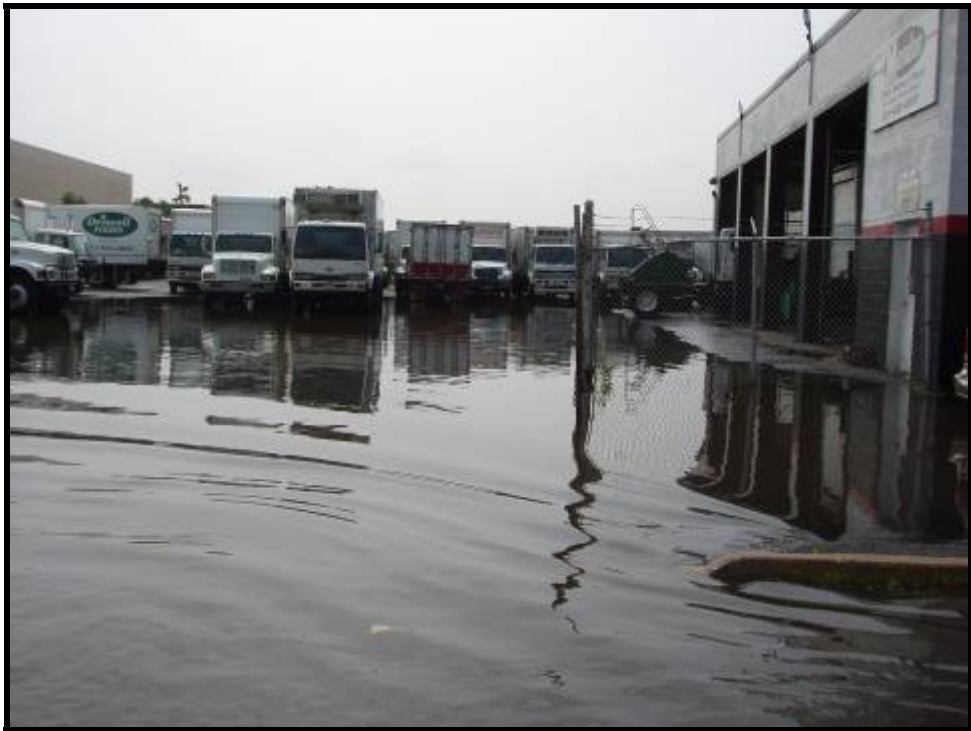
8. Flooding conditions in the truck yard at 120 Kero Road (6/10/05)

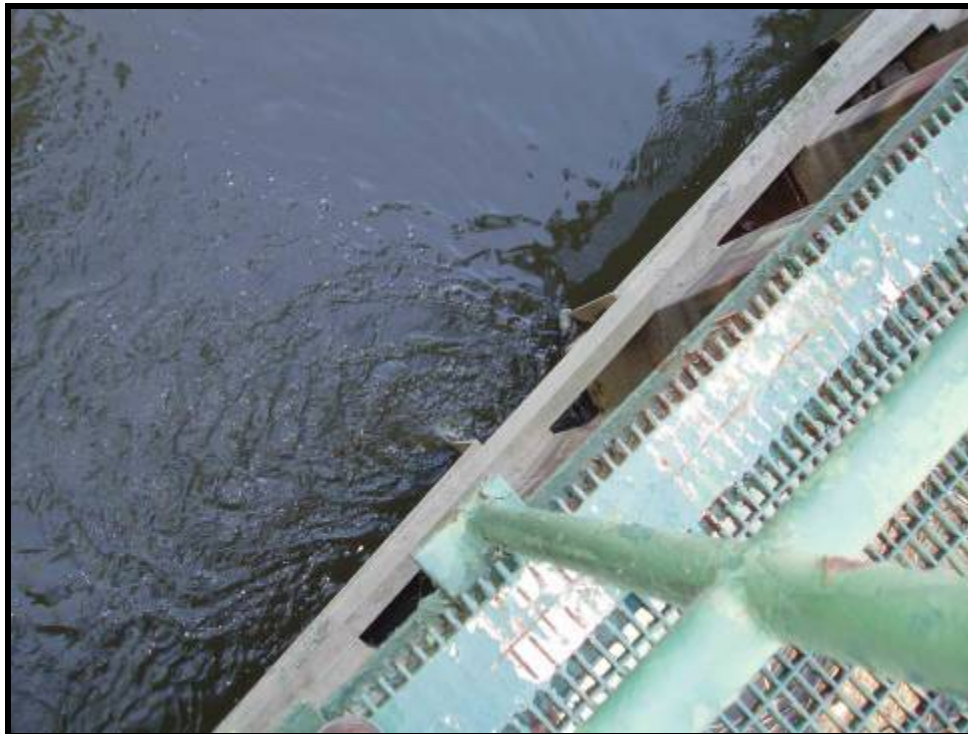
2. Boils observed upstream of West Riser Tide Gate during a tide change (10/06/05)

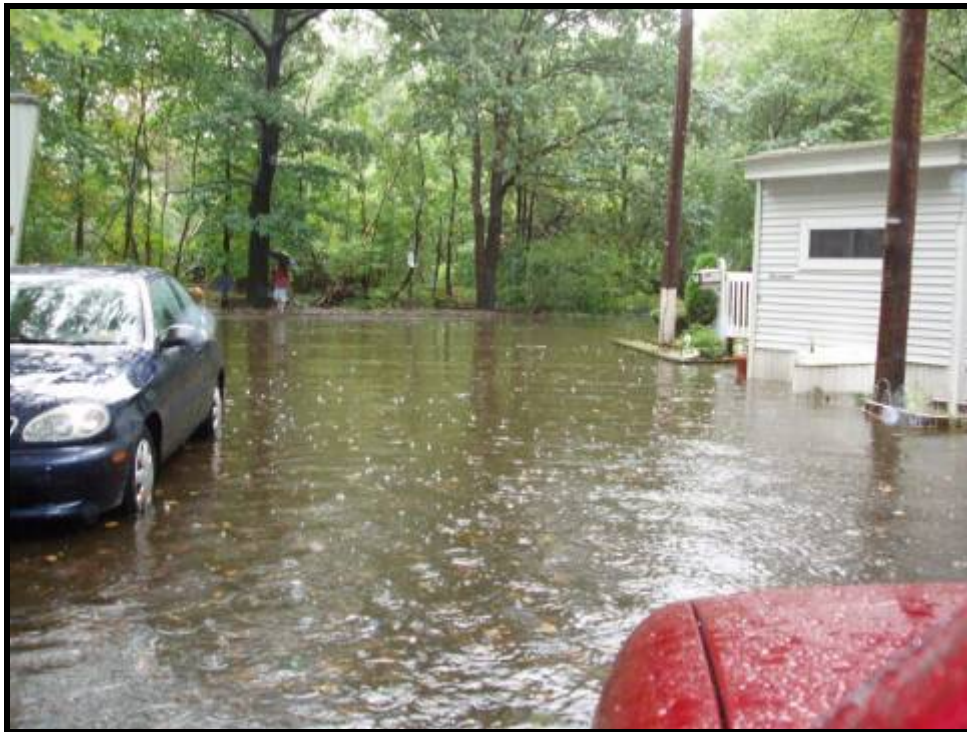
2. Flooding condition at Southeast of the mobile home area (10/14/05)

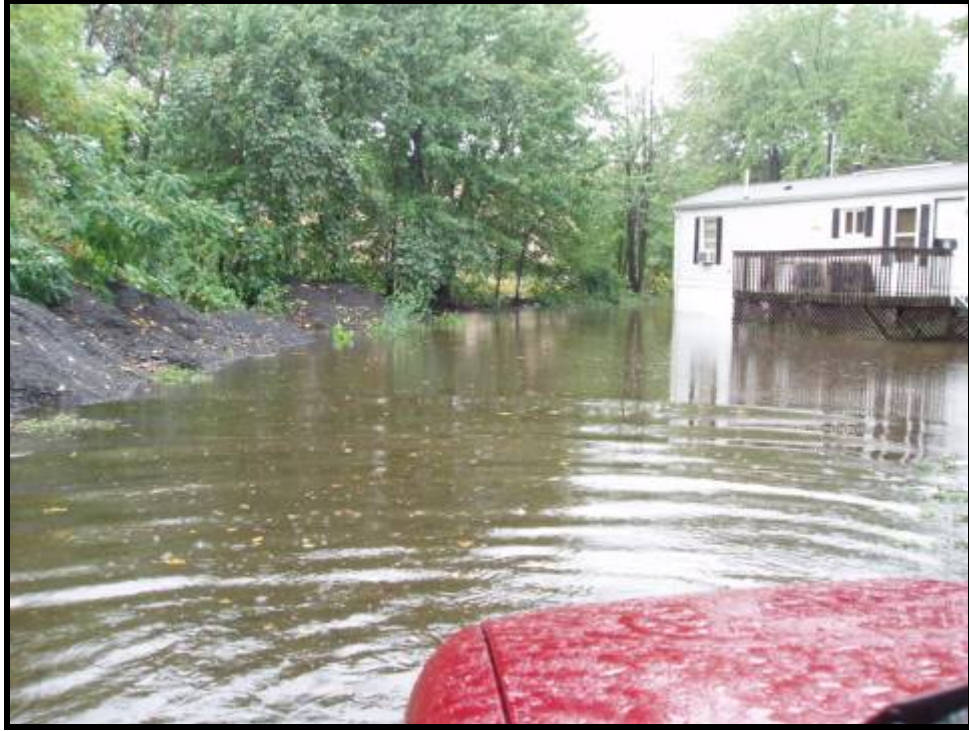
3. Flooding condition along the edge of the mobile home area (10/14/05)

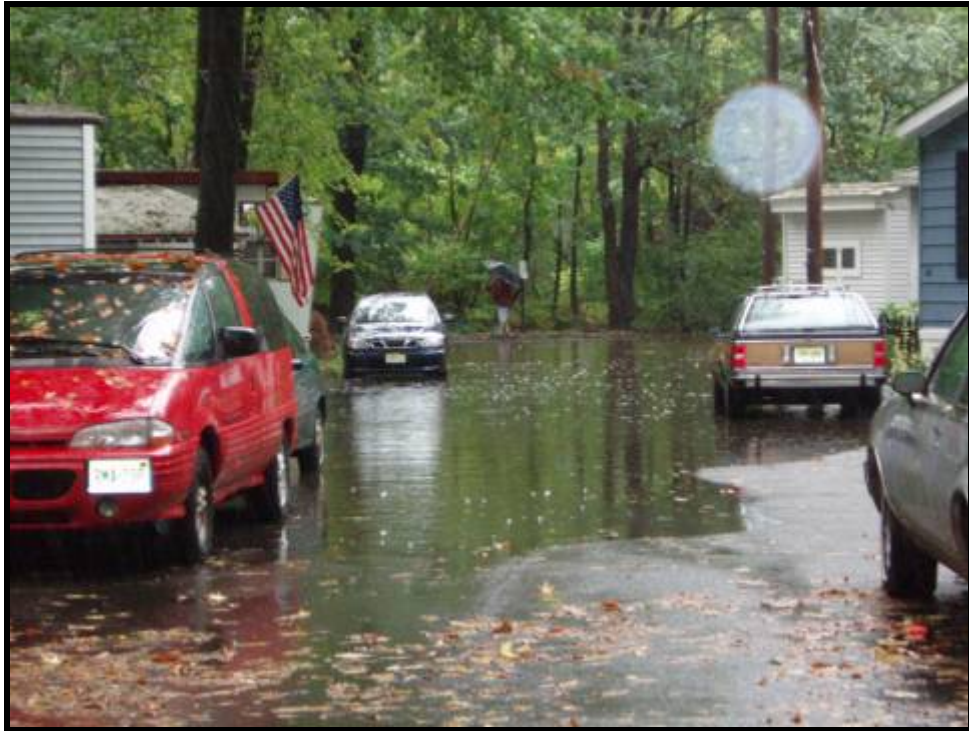
4. Flooding over the roadway in the mobile home area (10/14/05)

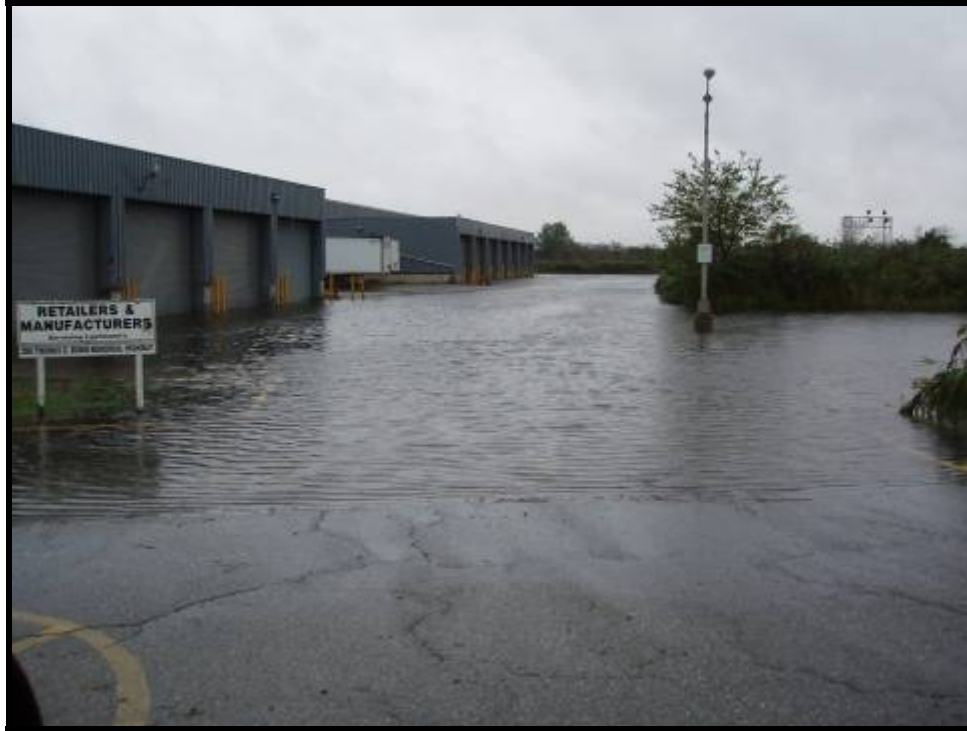
5. Flooding condition in loading docks at 299 Thomas E. Dunn Memorial Highway (10/14/05)

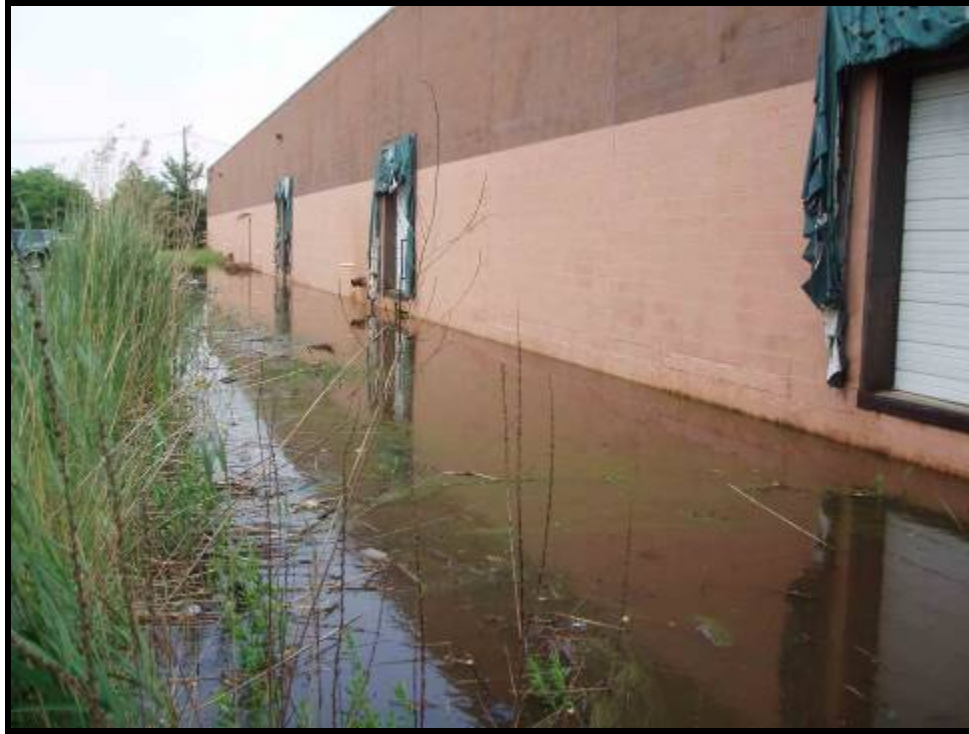
1. Flooding condition behind 360 Murray Hill Parkway (6/10/05)

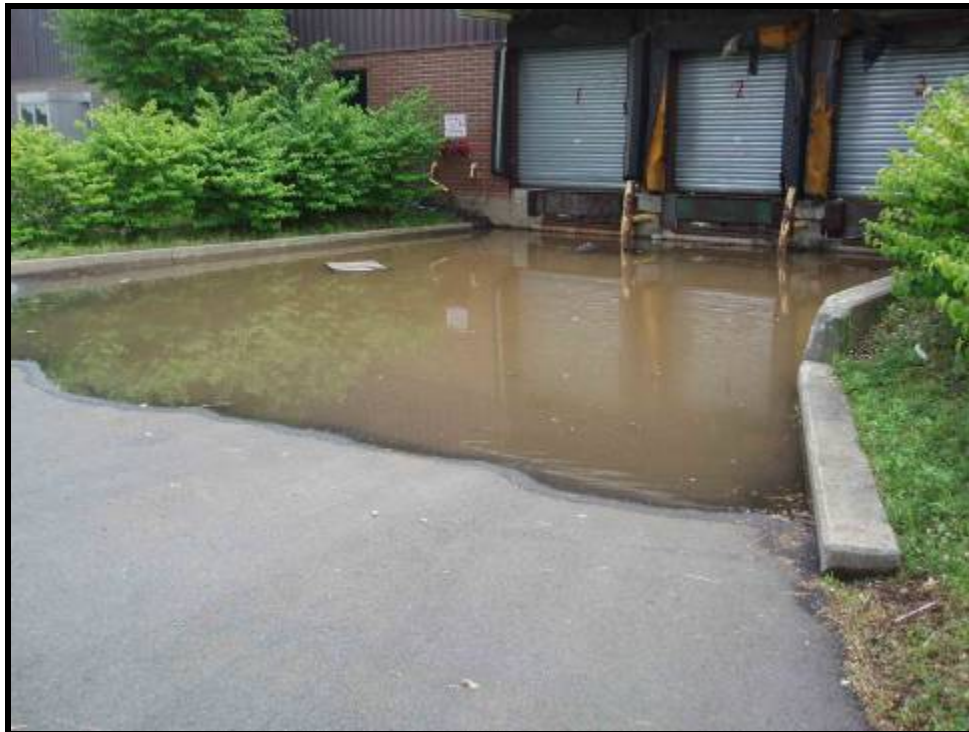
2. Flooding condition at loading docks on Madison Circle Drive (6/10/05)

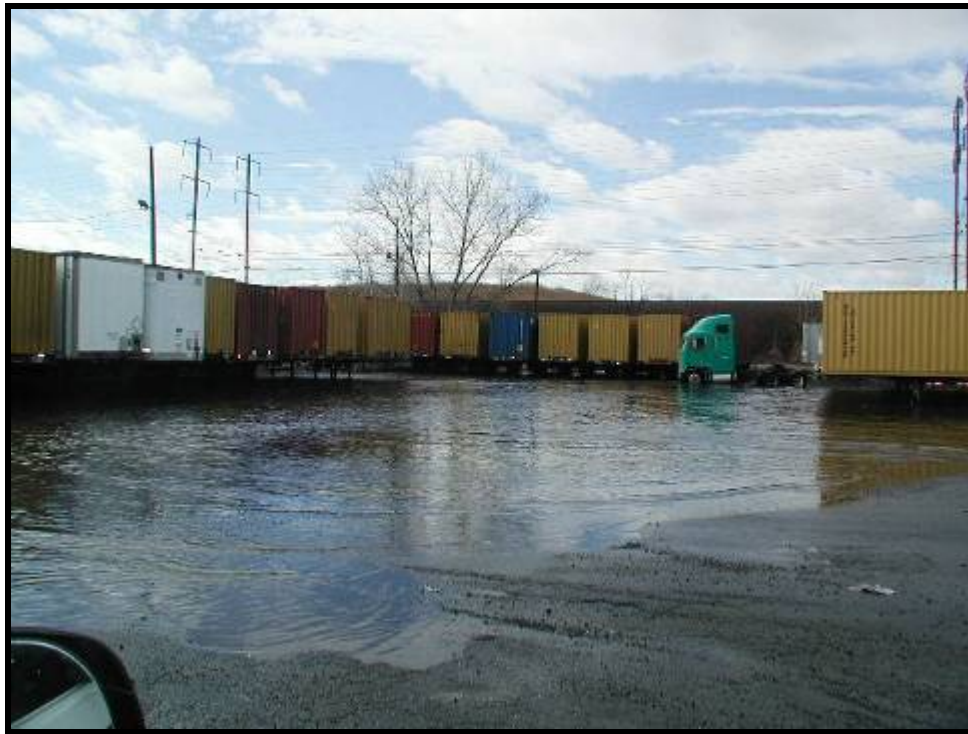
3. Flooding condition at the truck yard of 996 Belleville Turnpike (3/29/05)

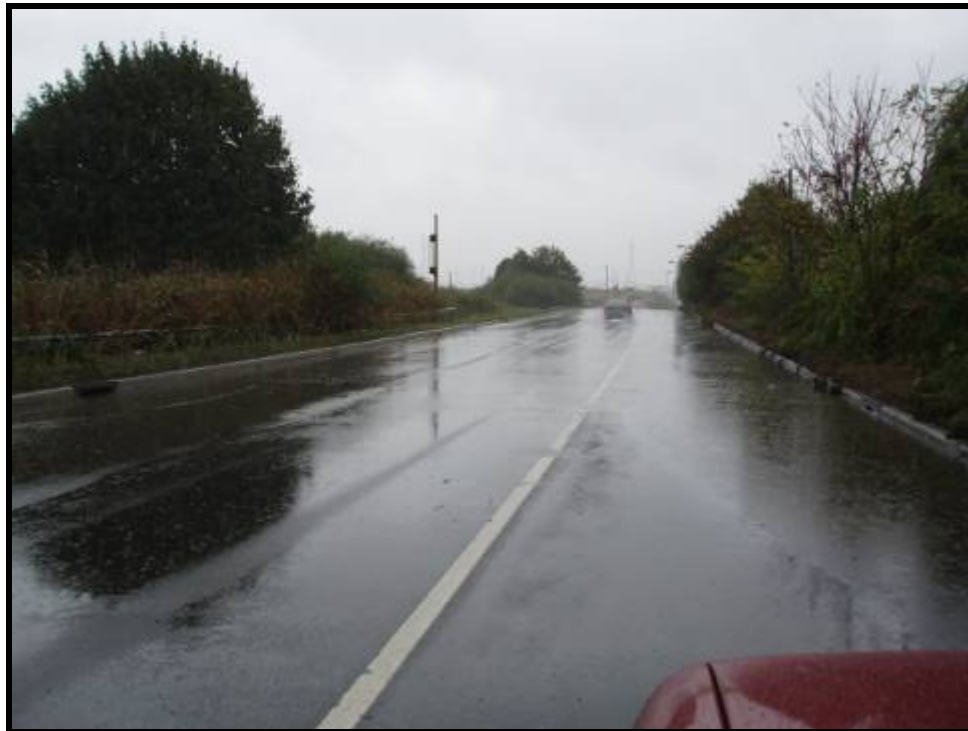
4. Ponding conditions on the shoulder of Belleville Turnpike (10/14/05)

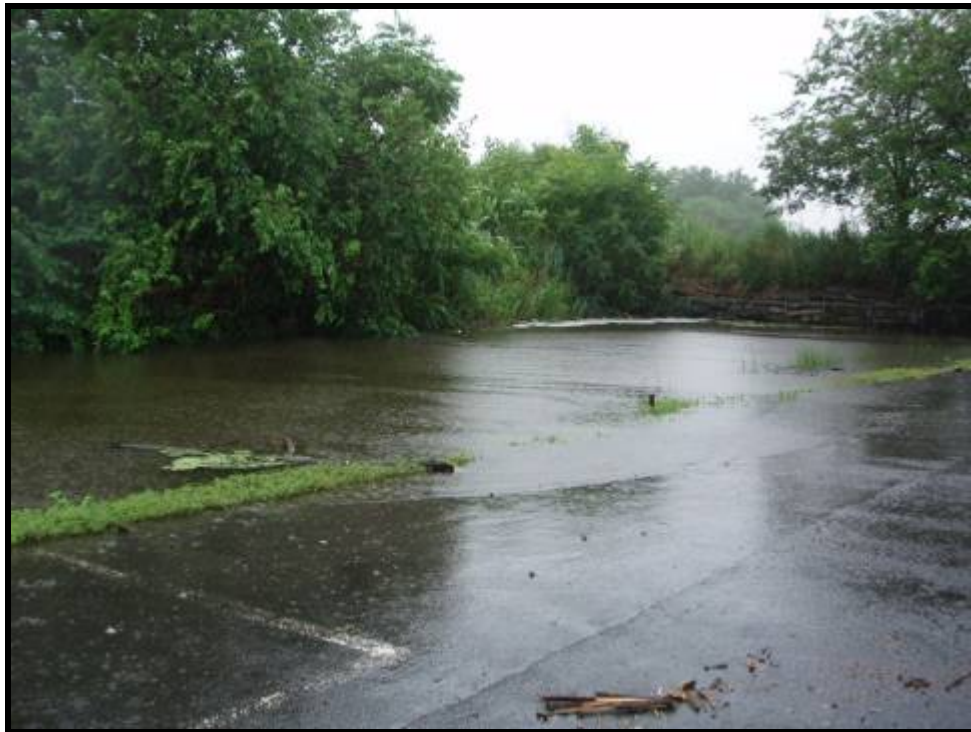
8. Flooding condition at 350 Gotham Parkway upstream of Peach Island Tide Gate (7/08/05)

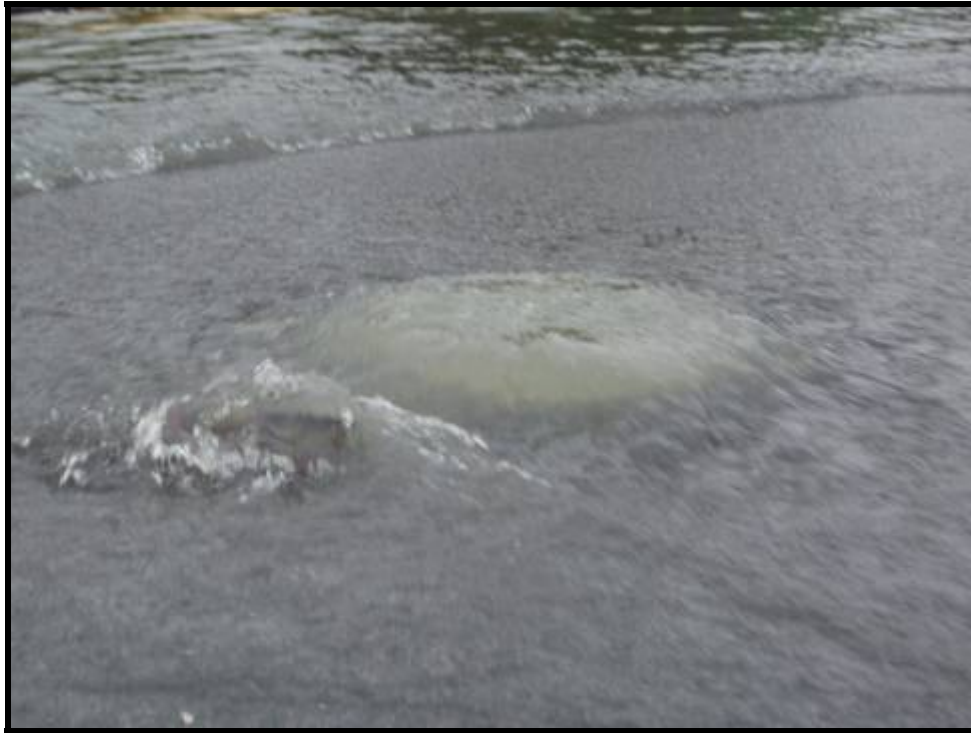
3. Surcharge condition for an inlet on 91<sup>st</sup> Street (10/14/05)

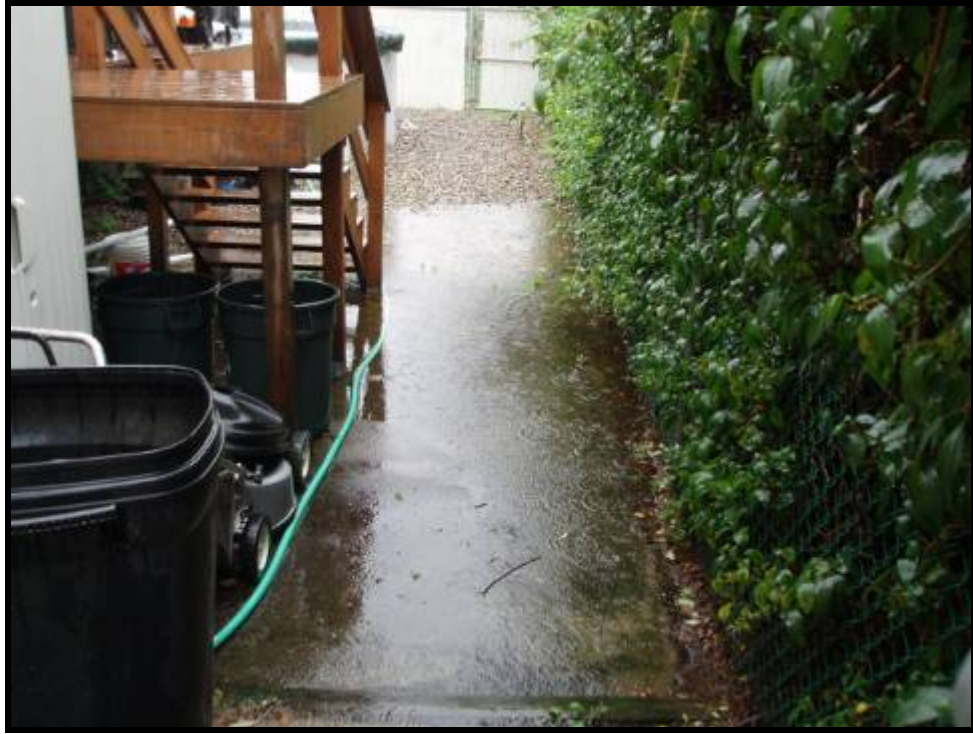
3. Ponding in the backyard of 15 Mill Ridge Road (10/14/05)
