# Mapping Earthen Berms in the Meadowlands

Soft Edges Around the Hackensack River Watershed

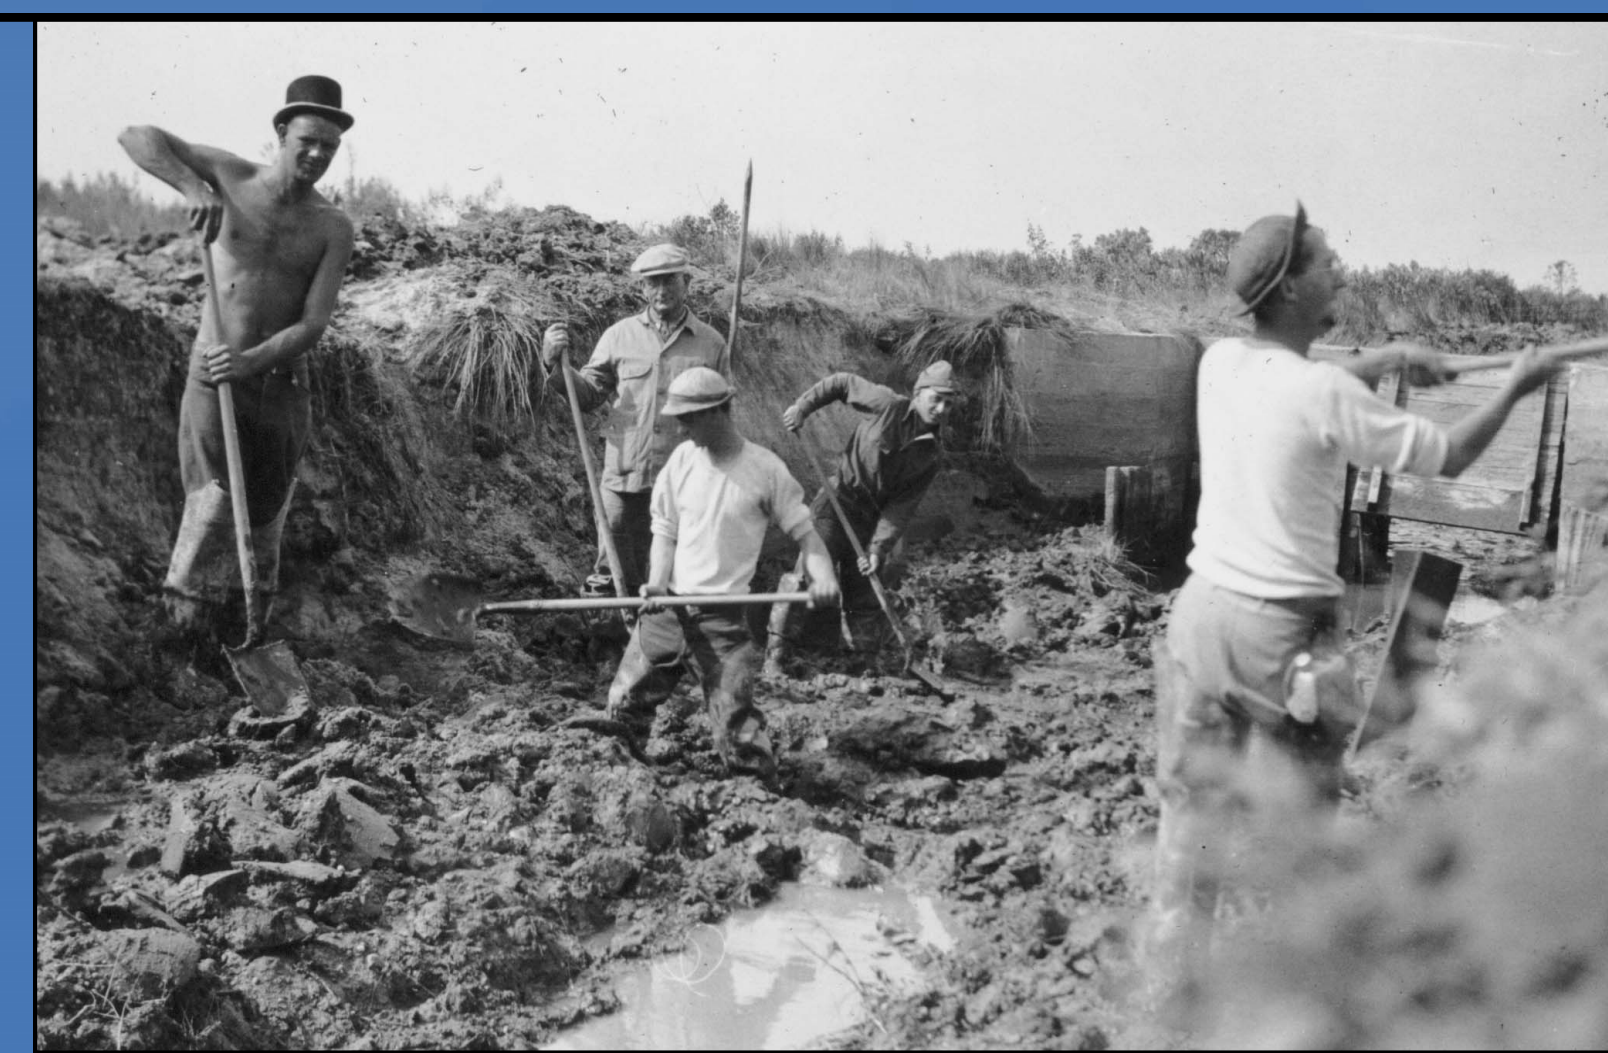
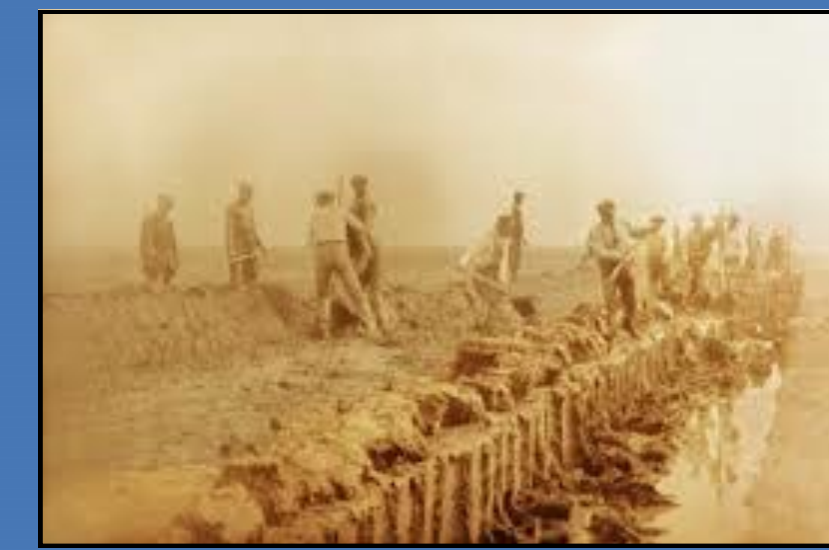
Early ditching efforts by the Mosquito Commission resulted in berms around the Meadowlands and are found throughout the Hackensack River Estuary. These earthen man-made berms were not intended to be flood control structures. In events such as a storm surge these structures are susceptible to overtopping.

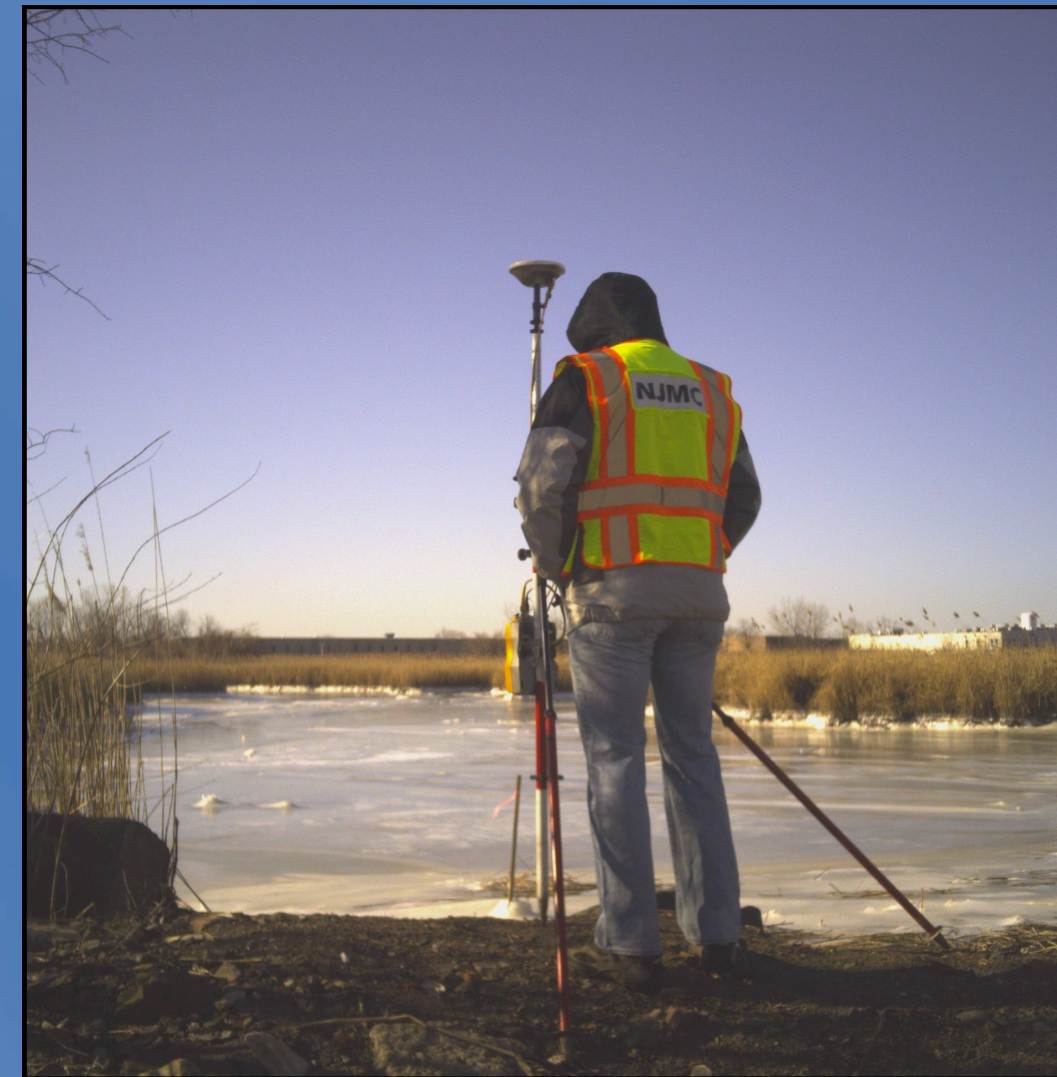
Elevations were taken along the known berms. This effort was to understand the heights of these structures that were overtopped by Superstorm Sandy.

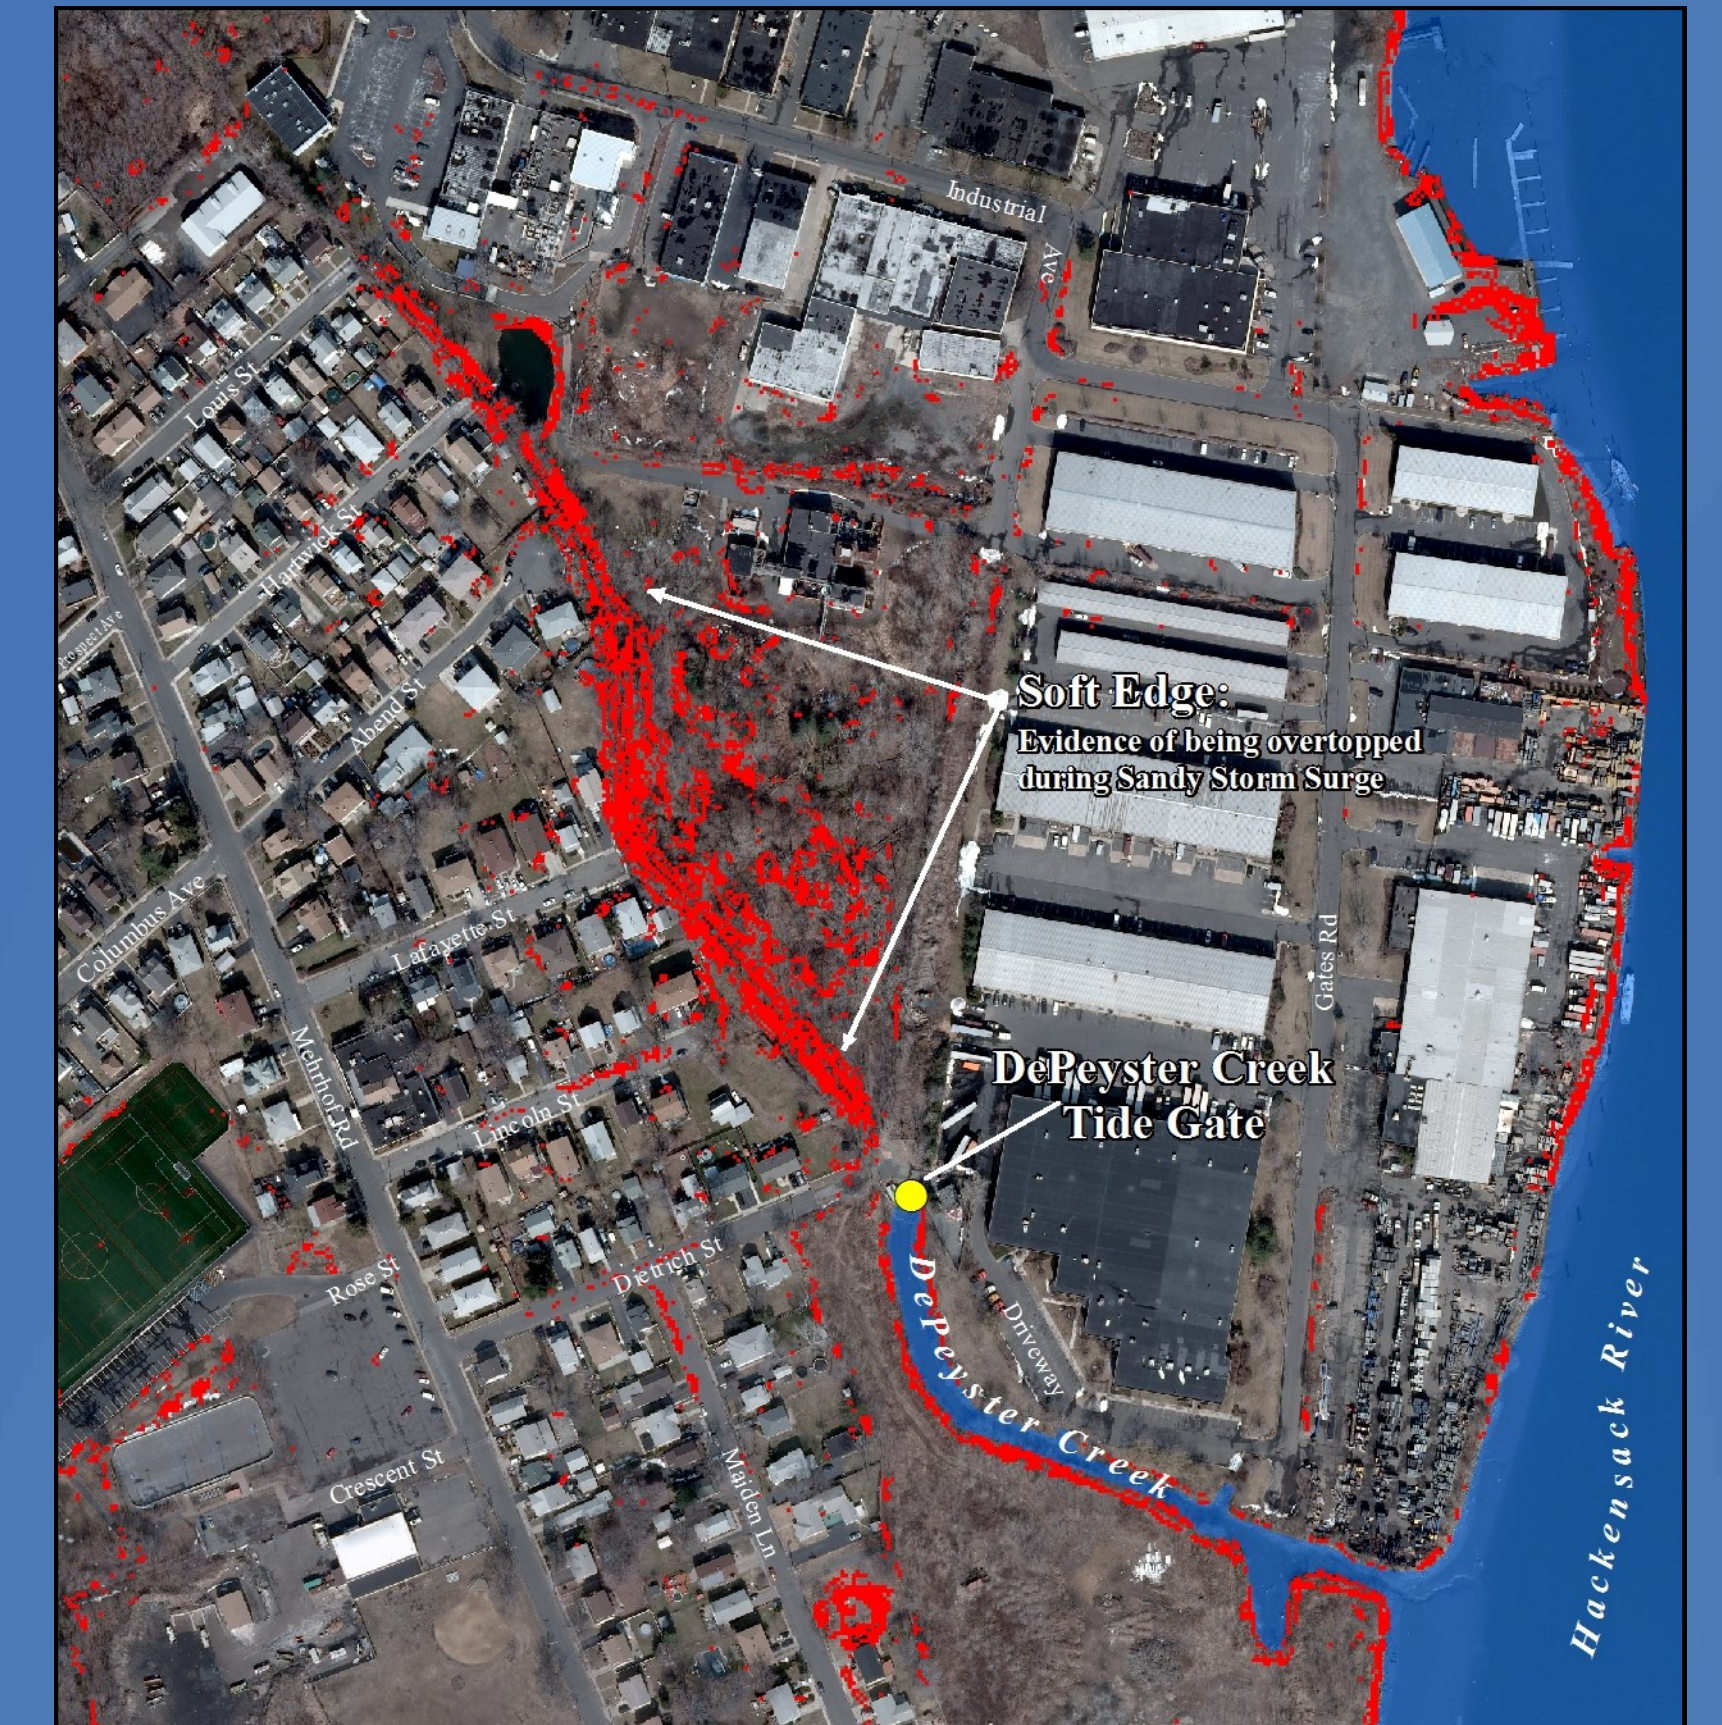
Pictured above is the result of the classifications; a known soft edge in red was overwhelmed during the Sandy storm surge. The soft edge is along a section of DePeyster Creek in Little Ferry adjacent to a residential area. The residents in this area experienced 3 feet of flooding in this neighborhood. The definition of the classification in red is top of berm with elevations below 5 feet.
