# Hackensack Meadowlands Floodplain Management Plan

**The National Flood Insurance Program  
Community Rating System  
Activity 510 Guidelines**

**The New Jersey Meadowlands Commission  
One DeKorte Park Plaza  
Lyndhurst, New Jersey**

**October 24, 2005**

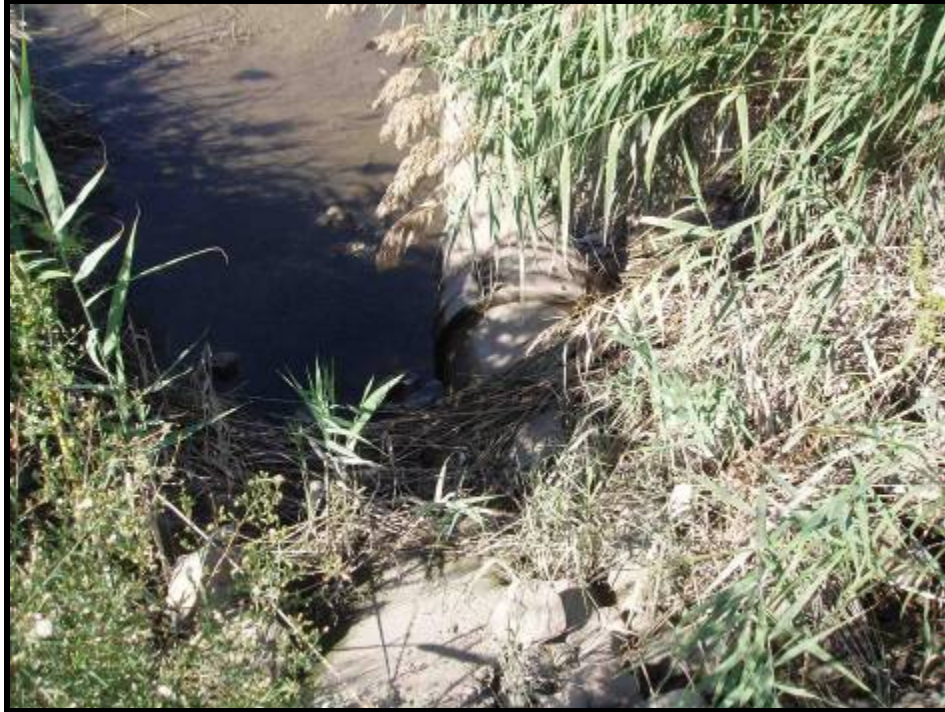
5. Looking at Meadowlands Parkway outfall near Route 3-East entrance ramp (10/03/05)

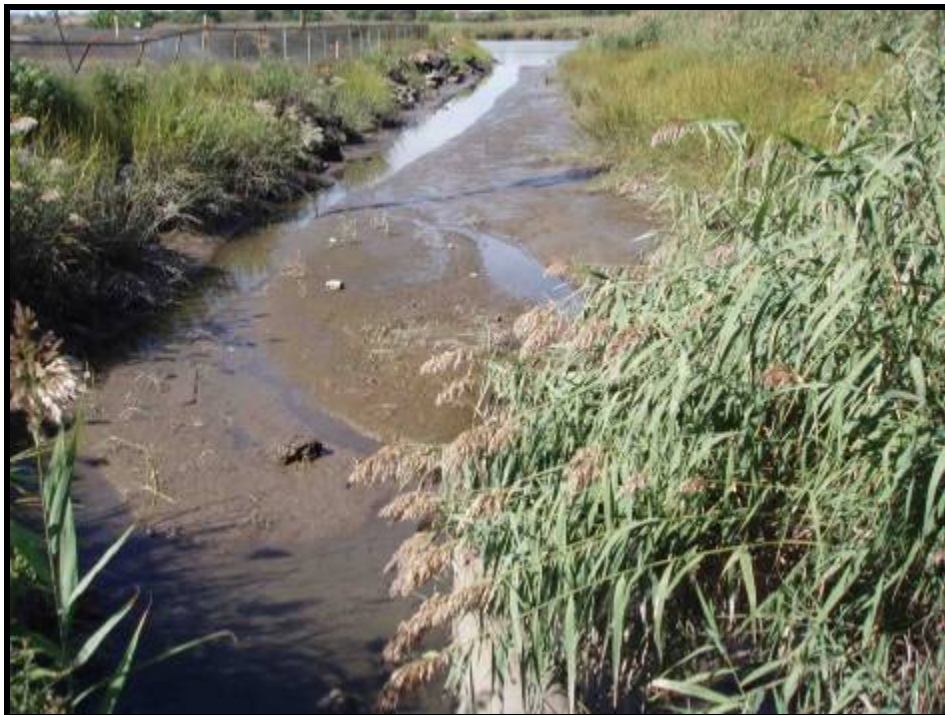
6. Discharge channel from above outfall to Hackensack River (10/03/05)

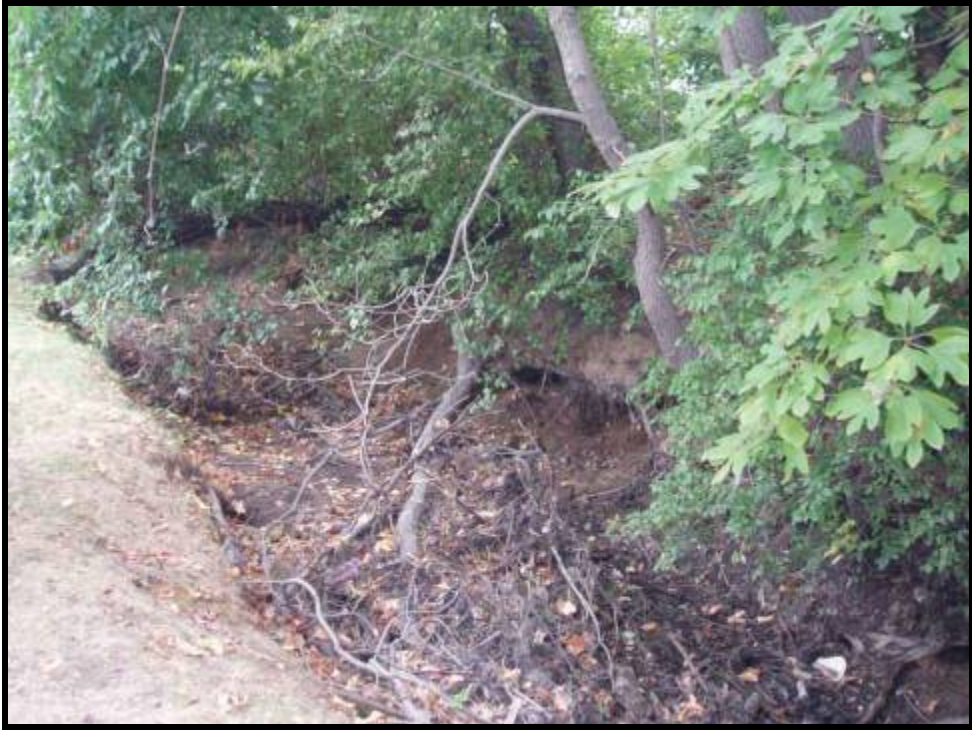
1. Drainage ditch at end of Carol Place (10/06/05)

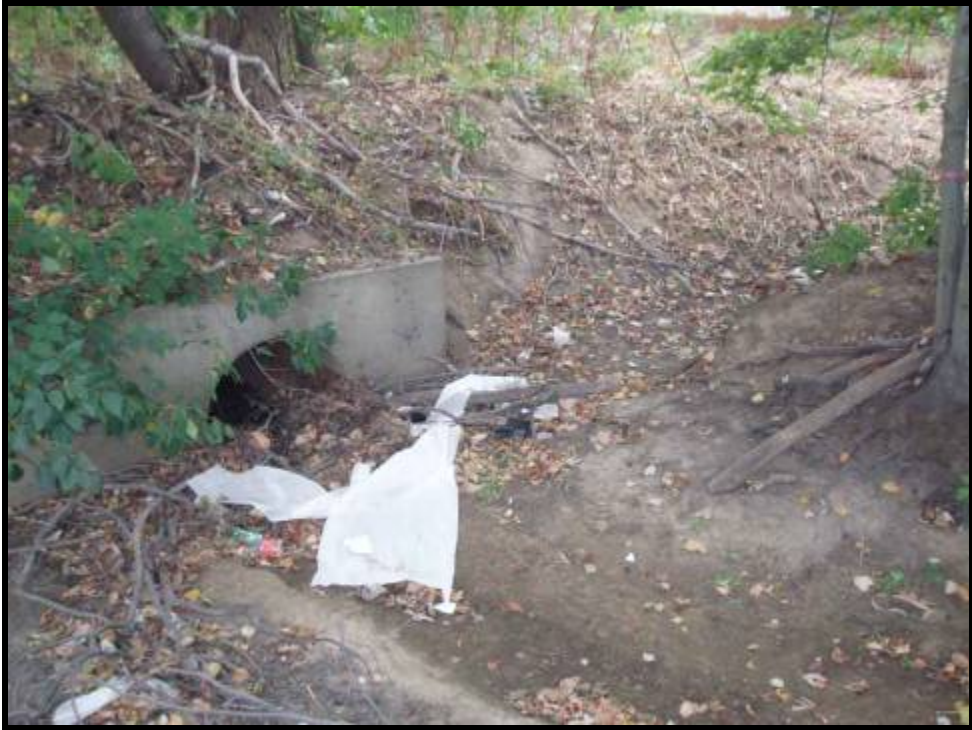
2. Drainage ditch at end of Carol Place (10/06/05)

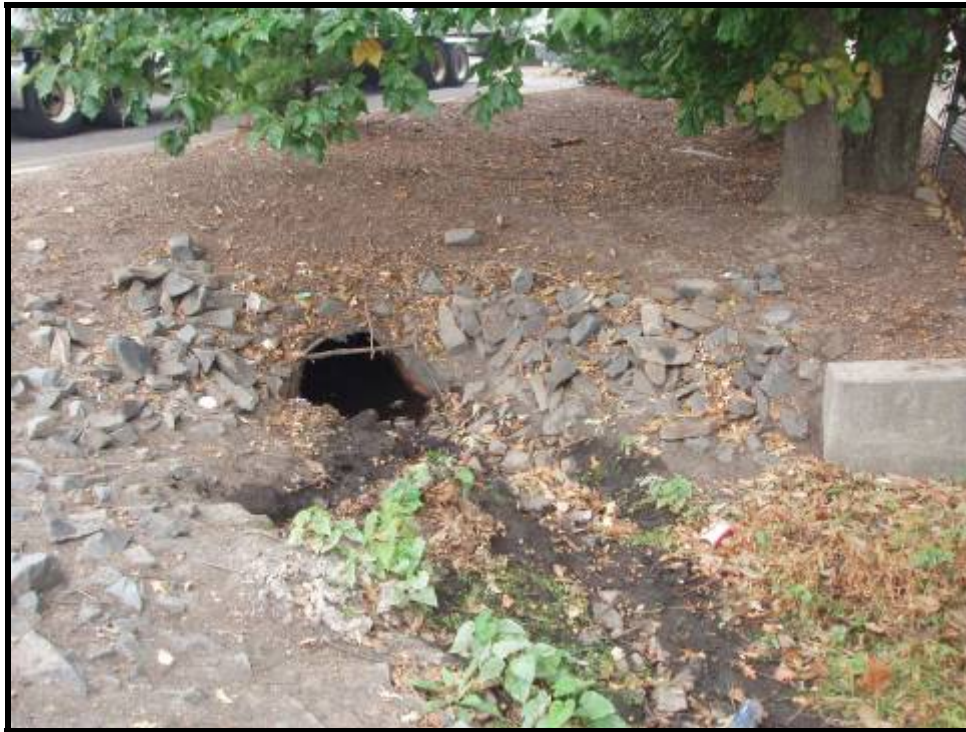
3. Detention basin located at 1 Carol Place (10/06/05)

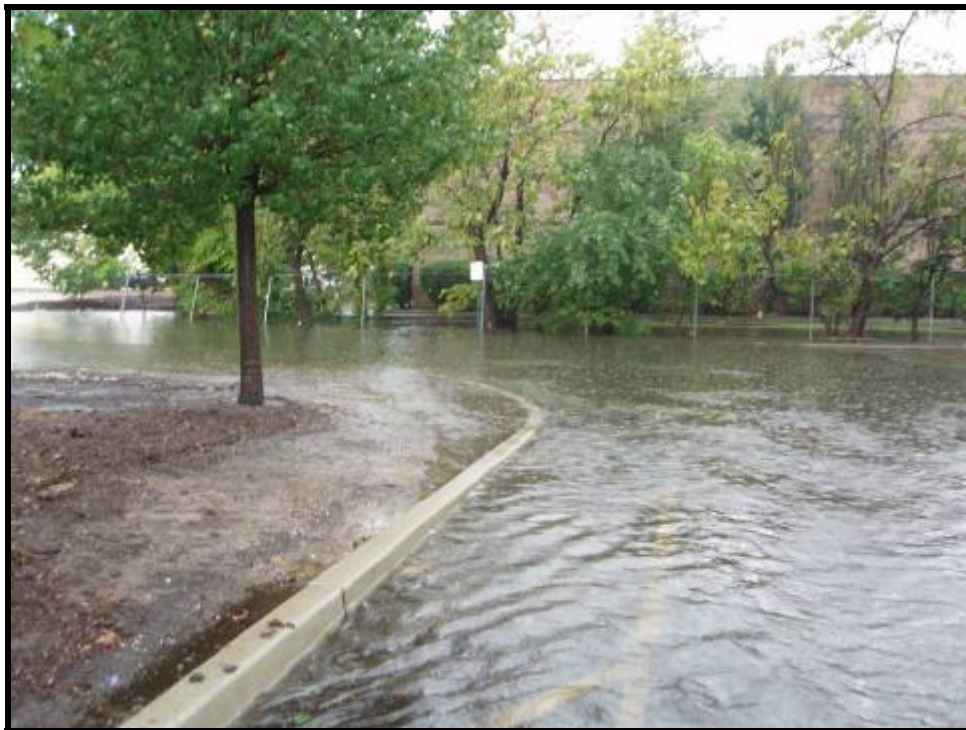
4. View of flooding in the parking lot at 1 Carol Place (10/12/05)

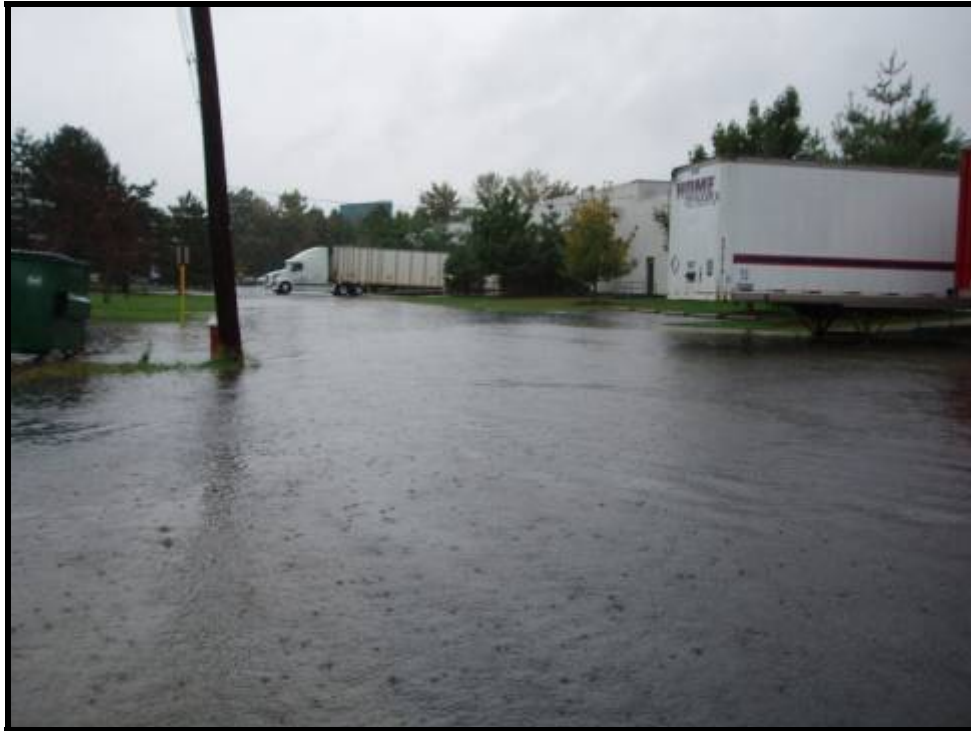
6. View of flooding at 1 Carol Place (10/12/05)

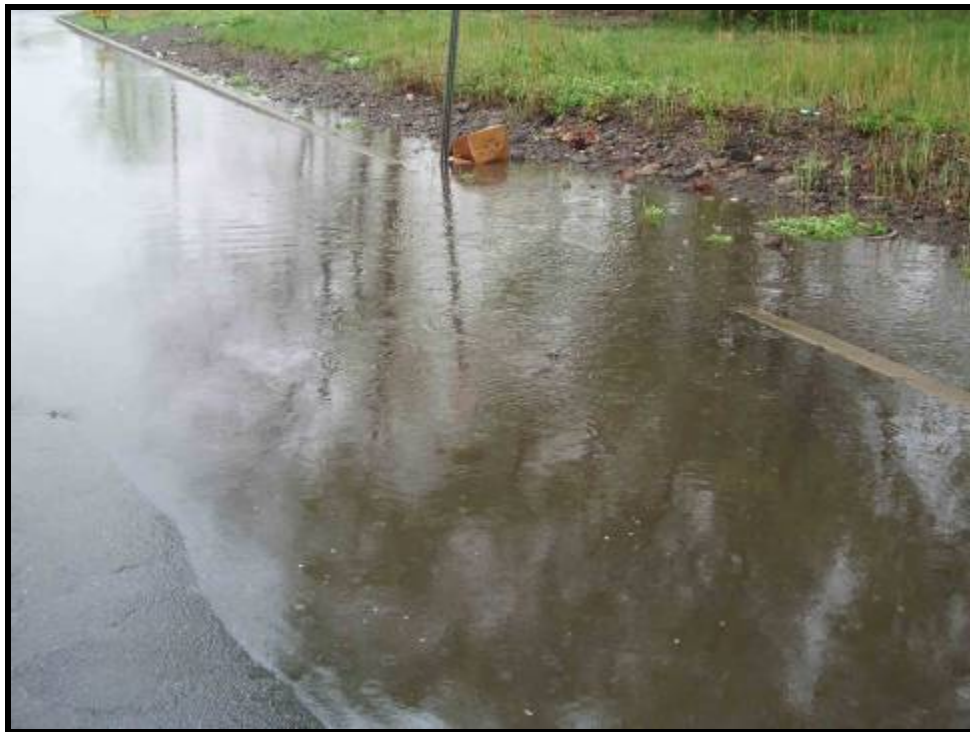
2. Looking Northeast on 16<sup>th</sup> Street along side Block 116, Lot 1 (4/25/05)

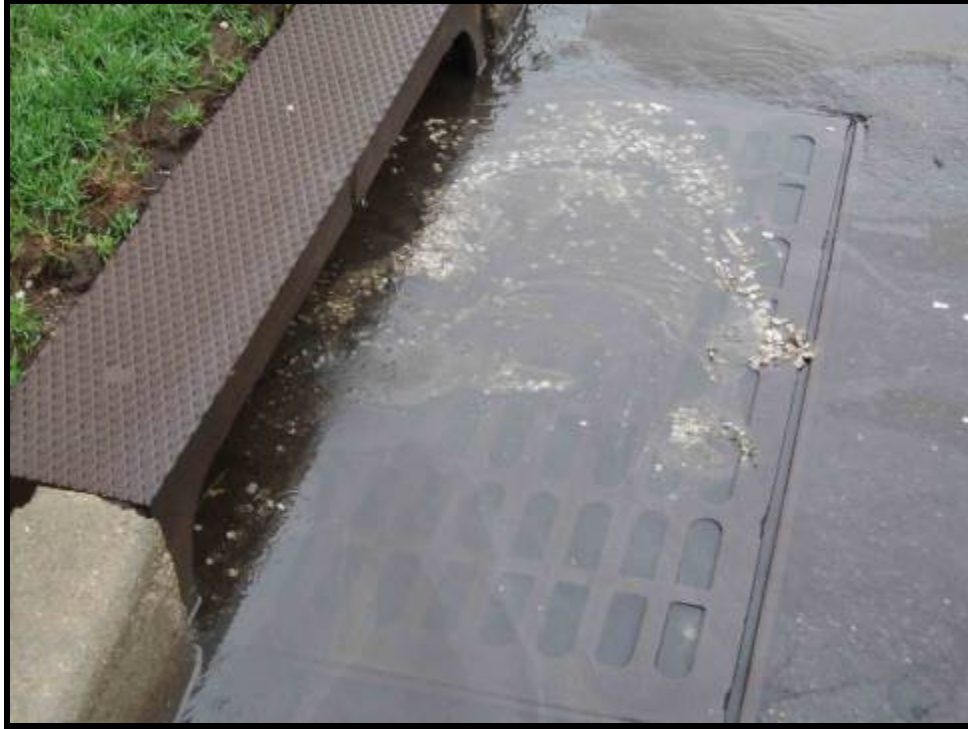
According to recent field inspections, several catch basins in the stormwater sewer system on 16<sup>th</sup> Street and Broad Street are either clogged or have failed (see Photo 3). The percentages of collapsed catch basins and catch basins clogged with silt and/or debris within the watershed are 14% and 25%, respectively, for a total of 39%. The condition of stormwater system outfall(s) could not be confirmed, as their location(s) is unknown.

3. Catch basin on 16<sup>th</sup> Street at the intersection of Paterson Plank Road and 16<sup>th</sup> Street (4/29/05)

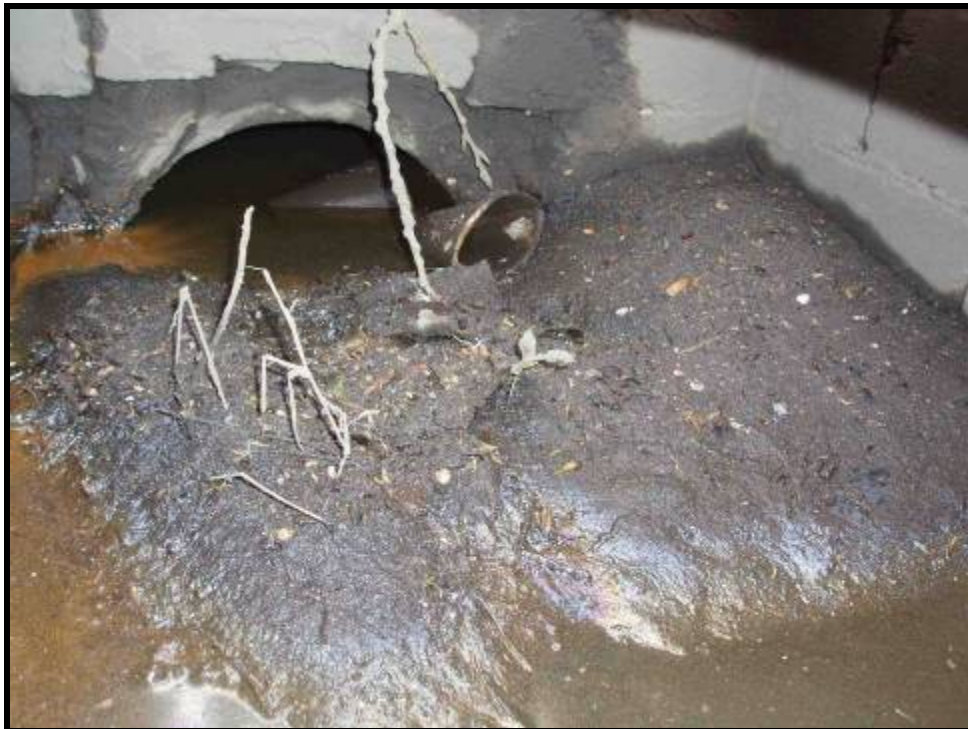
4. Interior of Photo No. 3 catch basin (4/29/05)

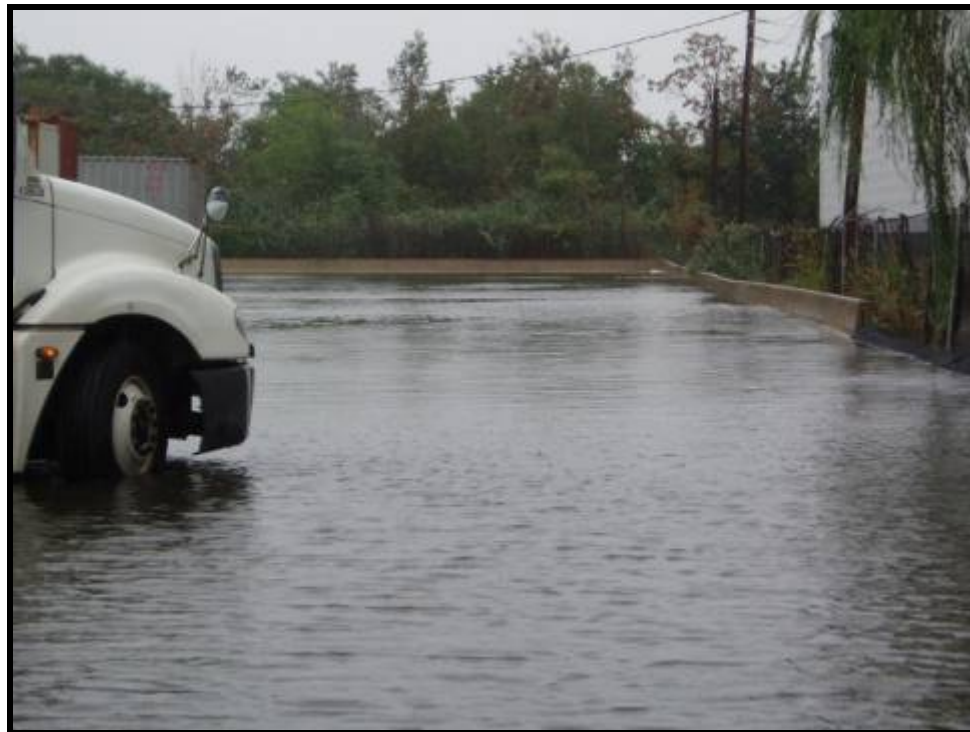
Flooding incidents have been reported to the NJMC in the vicinity of 40 Broad Street in Carlstadt, New Jersey (see Photos 2 and 4). The watershed is located in the western section of Carlstadt. The following table summarizes the flooding incidents:

2. Looking at Northeast corner of parking lot towards the floodwalls (10/14/05)

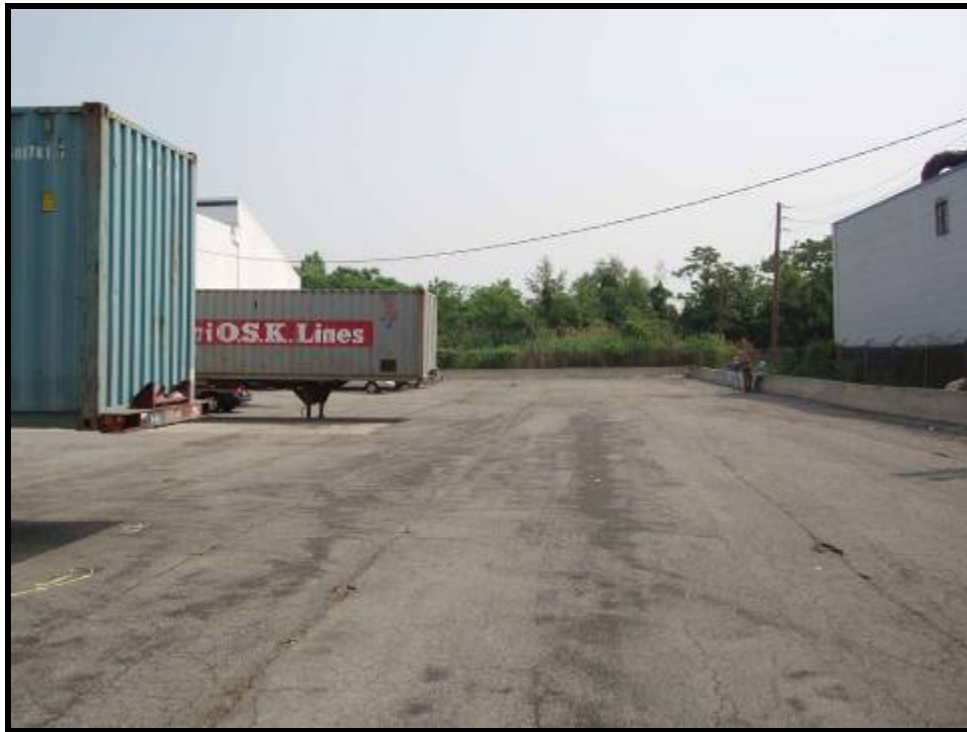
3. Looking Northeast of parking lot towards the floodwalls (6/15/05)

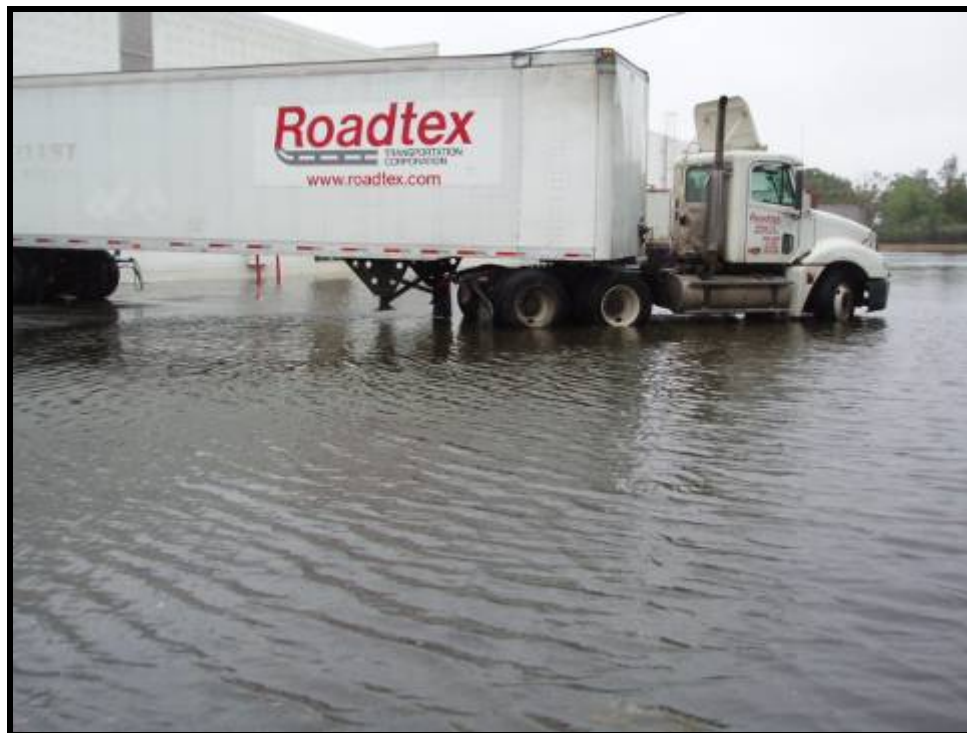
4. Flooded loading docks at 40 Broad Street (10/14/05)

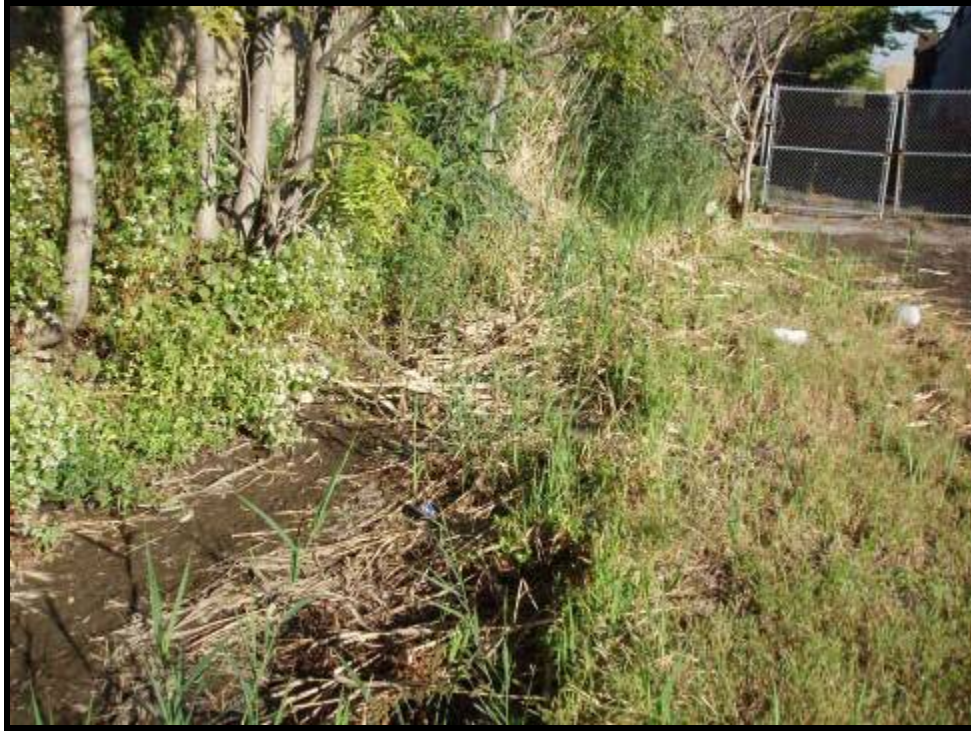
1. Looking downstream at drainage ditch behind 450 Barell Avenue (10/06/05)

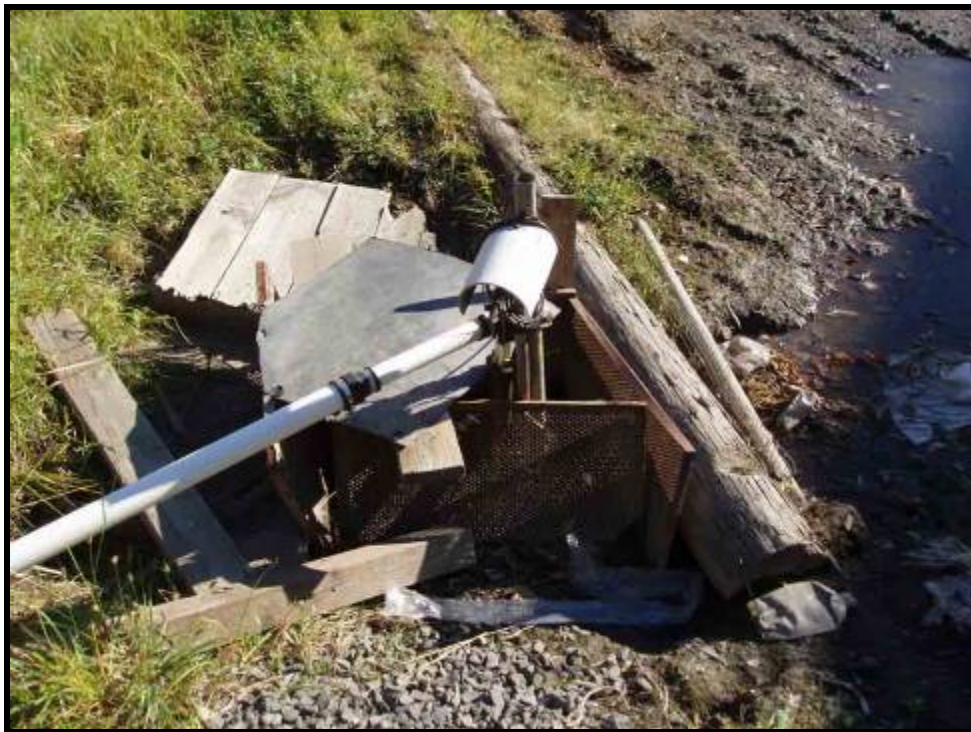
2. Make-shift pump system behind 462 Barell Avenue (10/06/05)

As a safety note, outdoor sump pumps constructed for flood relief by property owners north of the roadway should be dismantled and either abandoned or replaced with a system designed for safe outdoor use (see Photo 2).

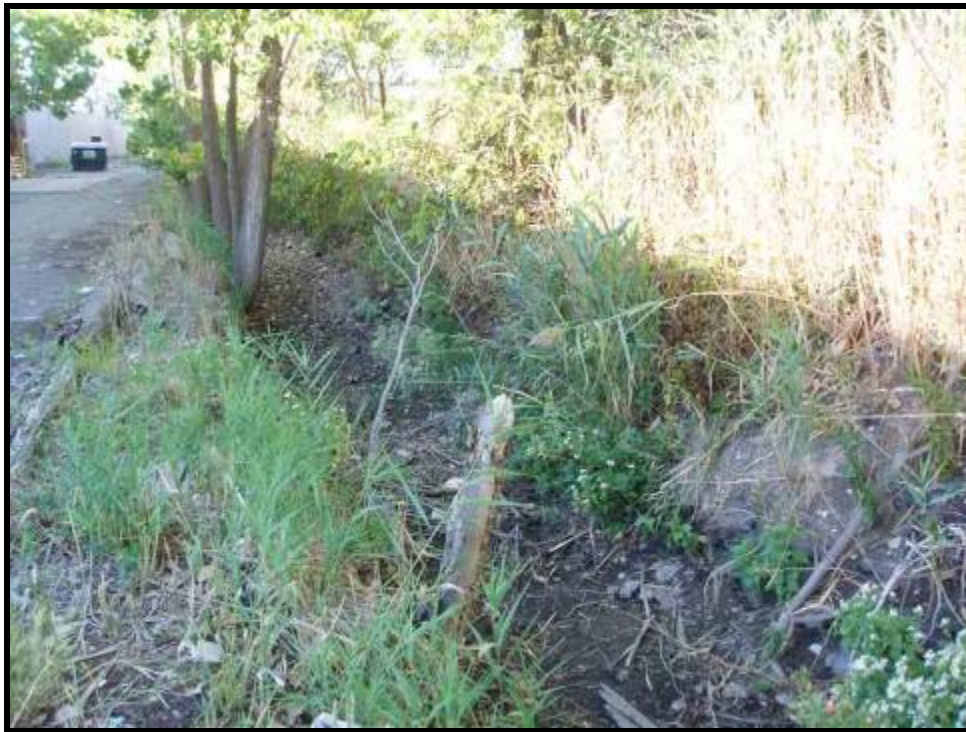
3. Looking upstream at drainage ditch behind 472 Barell Avenue (10/06/05)

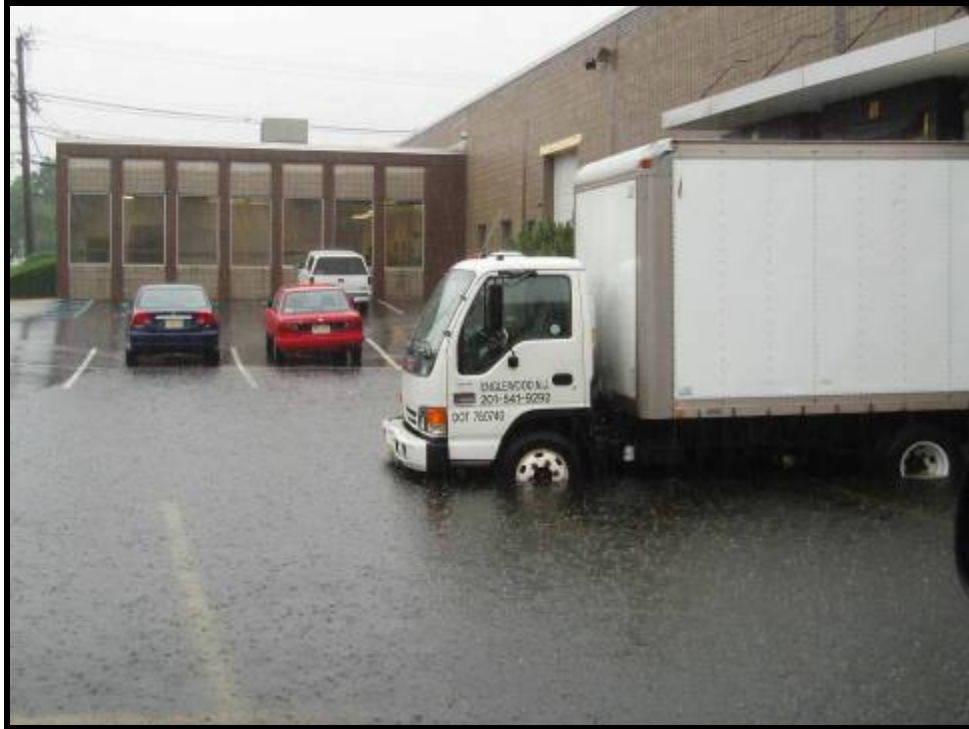
1. Looking Northwest at 120 Asia Place (6/10/05)

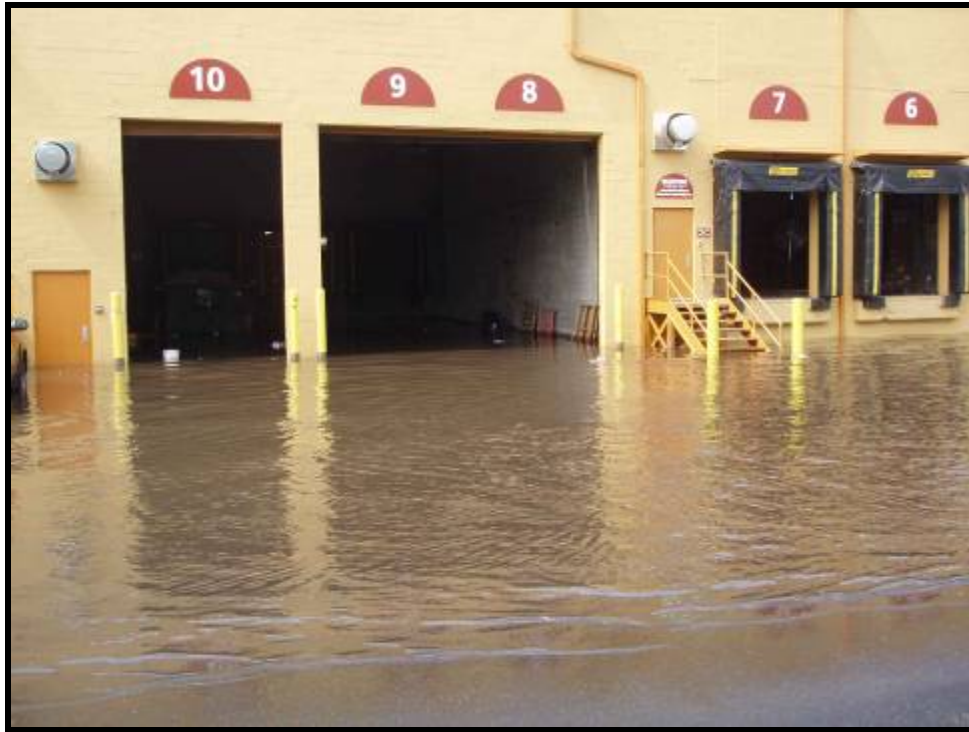
3. Looking Southwest at 135 Kero Road (7/08/05)

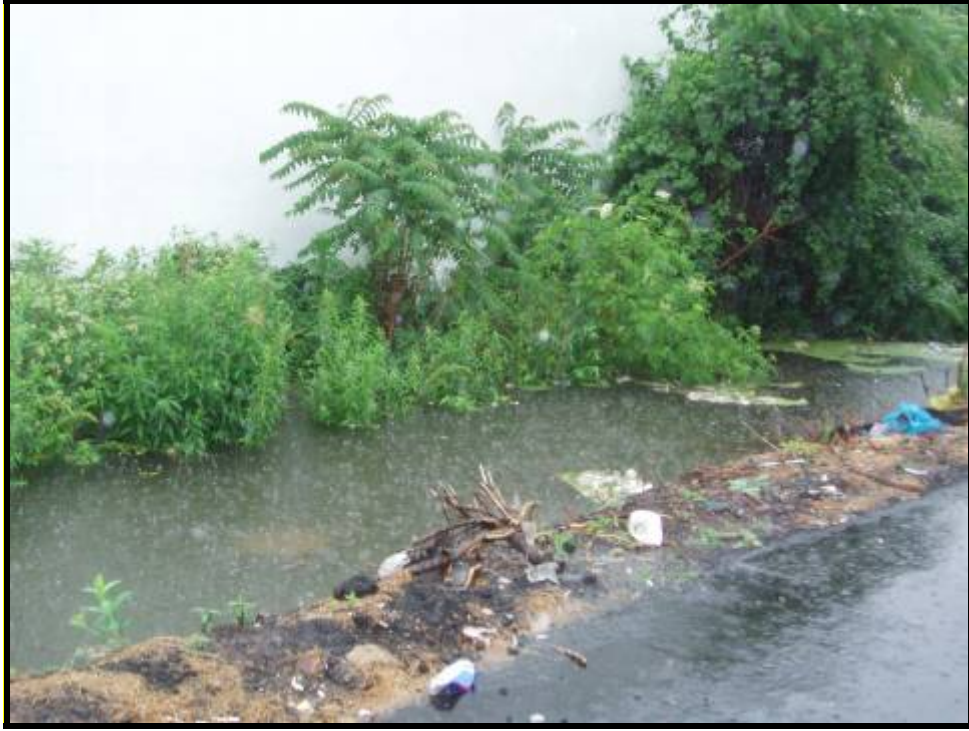
5. Drainage ditch behind 110 Asia Place (6/10/05)

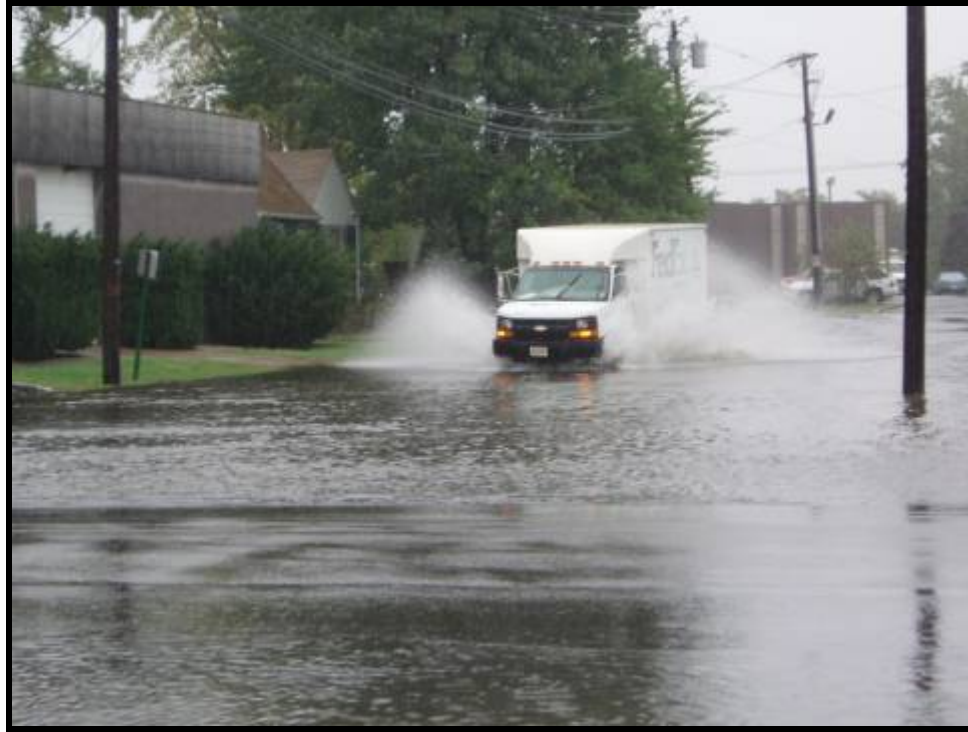
1. Flooding at the intersection of Grand Street and Moonachie Road (10/14/05)

In conjunction with the analysis of the tide gate systems, the Grand Street stormwater sewer system should be cleaned out. Clean out should include the removal of silt and debris from each catch basin and the associated pipe network and outfall(s). Vegetation may need to be removed at the outfall(s). A one-way valve system installation at the outfall(s) is encouraged as part of the drainage system maintenance.

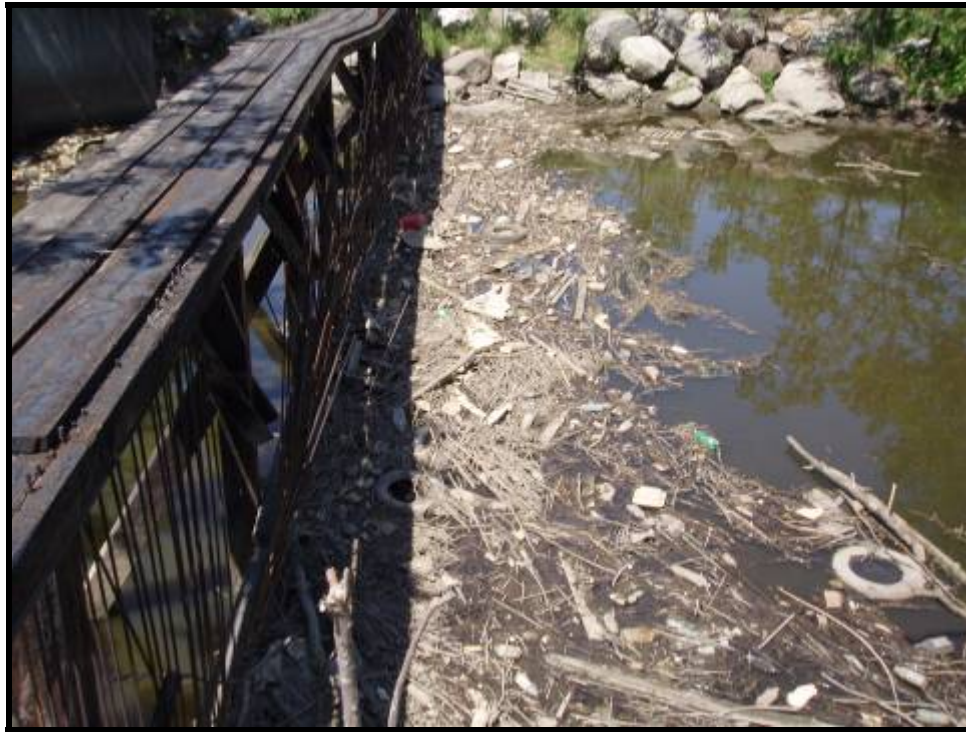
3. Trash rack for East Riser Tide Gate (5/17/05)

The East Riser Tide Gate is located to the south of the watershed. The condition of the tide gate is "good" per the 2004 NJMC field inspection report, but a clean out of the East Riser ditch and the East Riser Tide Gate's trash rack are necessary. The stream located to the west of Avenue C may be tidally influenced if the East Riser Tide Gate is not fully functional.

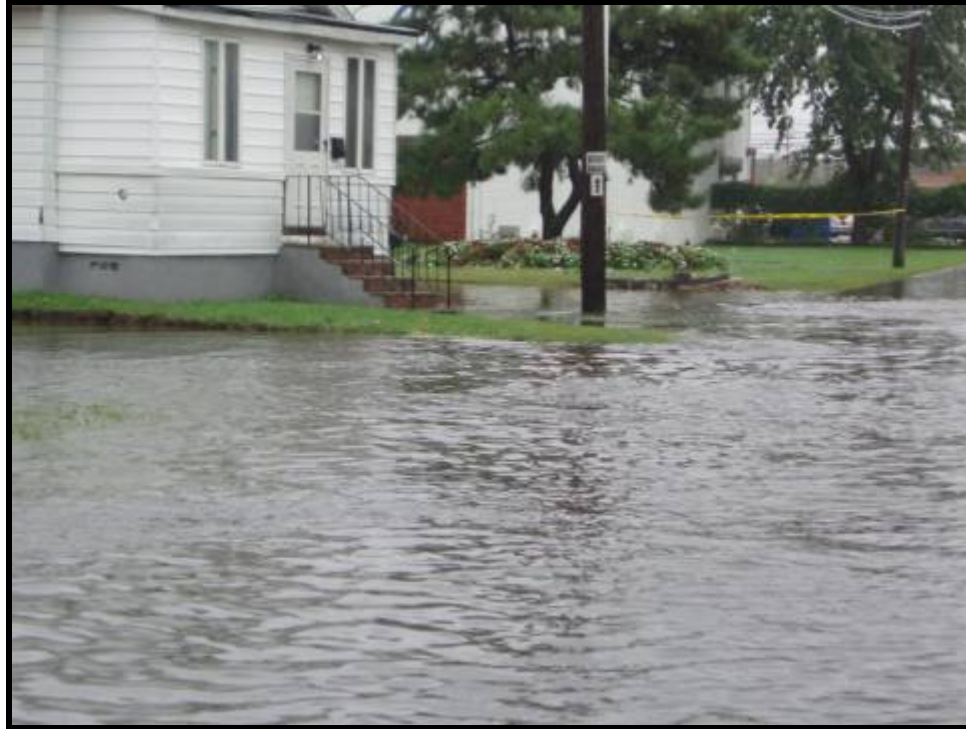
4. Flooding at the intersection of Grand Street and Anderson Avenue (10/14/05)

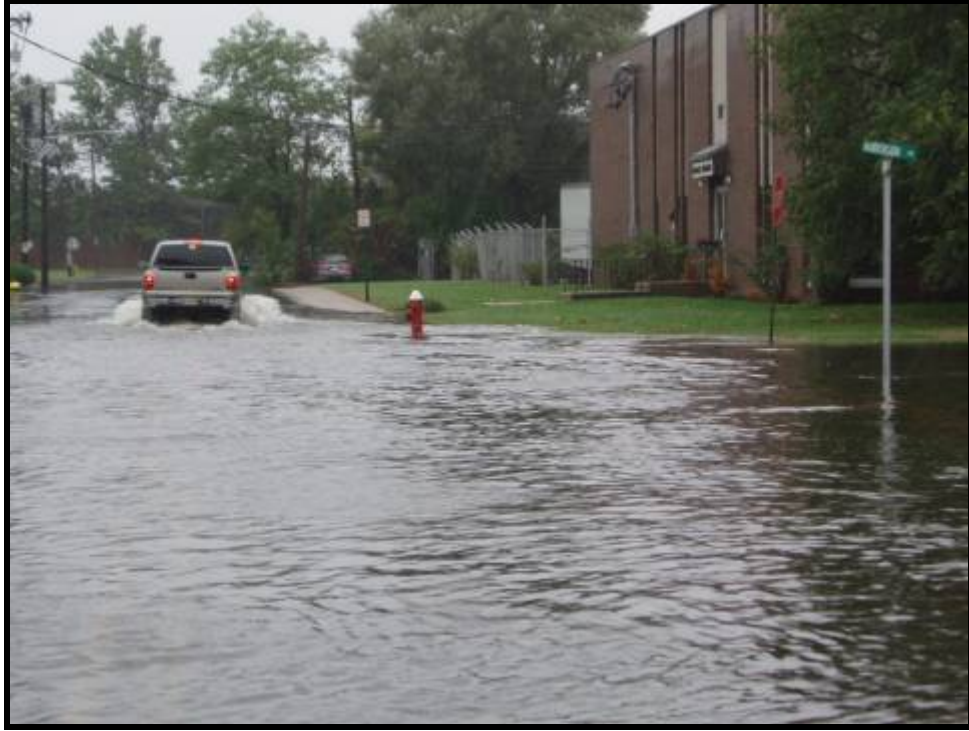
5. Flooding at the intersection of Grand Street and Anderson Avenue (10/14/05)

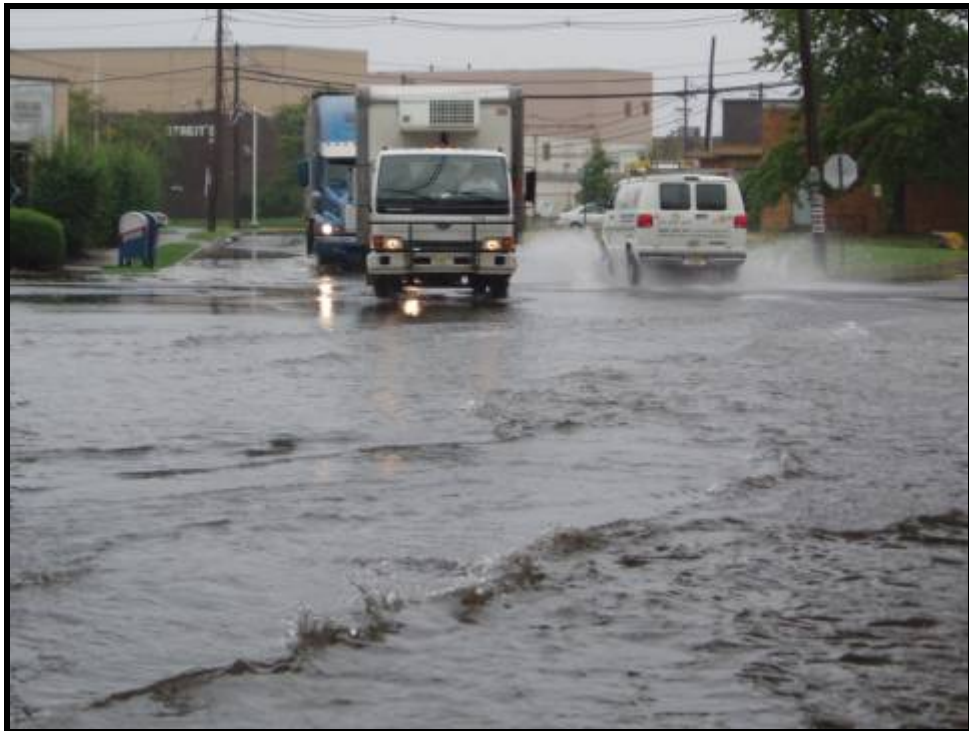
6. Flooding at the intersection of Grand Street and Christiana Avenue (10/14/05)

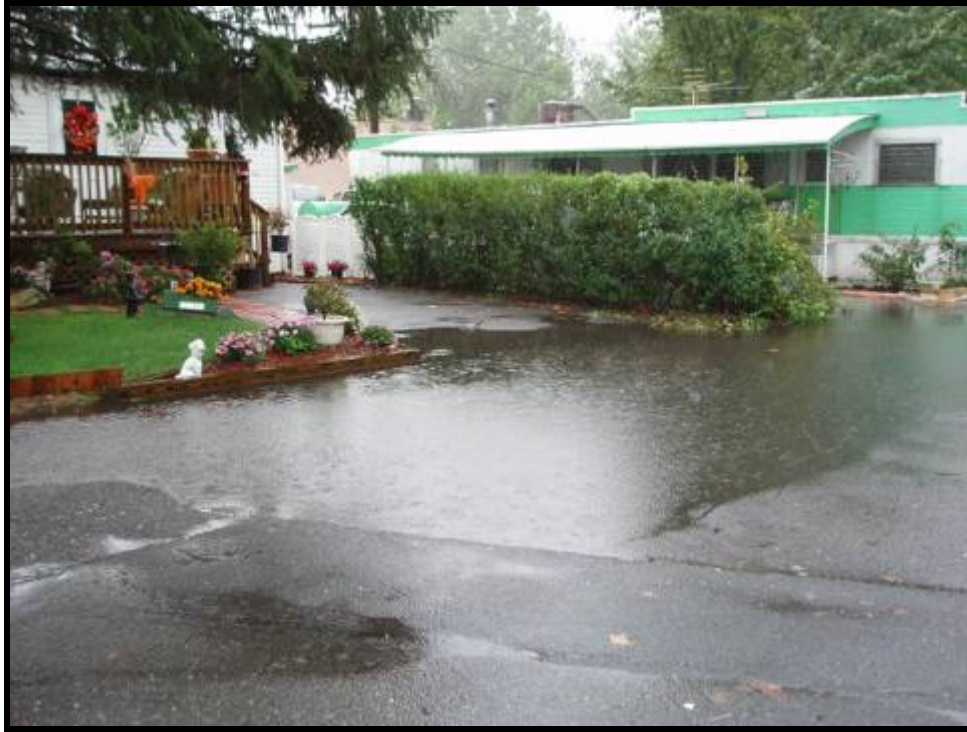
1. Looking southwest from the entrance to the mobile home area (10/14/05)

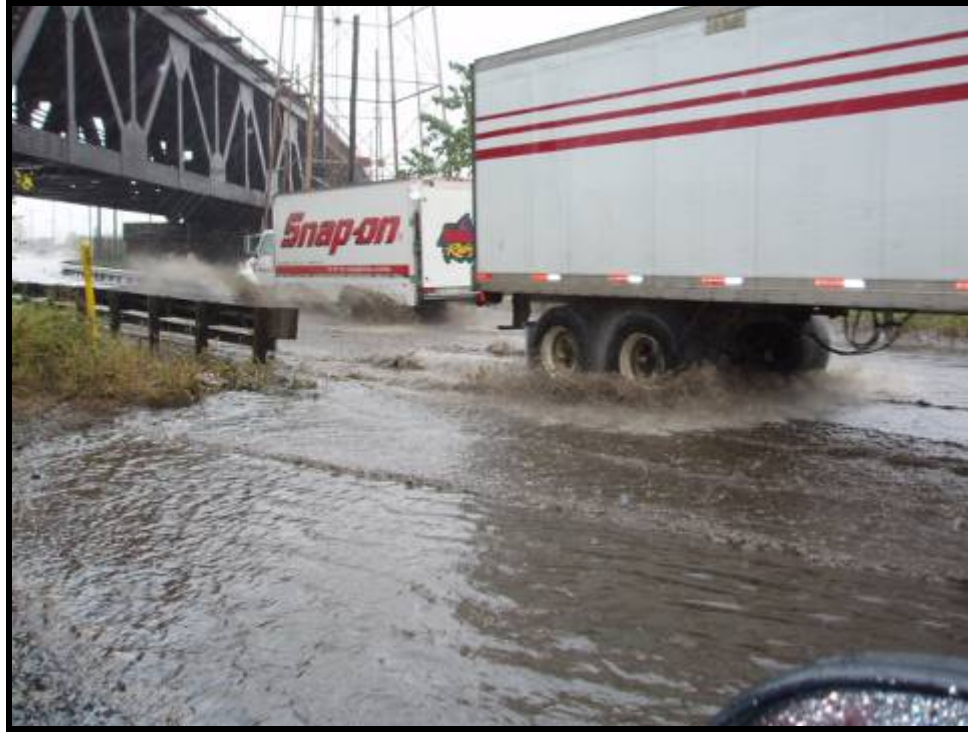
1. Looking Southwest along Fish House Road near the CSX rail bridge (10/14/05)

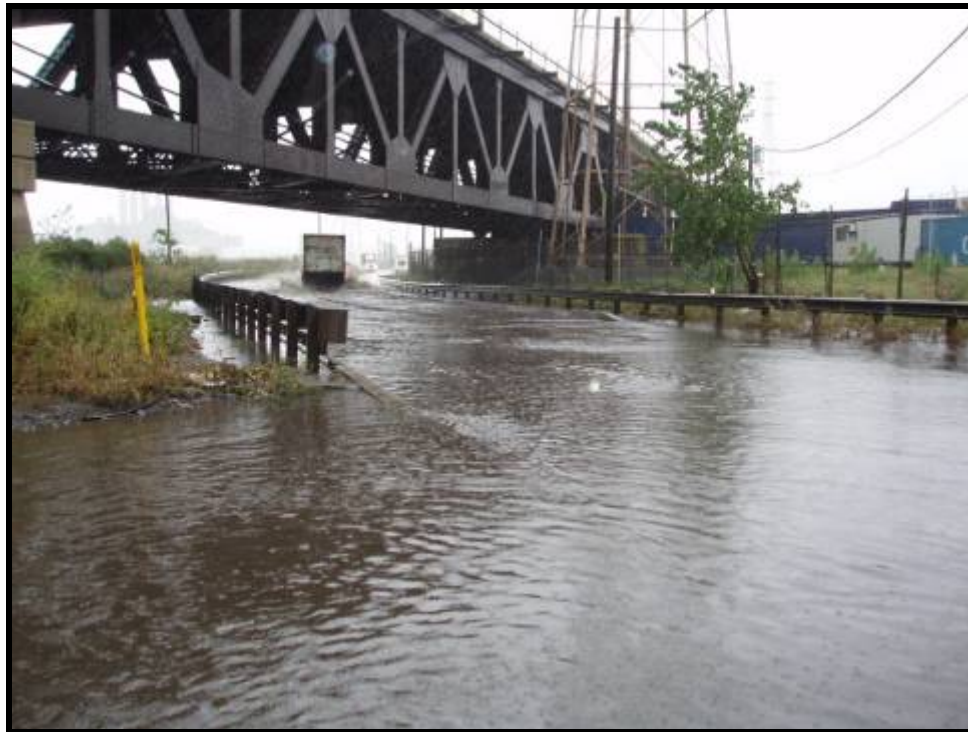
2. Looking Southwest along Fish House Road near CSX rail bridge (10/14/05)

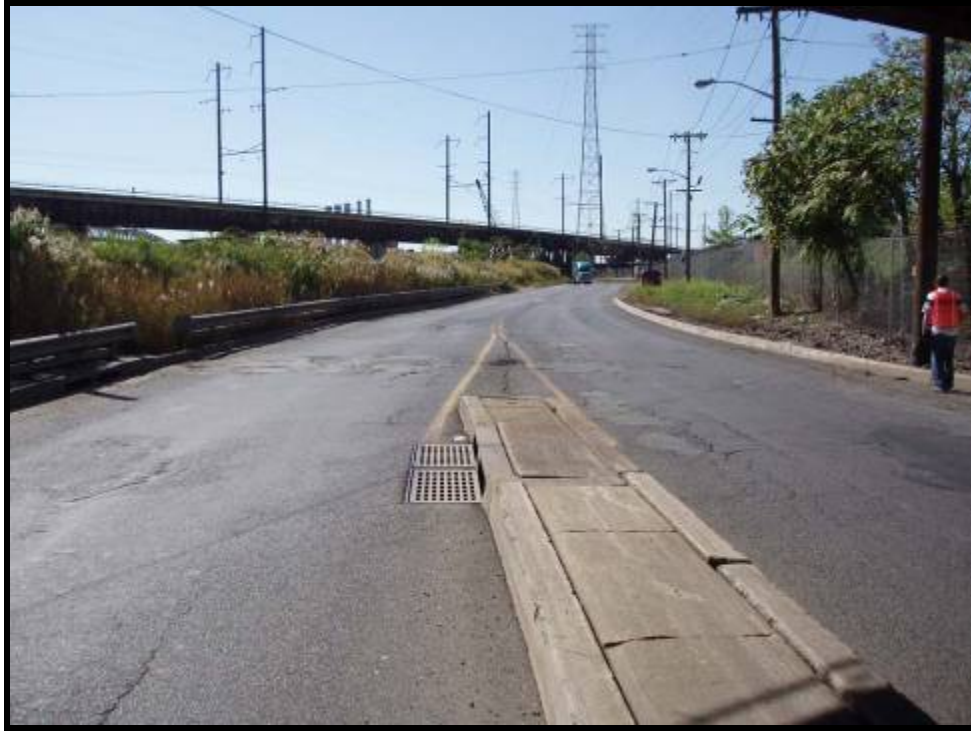
3. Looking West Along Fish House Road underneath the PATH bridge (10/06/05)

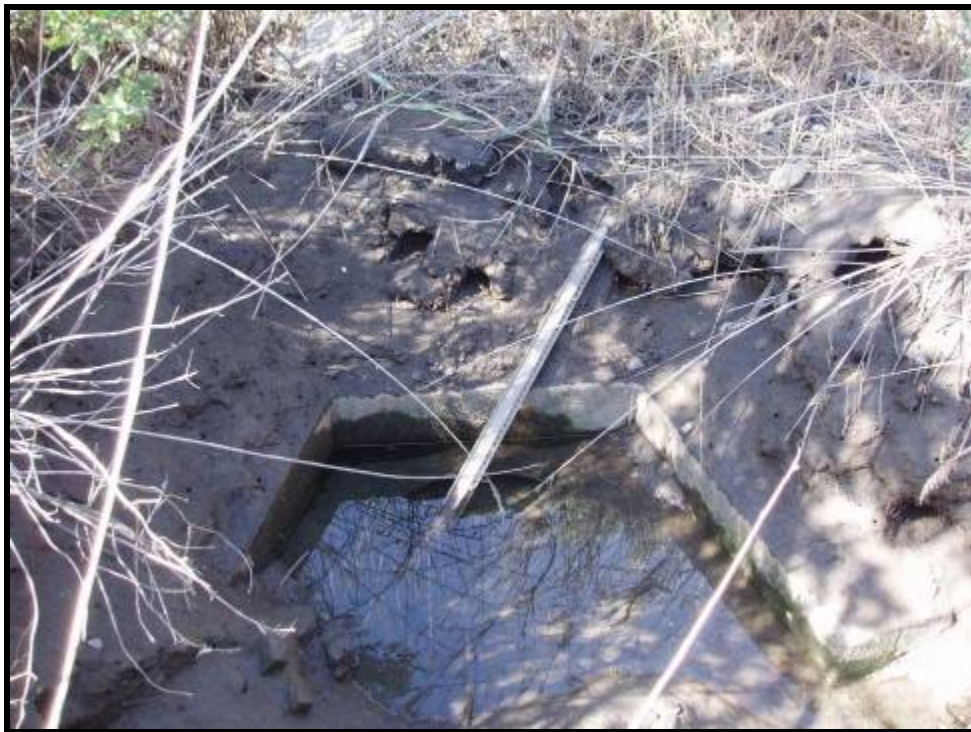
The first stormwater sewer system outfall is located east of Fish House Road immediately south of the PATH Bridge and the Route 7 Bridge. The concrete outfall pipe is 80% to 90% clogged with sediment (see Photo 4). A discharge channel conveys flows to the Hackensack River. The discharge channel is completely blocked with sediment and vegetation (see Photo 5).

4. Outlet located alongside Fish House Road near the PATH bridge (10/06/05)

Additional short-term needs include permanent access to the outfalls and the installation of a one-way valve on the outfall nearest the PATH bridge. It is noted that there is a natural gas pipeline warning marker near the outfall (see Photo 7). Riprap scour control should be designed and placed following the clean out.

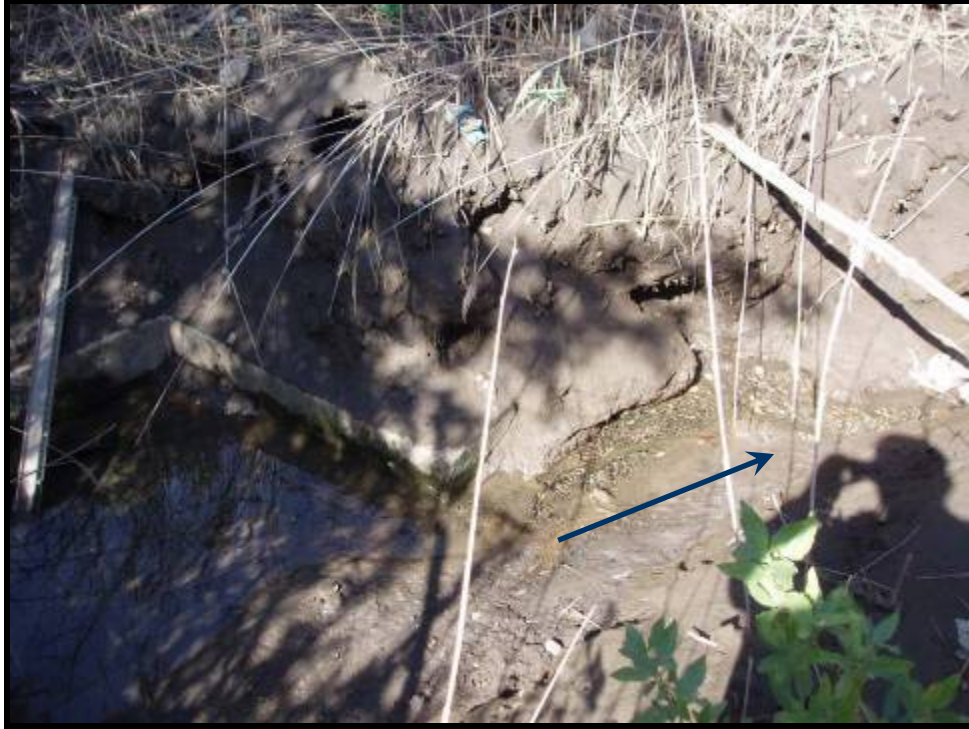
5. Drainage ditch serving system in Photo 4 (10/06/05)
