# Hackensack Meadowlands Floodplain Management Plan

**The National Flood Insurance Program  
Community Rating System  
Activity 510 Guidelines**

**The New Jersey Meadowlands Commission  
One DeKorte Park Plaza  
Lyndhurst, New Jersey**

**October 24, 2005**

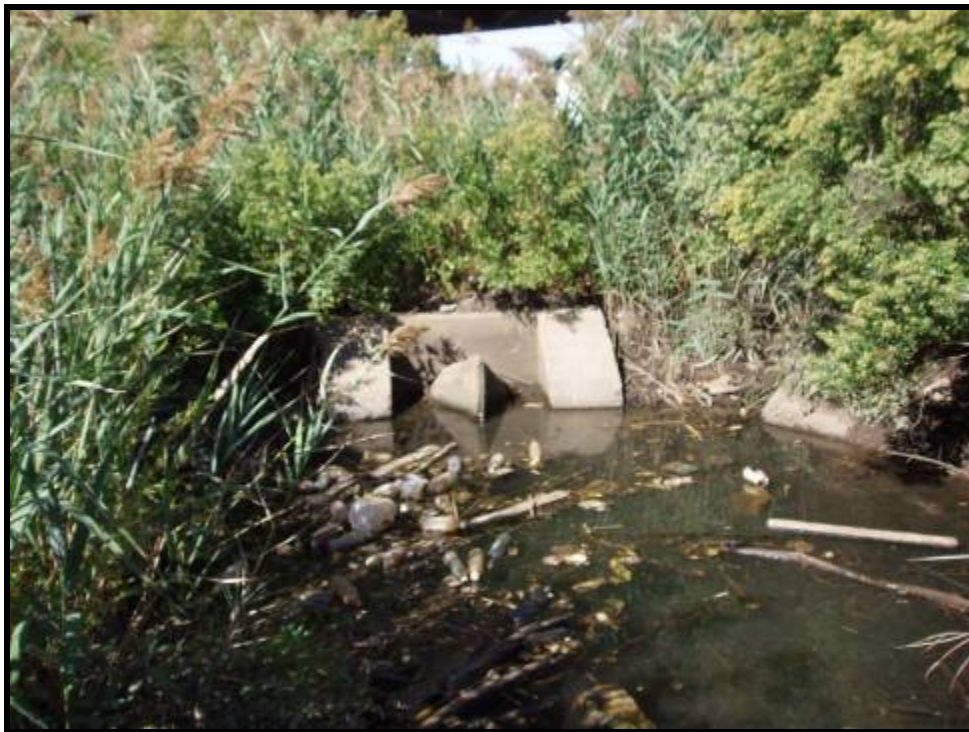
The second stormwater sewer system outfall is located east of Fish House Road near the CSX bridge and south of the above system. The outfall pipe is fitted with a TideFlex valve (see Photo 6). The associated discharge channel to the Hackensack River is completely clogged with sediment and vegetation (see Photo 7). Note that the Hudson County Division of Engineering does not think that this outfall is associated with the roadway but rather serves private property.

6. Second outfall with one-way valve system located alongside Fish House Road near CSX Rail Bridge (10/06/05)

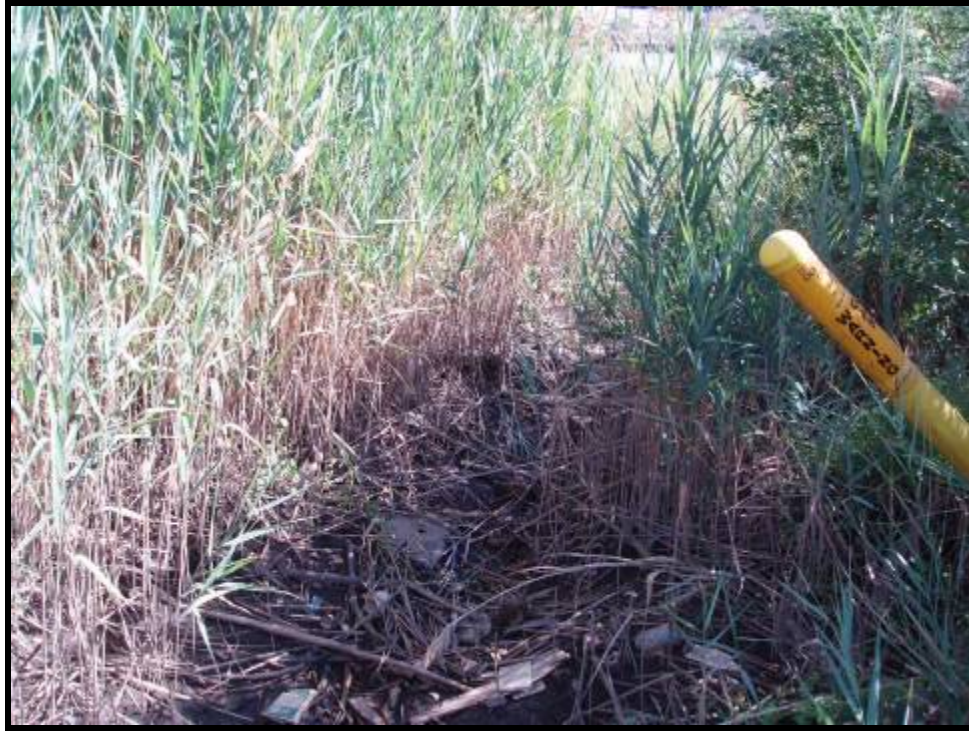
7. View of discharge channel to Hackensack River from above system (Photo 6) (10/06/05)  
**(Note: Gas line warning marker at right)**

Additional short-term needs include permanent access to the outfalls and the installation of a one-way valve on the outfall nearest the PATH bridge. It is noted that there is a natural gas pipeline warning marker near the outfall (see Photo 7). Riprap scour control should be designed and placed following the clean out.

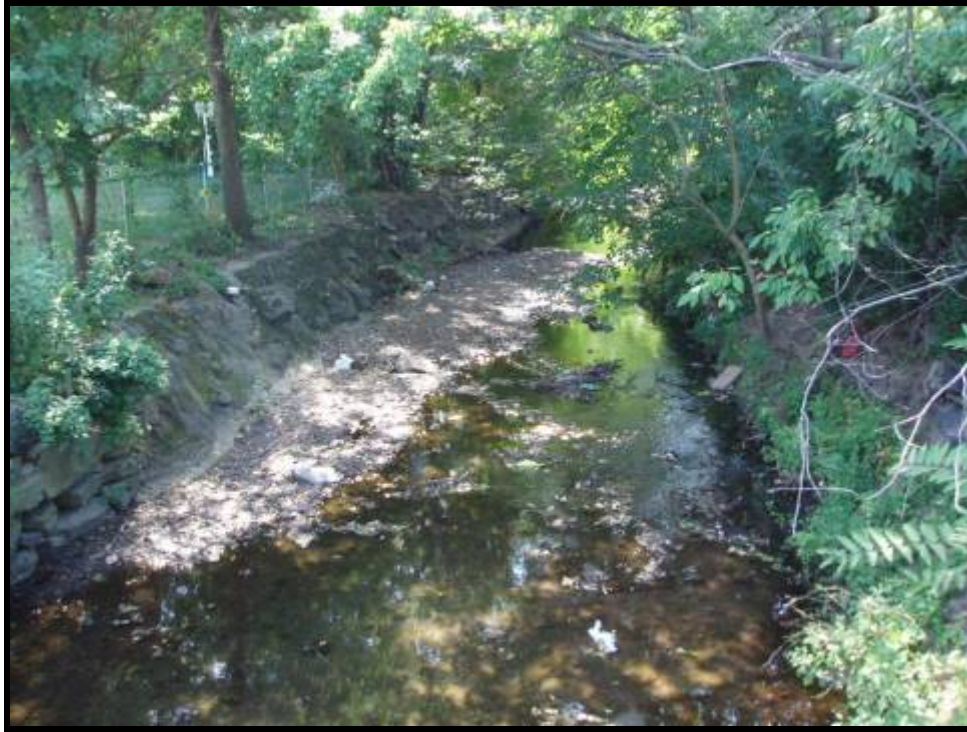
1. Wolf Creek looking Southwest from Elite Court Overpass (9/09/05)

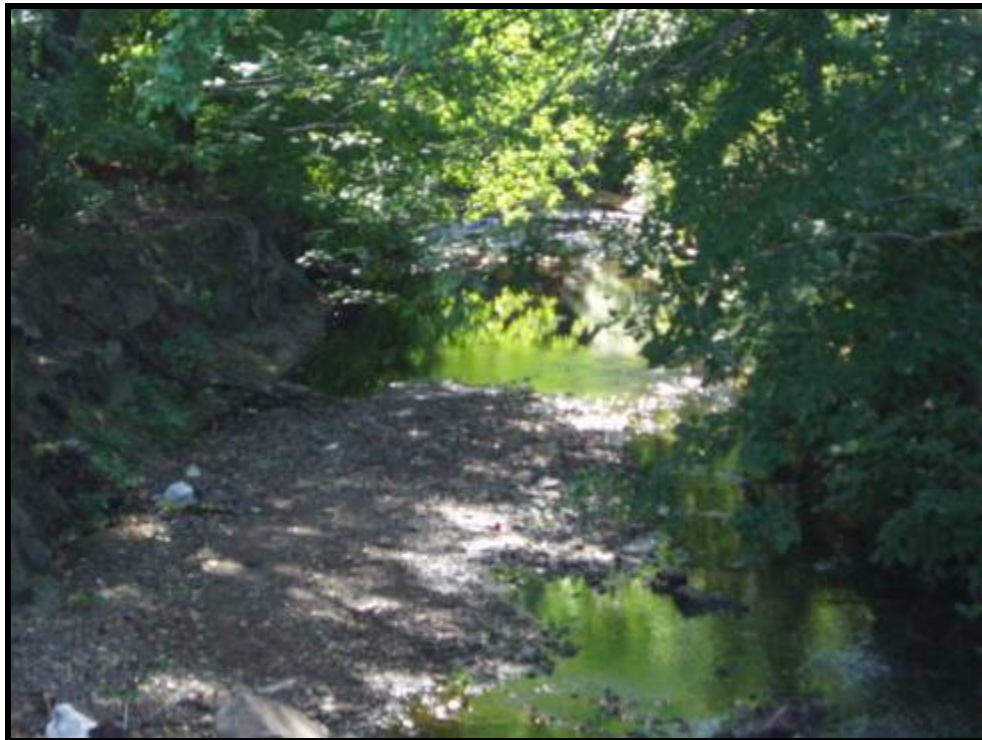
2. Wolf Creek looking Northeast from Elite Court Overpass (9/09/05)

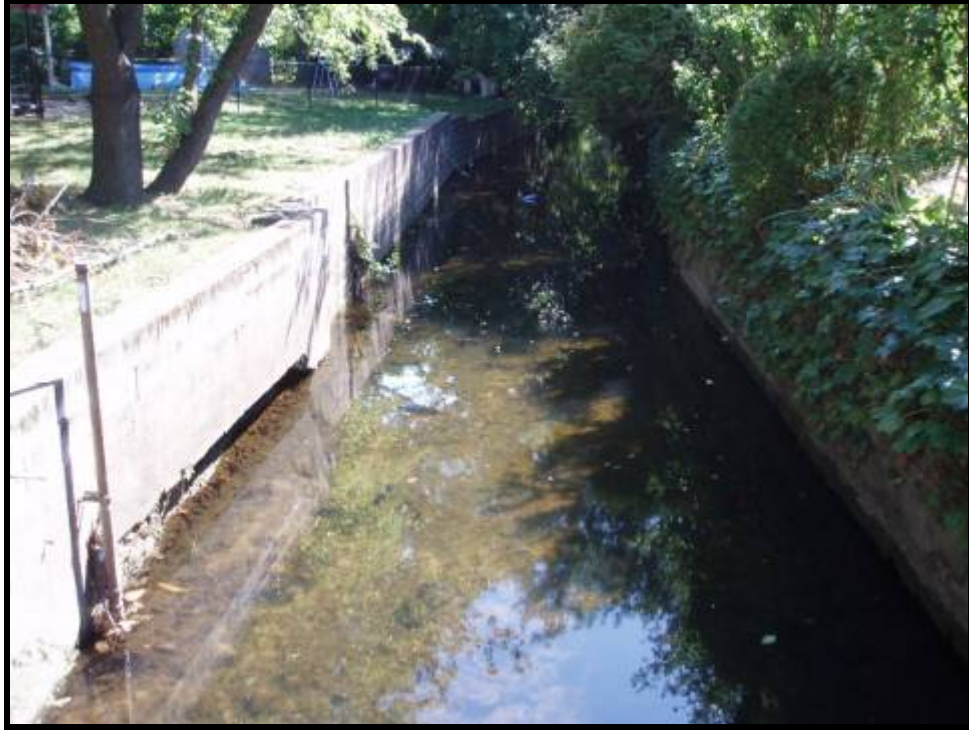
3. Wolf Creek looking Southwest from Clark Avenue Overpass (9/09/05)

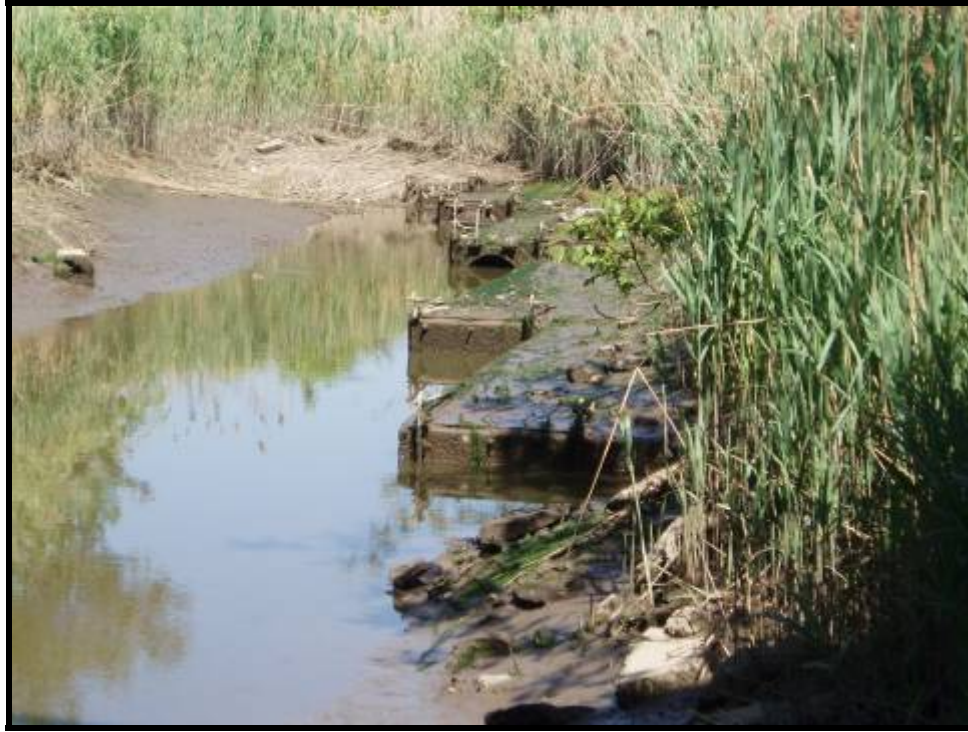
1. Looking Northwest at Rutherford Tide Gates outfalls (5/17/05)

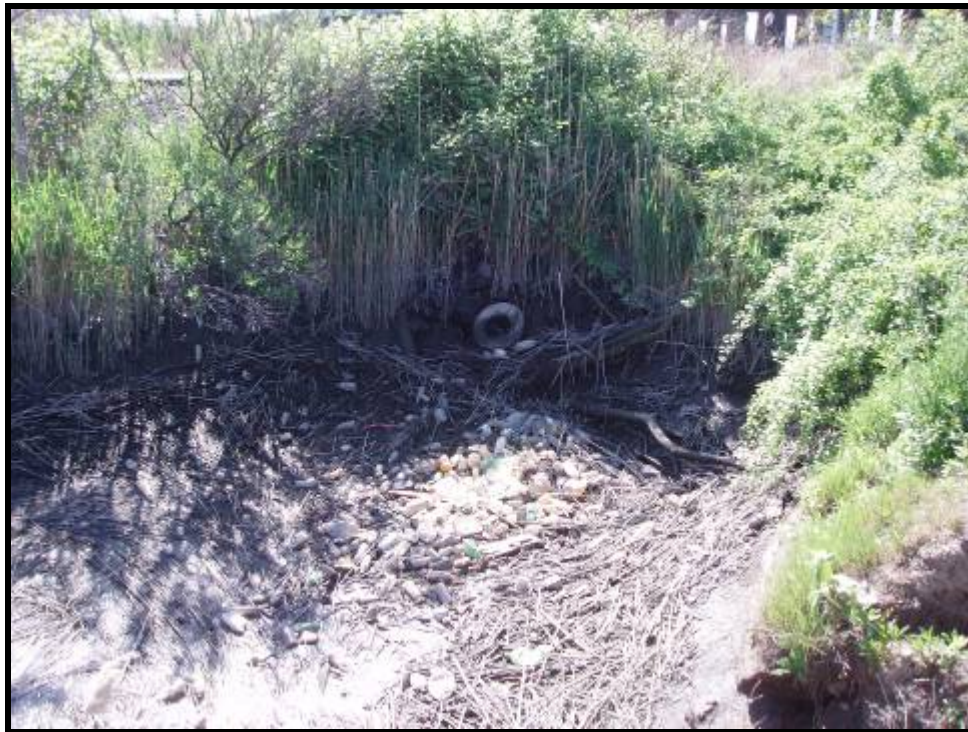
2. Upstream inlets (submerged) to the Rutherford Tide Gates (5/17/05)

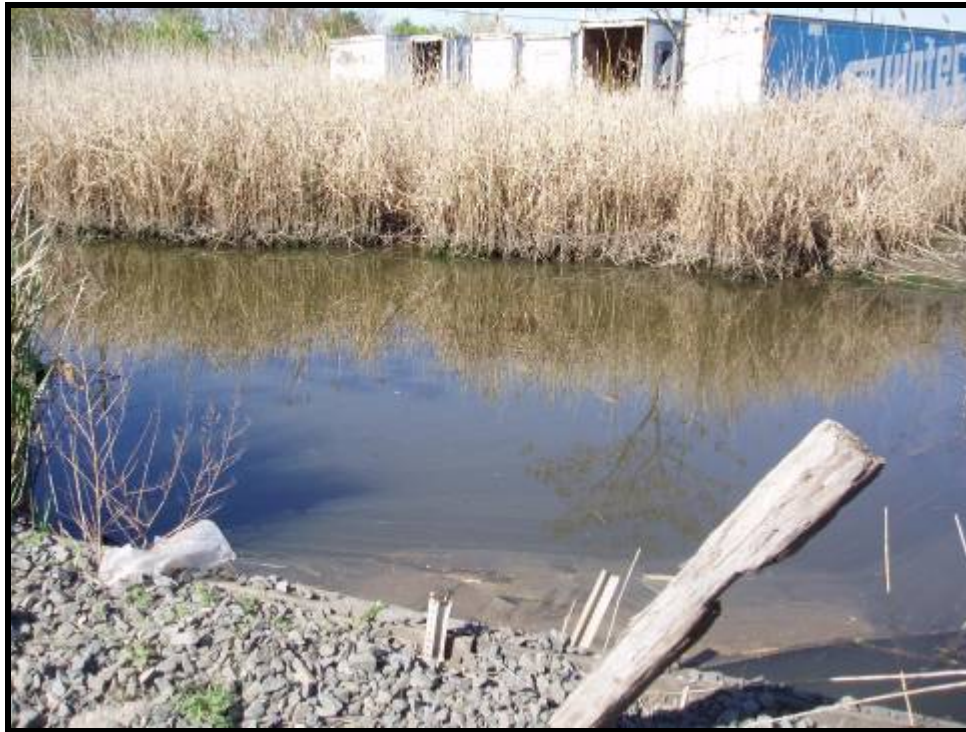
The upstream culverts noted above, two (2) 36-inch corrugated metal pipes, are completely collapsed. The embankment supporting a light industrial rail siding that passes over the culverts and connects to the Bergen County Line is showing signs of subsidence. Additionally, the drainage ditches upstream of the tide gates that run parallel to, and on each side of the Bergen County Line, are partially clogged and are in inadequate condition to convey stormwater from Route 17 (see Photo 4).

3. Entrance channel to collapsed twin culverts (5/17/05)

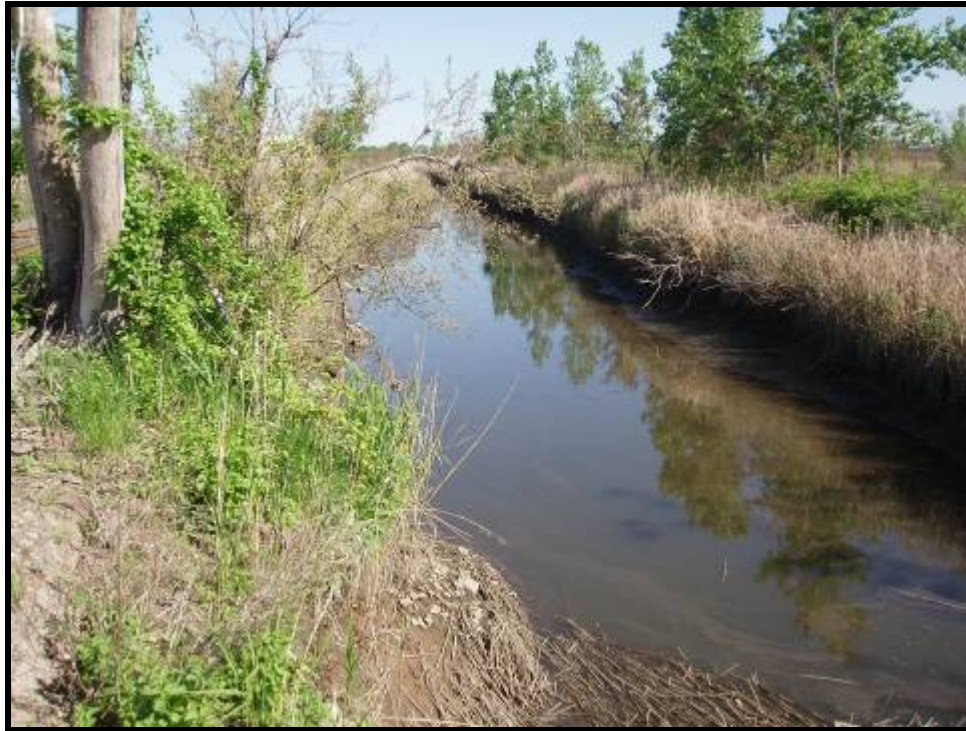
4. Drainage channel upstream of the Rutherford Tide Gates (5/17/05)

While the analysis and restoration of the tide gate system is underway, the stormwater sewer system within the watershed should be cleaned out immediately, including the removal of silt and debris from each catch basin and the removal of silt, debris, and/or vegetation from all outfalls. A one-way valve system installation at the outfall(s) should be considered as part of the drainage system cleanout.

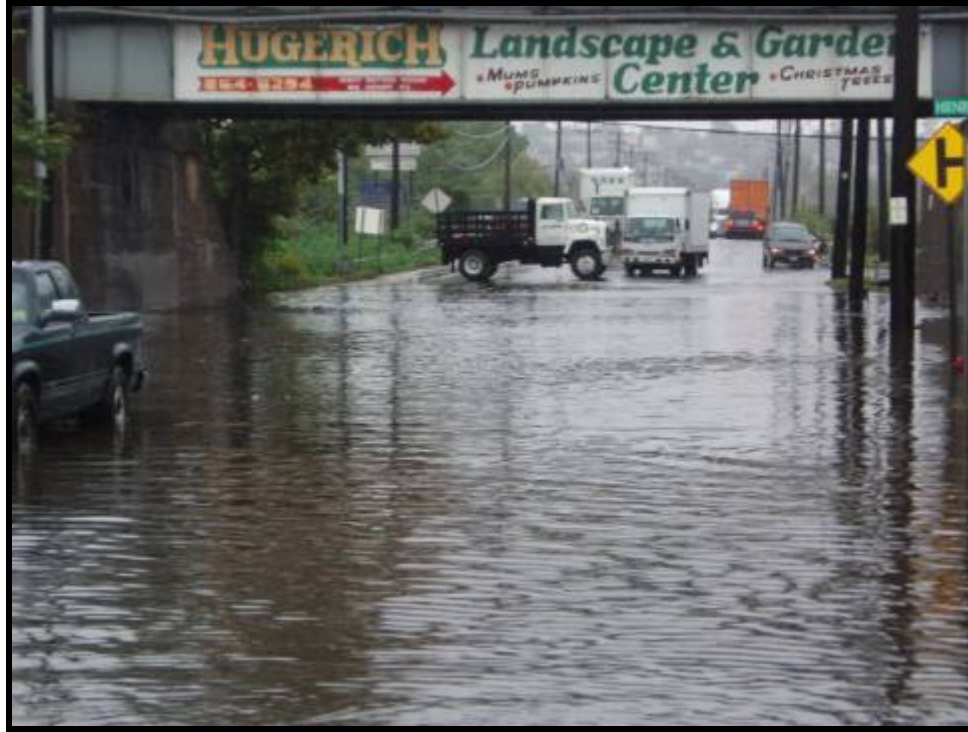
1. Looking Southeast on Secaucus Road near NJ Transit railroad (10/14/05)

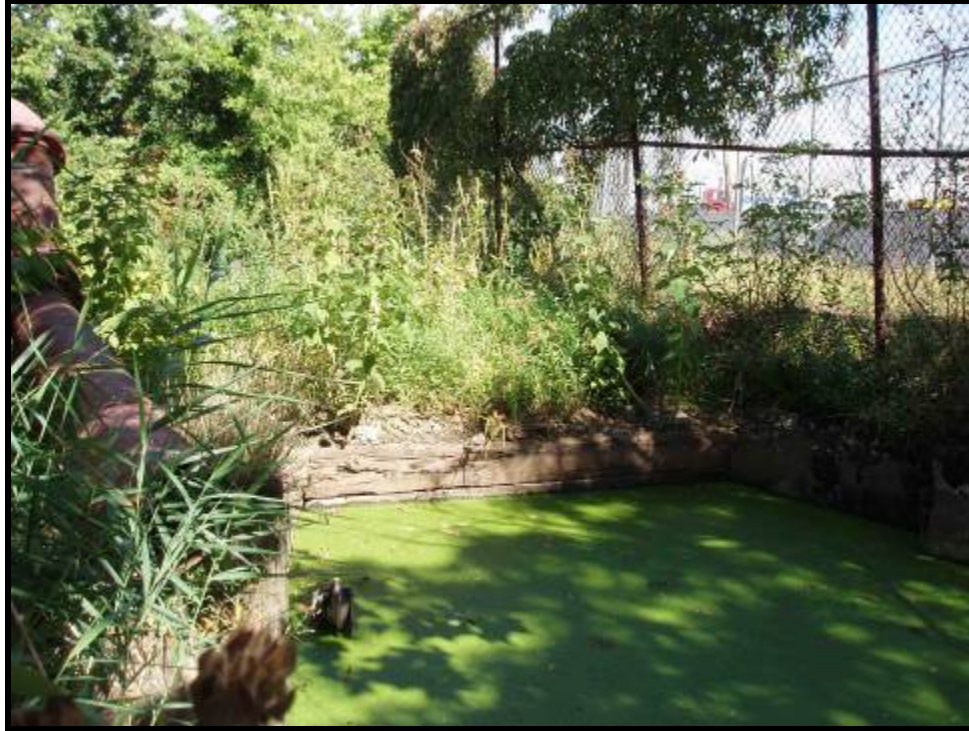
5. Downstream of Penhorn Avenue Pump Station (facing upstream) (10/06/05)

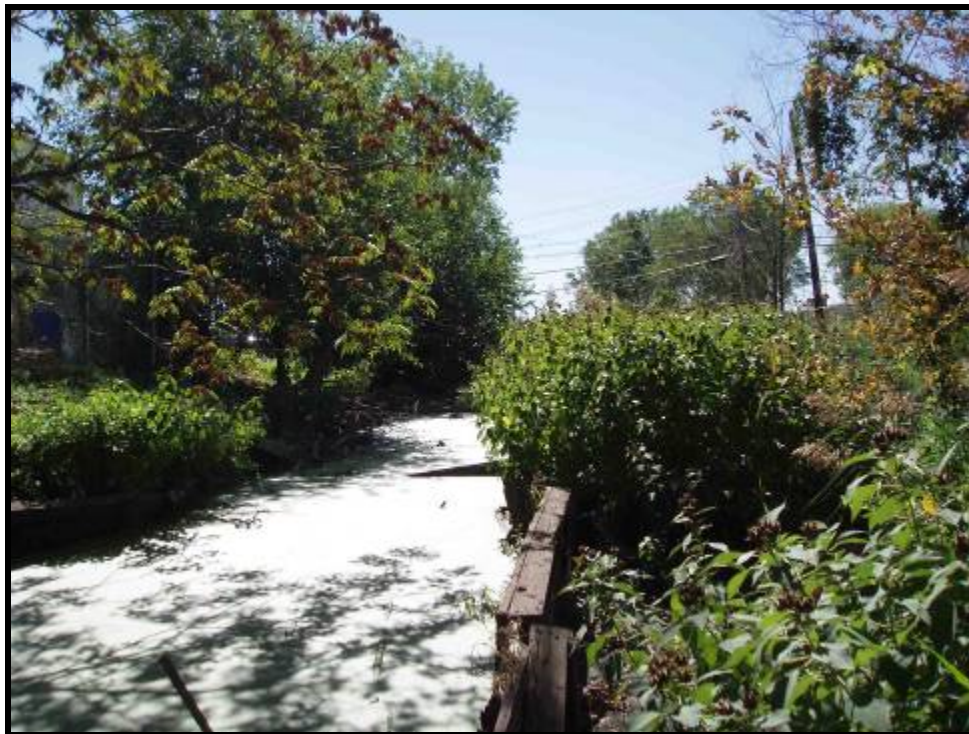
6. Downstream of Penhorn Avenue Pump Station (10/06/05)

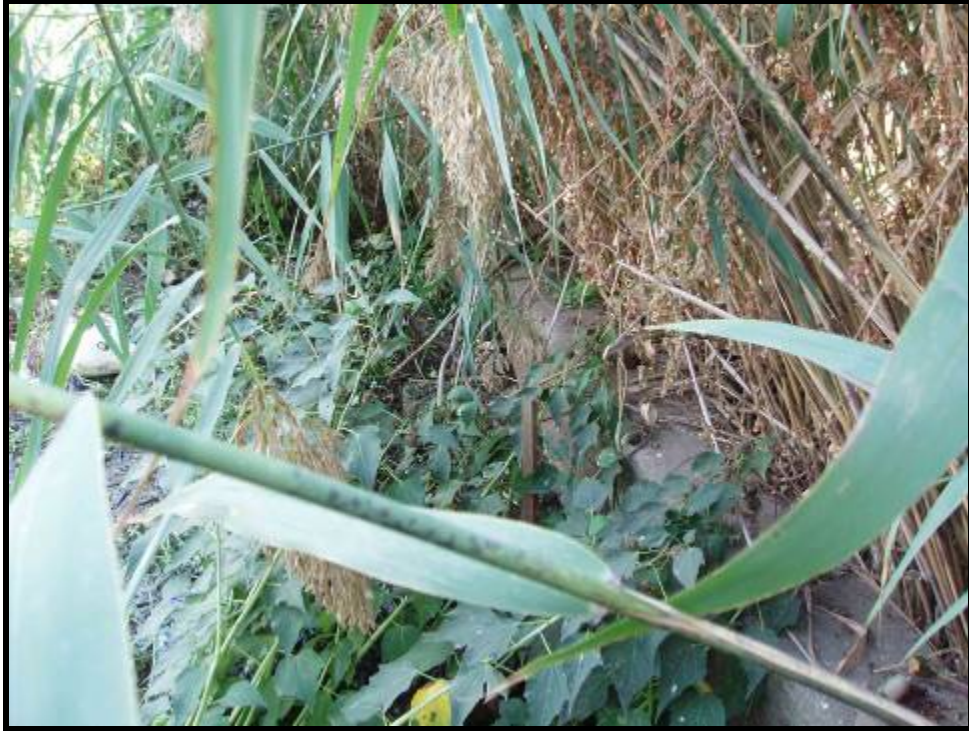
7. Headwall located underneath railroad, to pump station (10/06/05)

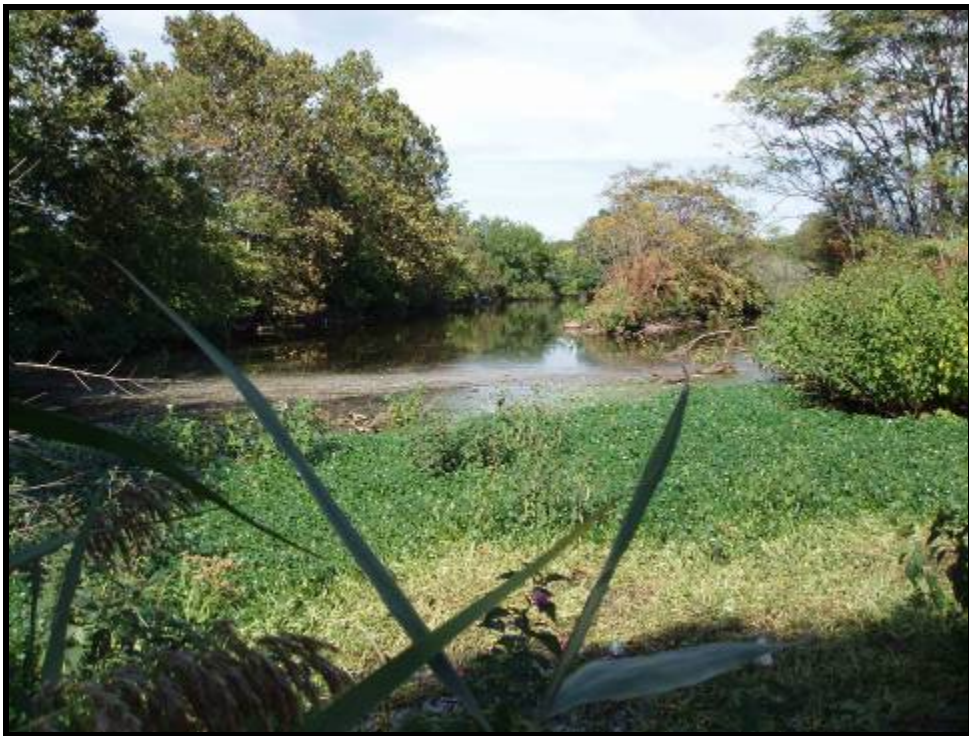
8. Upstream of headwall, along side of NJ Transit railroad tracks (10/06/05)

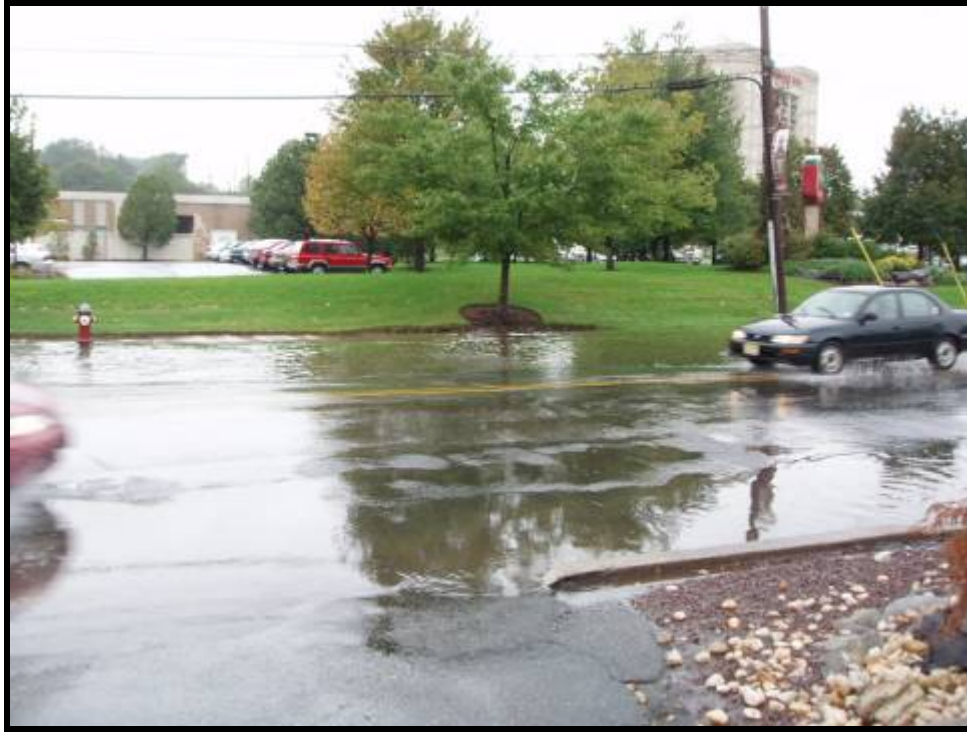
1. Looking West on Polito Avenue near intersection of Polito and Rutherford Avenues (10/14/05)

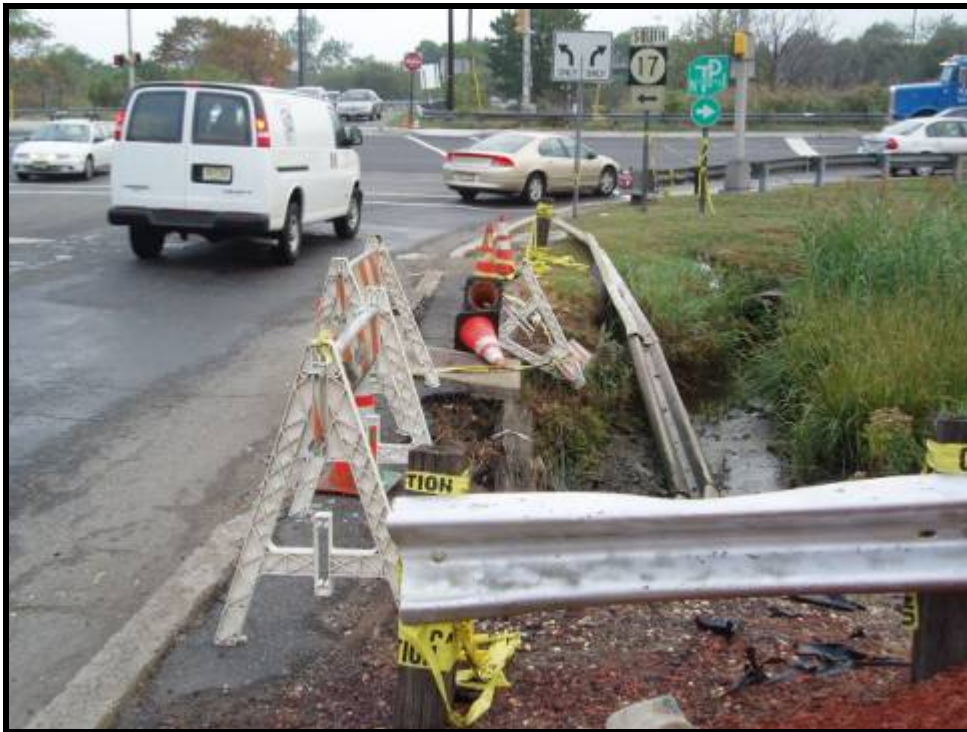
2. Collapsed catch basin located near the intersection of Polito and Rutherford Avenue (10/06/05)

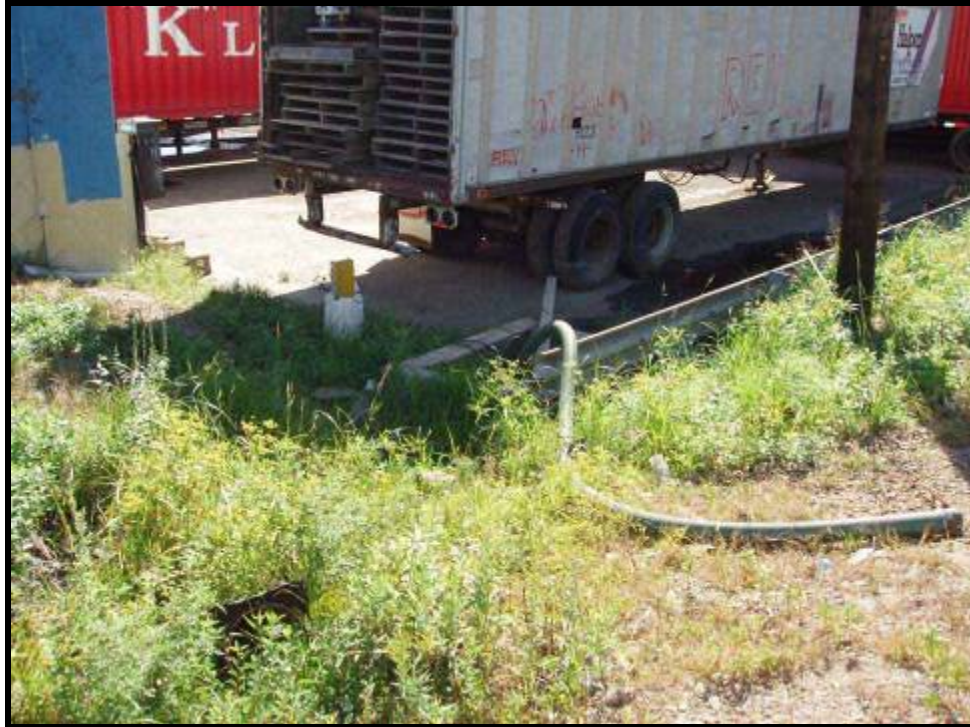
1. Make-shift pump system at 996 Belleville Turnpike (10/06/05)

Additionally, private property owners with pump systems should ensure that pump system components, including power supply, are intended for outdoor use to eliminate the threat of electrocution. All discharges should be directed to existing, clear channels and never up-slope or toward a neighbor. It is highly recommended that outflow be directed to an open-water system as stormwater sewers in flat areas have limited capacity and tend to clog during large storm events. All privately-owned catch basins and stormwater sewer pipes should also be cleaned out. Associated outfalls should be cleared and one-way valves installed. Prior to any system restorations, a licensed Professional Engineer should be consulted to see if the system is adequate and should be restored in-kind.

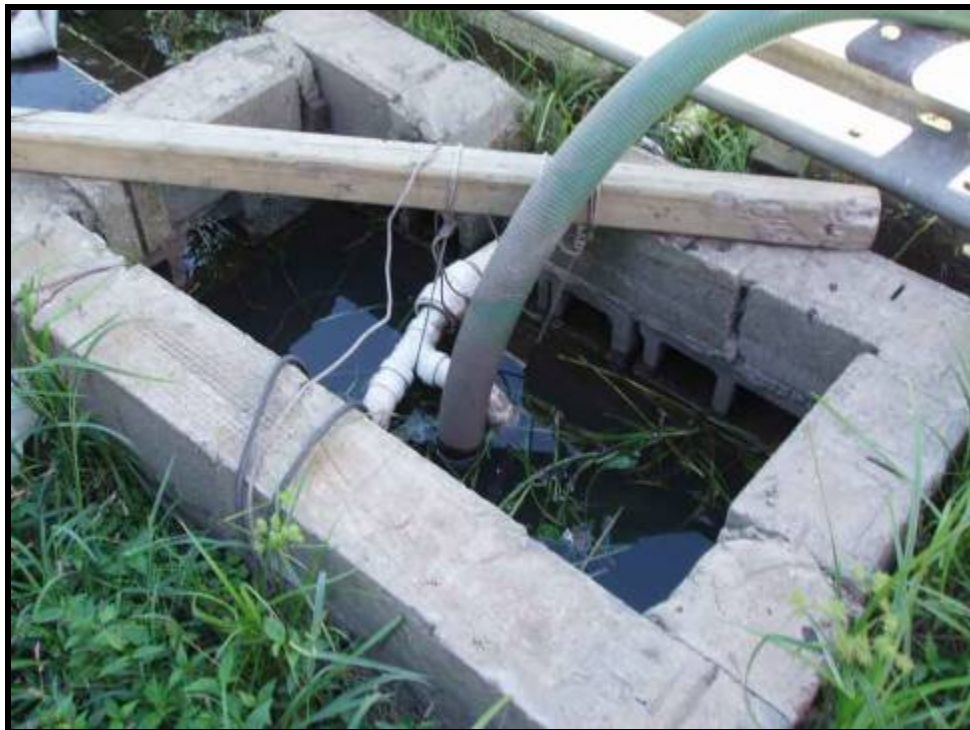
2. Sump pit for make-shift pump system at 996 Belleville Turnpike (10/06/05)

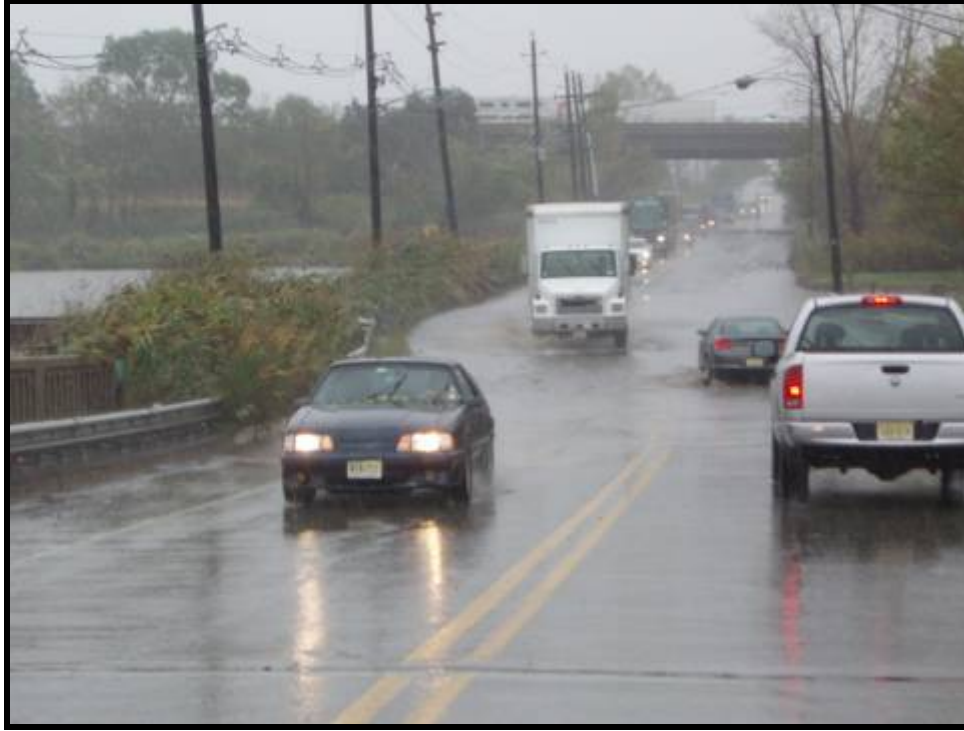
5. Looking east on Route 7 / Belleville Turnpike looking towards the Western Spur of the New Jersey Turnpike (10/14/05)

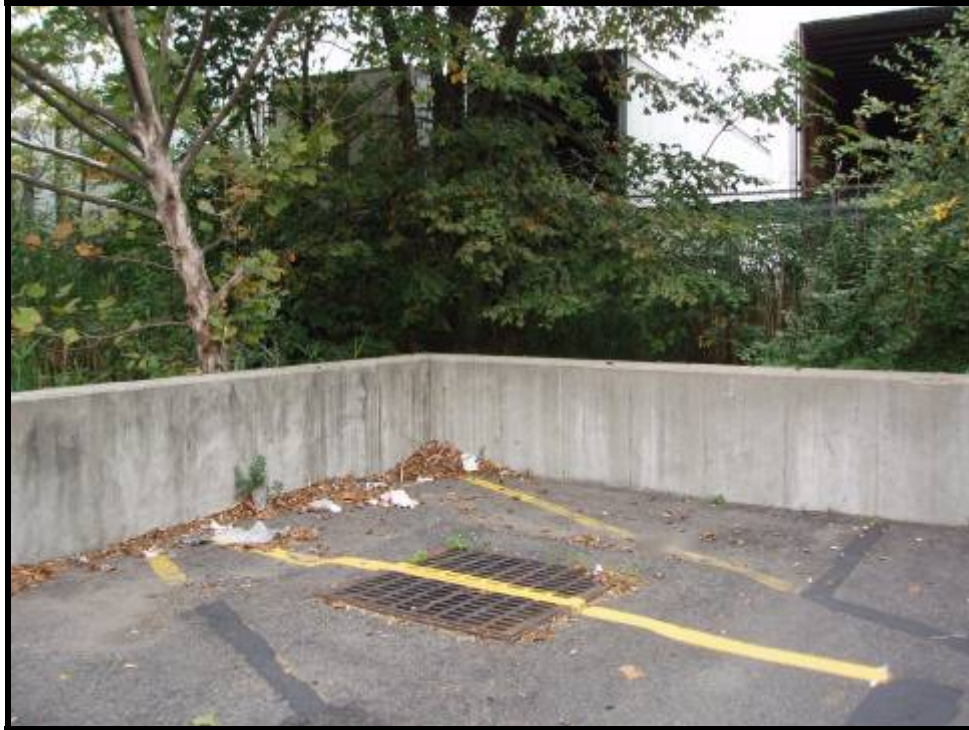
1. Inlet and floodwall at 430 Gotham Parkway (10/06/05)

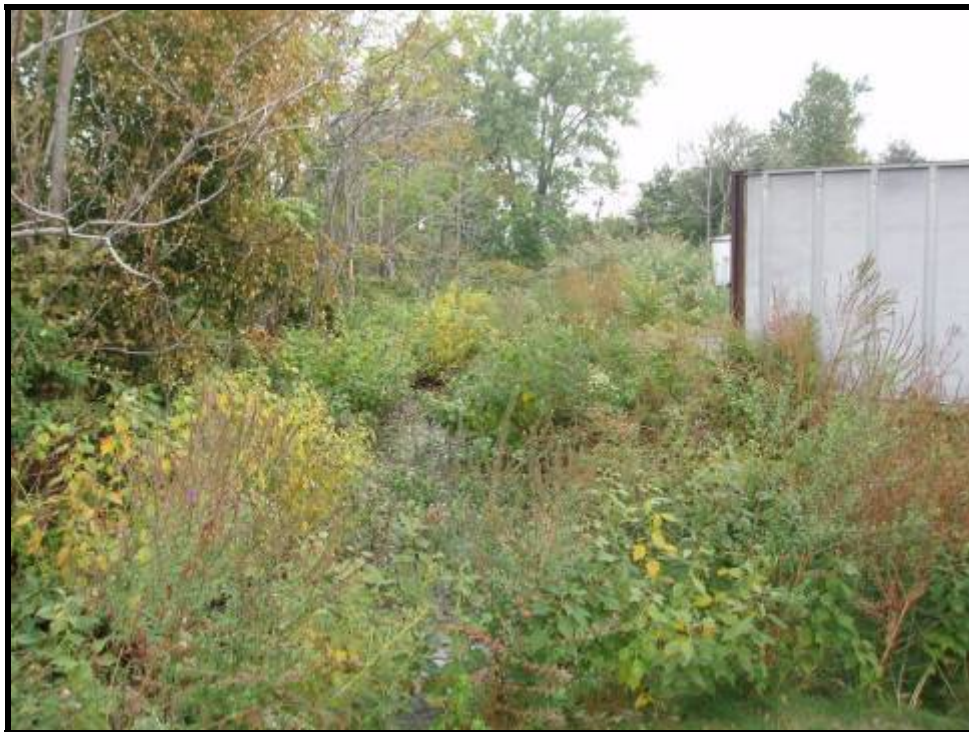
2. Upstream of confluence point with Peach Island Tide Gate (10/06/05)

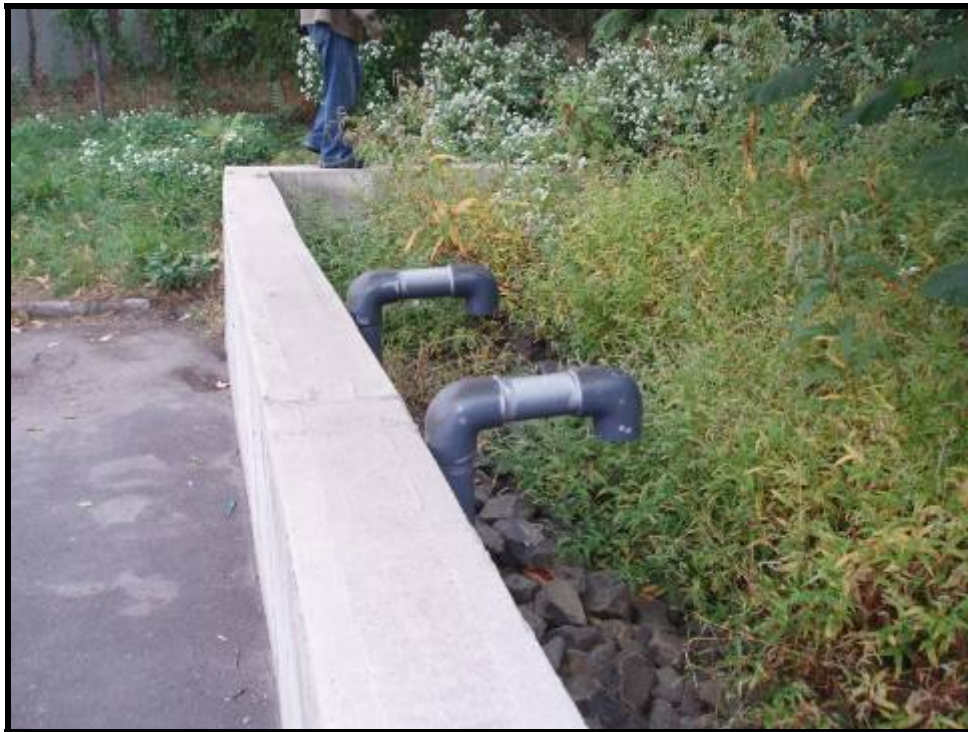
3. Outfall pipes from pump station at 480 Gotham Parkway (10/06/05)

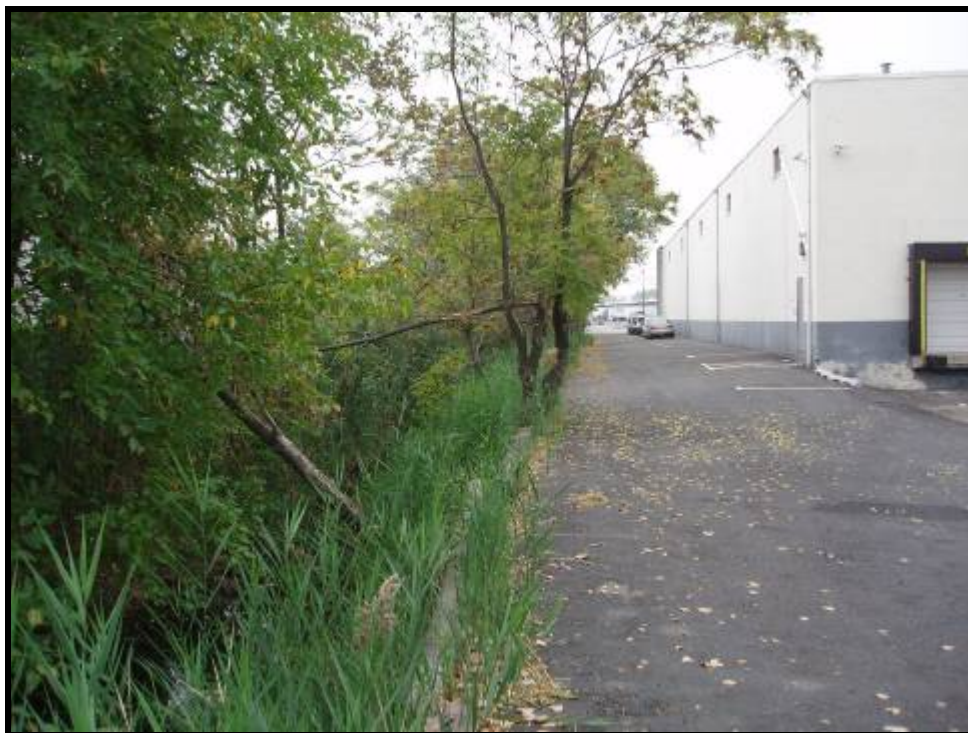
4. Looking downstream at rear of 725 Dell Road (ditch at far left) (10/06/05)

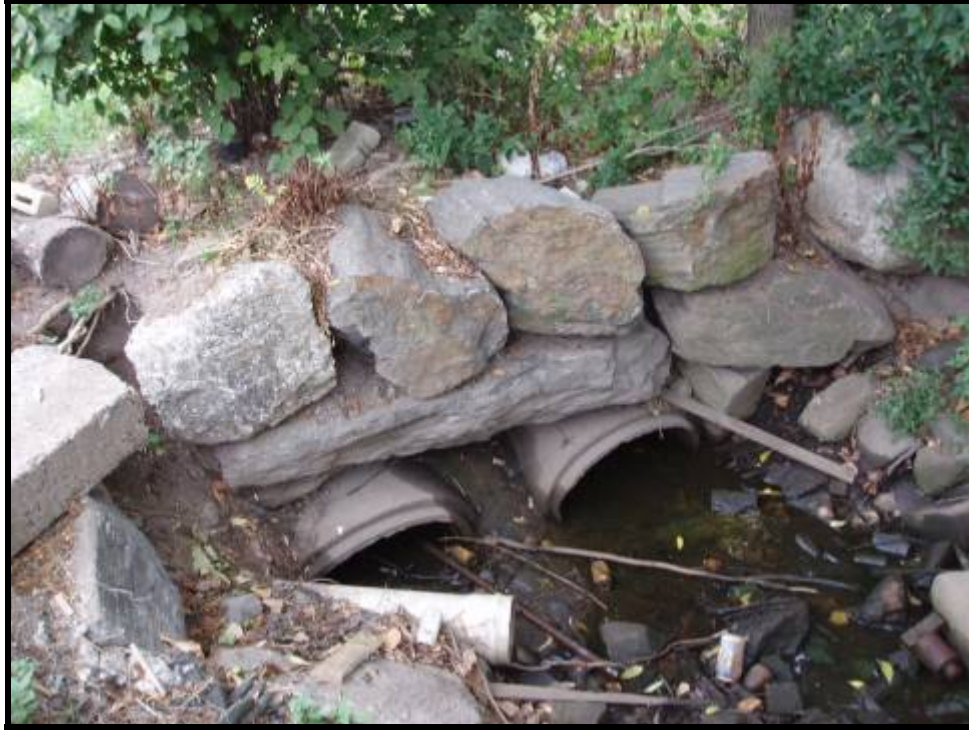
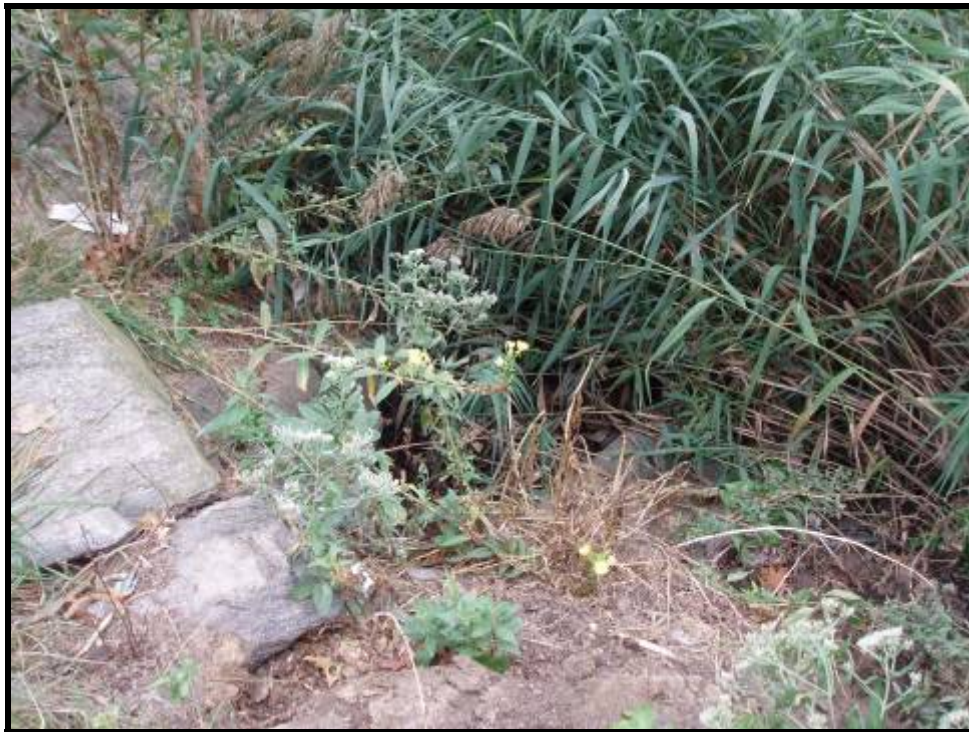
Upstream of these buildings, the system moves through a culvert beneath Starke Road. The culvert appears to be functional and is protected by a trash rack. The drainage ditches above the culvert are in good condition. However, elliptical concrete culverts 2,200 feet upstream of Starke Road beneath an abandoned CSX rail are in need of cleanout or repair (see Photos 5 to 7). As the system upstream of the rail is stagnant, vegetation has choked the drainage ditch system.

5. Elliptical culvert clogged with debris at the rear of 545 Dell Road (10/06/05)

6. Elliptical culvert clogged with debris and vegetation at the rear of 545 Dell Road (10/06/05)

No engineering analysis appears to be necessary at this time. Once the maintenance project is complete, the flooding issues within the watershed should be completely alleviated during small storms. However, the local catch basins must remain clear of debris and sediment for the entire system to function. A NJDEP Stream Encroachment Permit will be required for this maintenance cleanout.

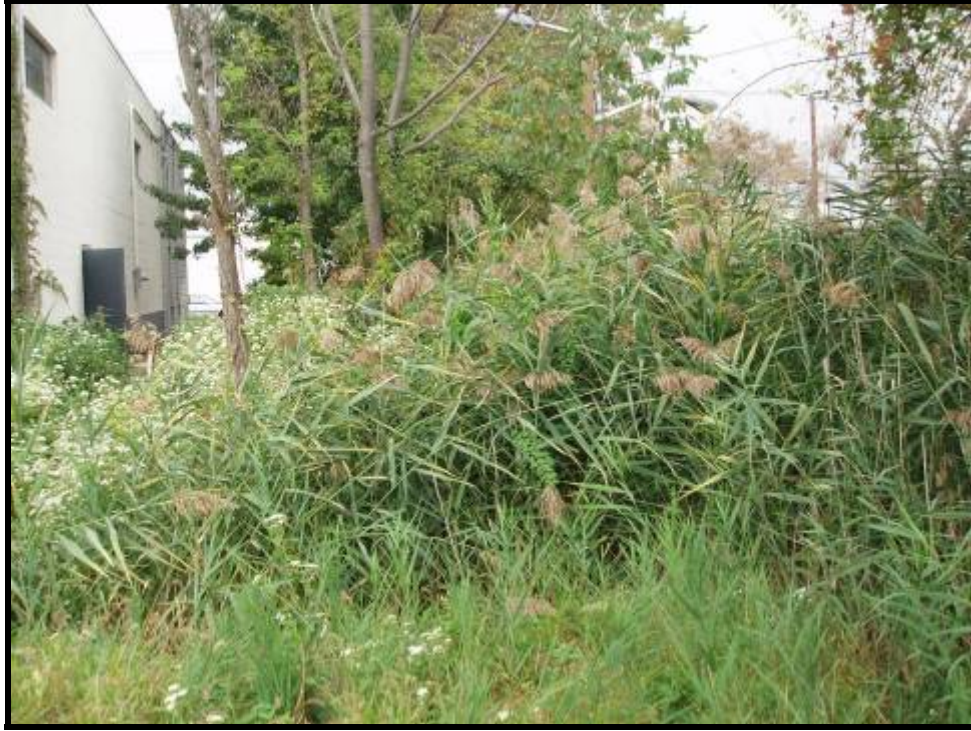
7. Drainage ditch at the rear of 654 Gotham Parkway (10/06/05)

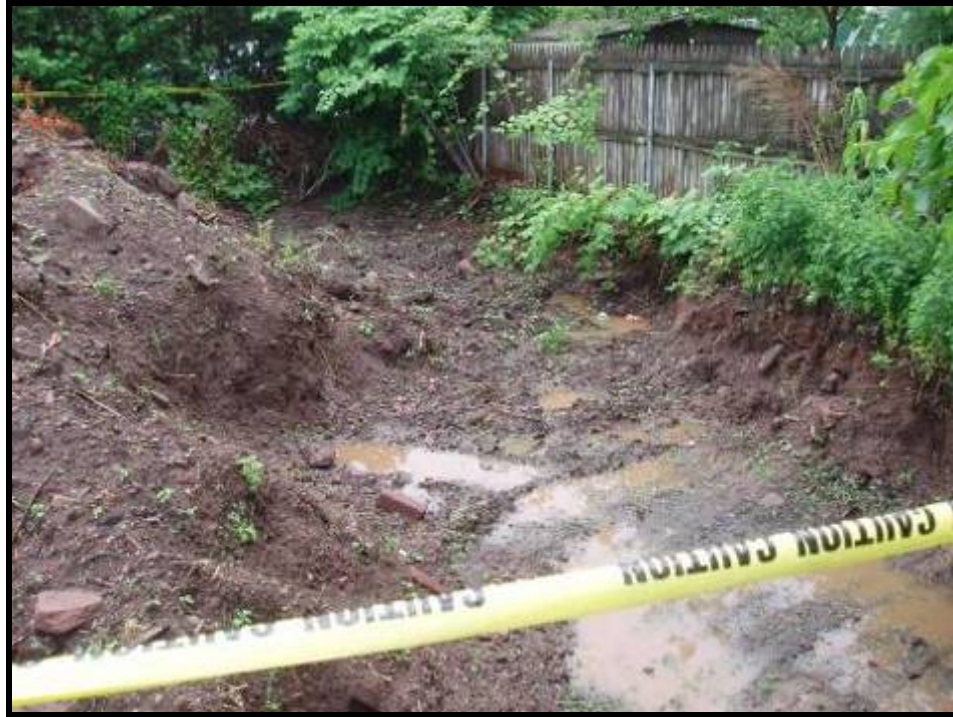
1. Infiltration basin located at 1600 Paterson Plank Road behind 1089 Farm Road (right) (6/10/05)

The NJMC, following an inspection in 2004 confirming the above condition, asked the neighboring developer (1600) to create an infiltration basin at the rear of 1089 to improve sheet flow runoff during storm events. The basin was constructed and, per follow-up inspections, temporarily alleviated the flooding in the area (see Photos 1 and 2). Once 1600 Paterson Plank Road has been built upon, this system can be abandoned and a permanent stormwater system must be constructed. **As such, this matter is considered temporarily closed.**

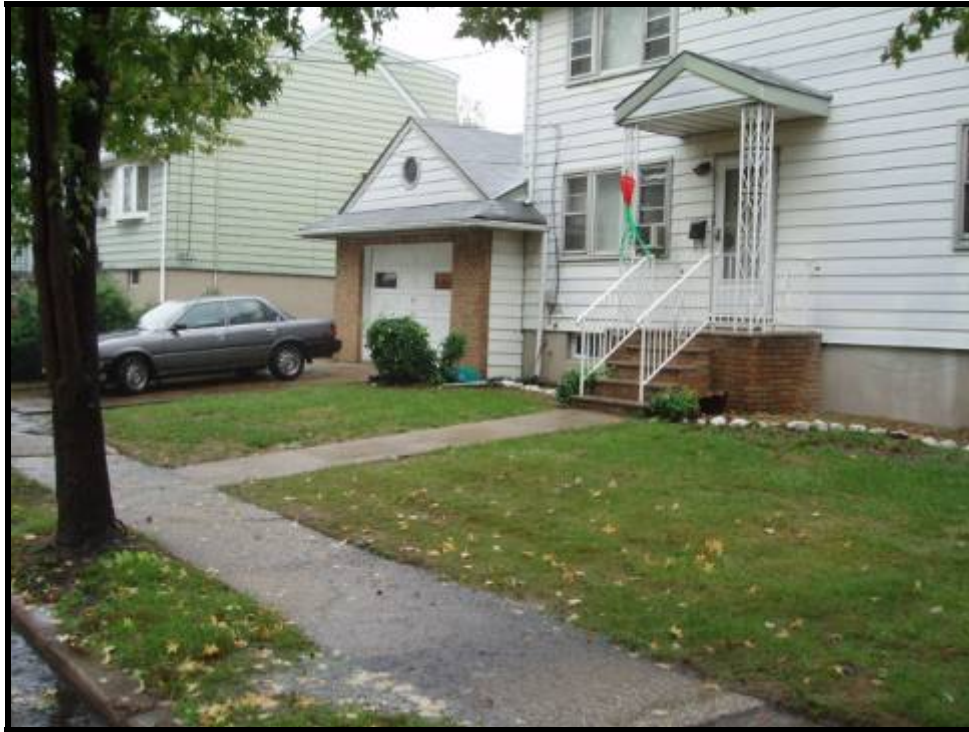
1. Looking at the south side of the property at 176 Louis Street (10/14/05)

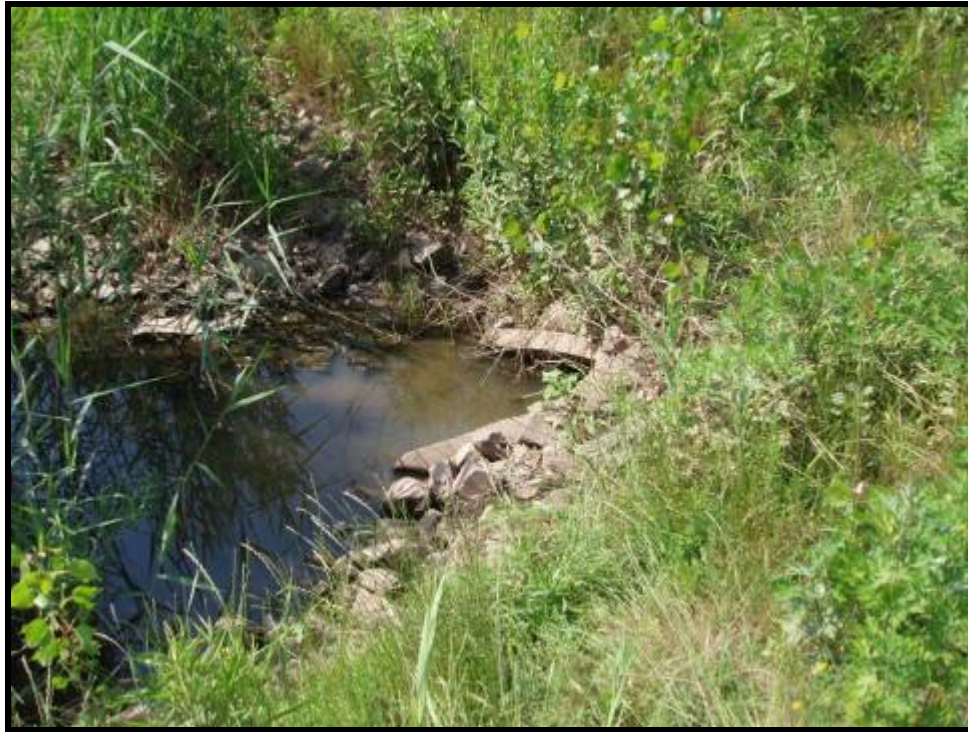
1. Looking at outfall that is connected to the inlet at 758 Paterson Plank Road (6/22/05)

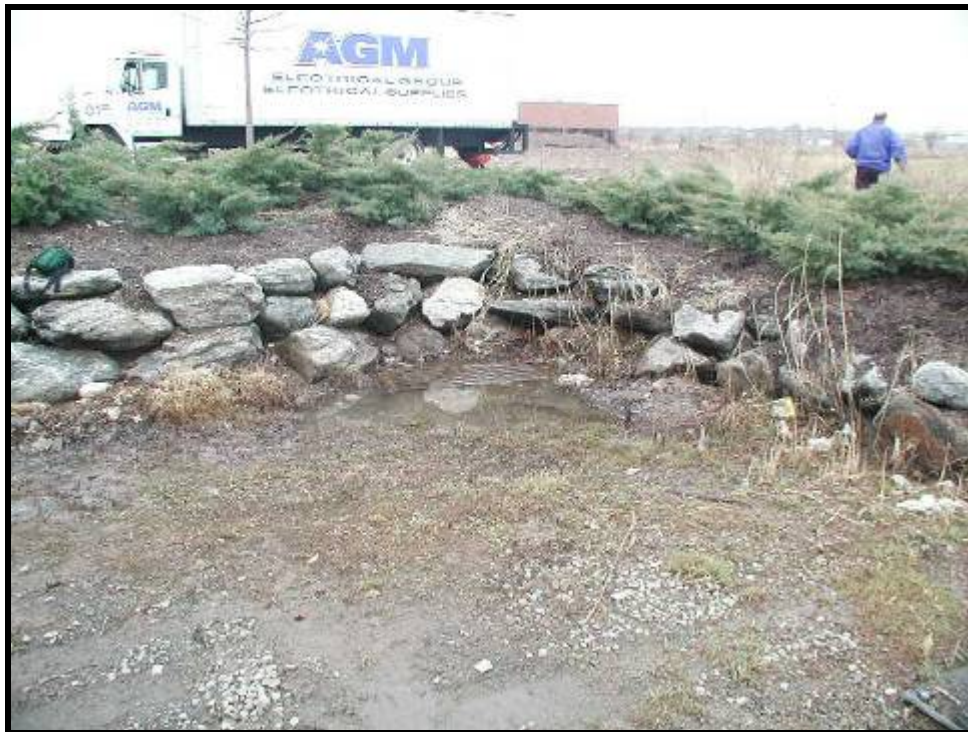
2. Inlet on 758 Paterson Plank Road discharging to above outlet (Photo 1) (3/21/05)
