# Hackensack Meadowlands Floodplain Management Plan

**The National Flood Insurance Program  
Community Rating System  
Activity 510 Guidelines**

**The New Jersey Meadowlands Commission  
One DeKorte Park Plaza  
Lyndhurst, New Jersey**

**October 24, 2005**

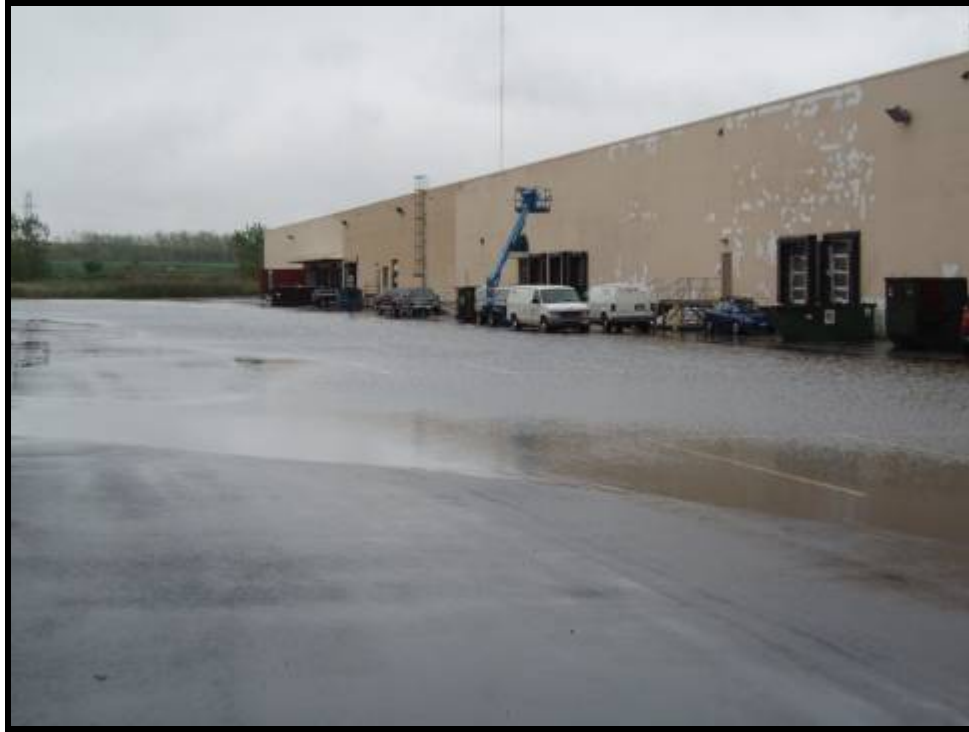
1. Looking southeast towards ditch at rear of property (10/14/05)

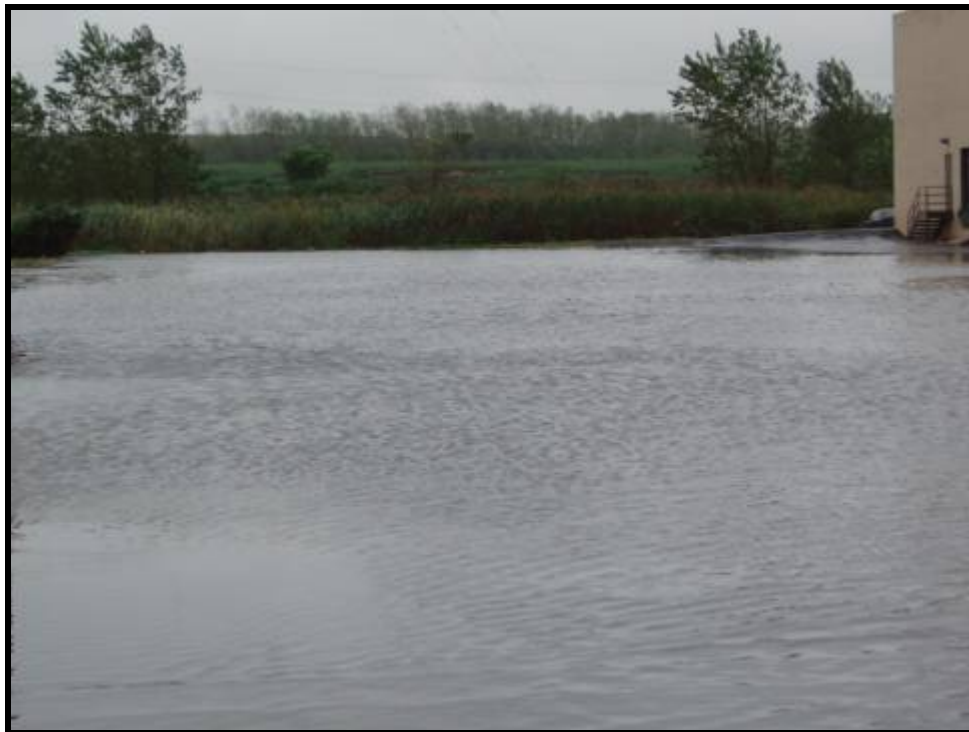
2. Looking southeast towards ditch at rear of property (10/14/05)

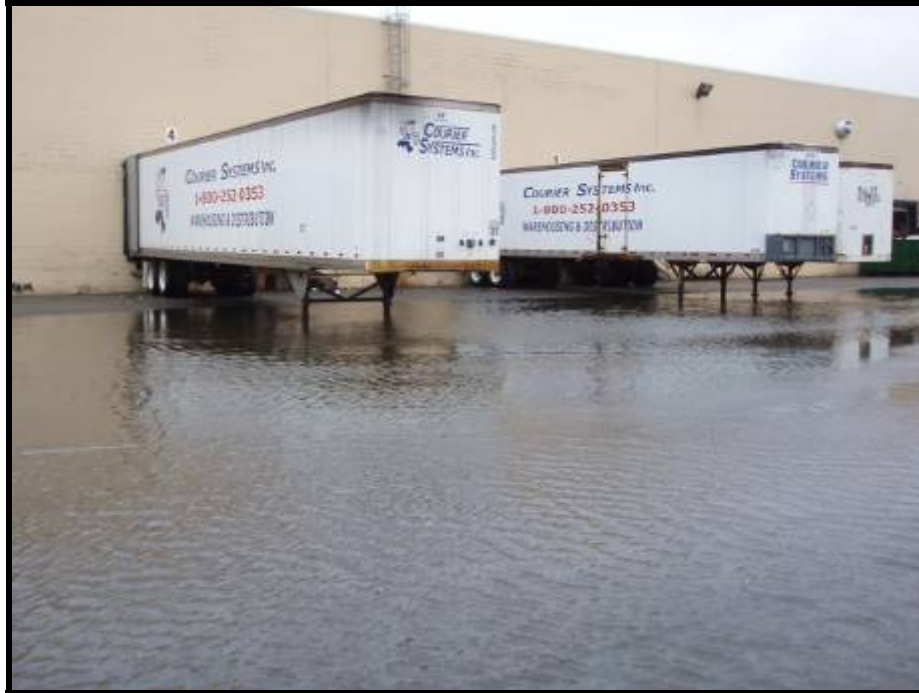
3. Looking southwest towards loading docks (10/14/05)

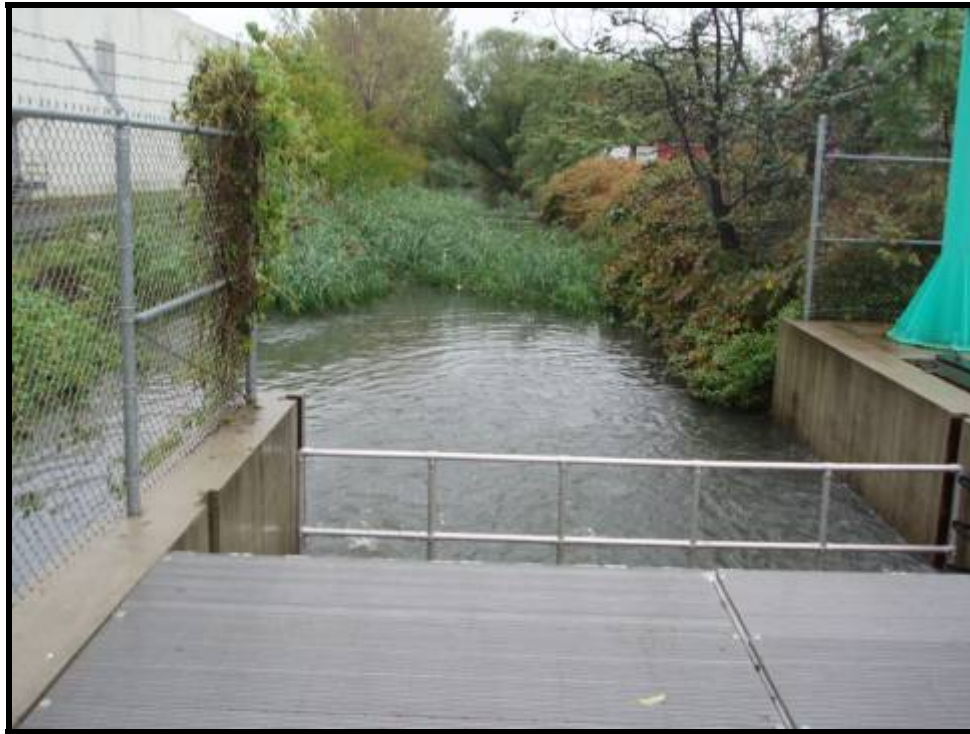
1. Looking downstream of Bellman's Creek at 91<sup>st</sup> Street (10/14/05)

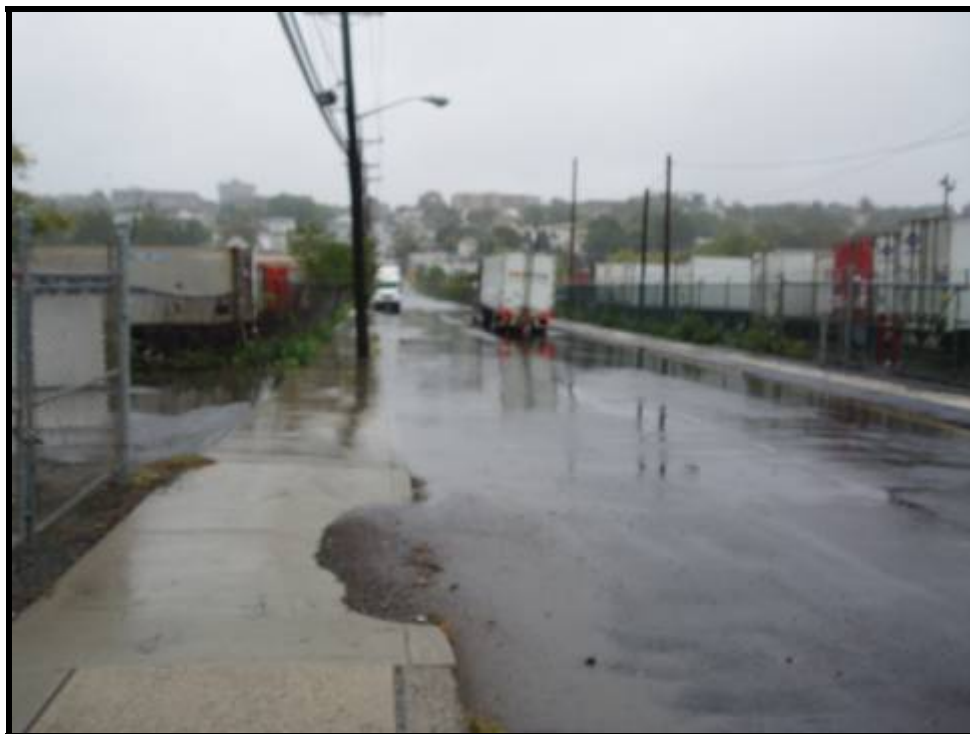
2. Looking east towards Route 1&9 at 91<sup>st</sup> Street (10/14/05)

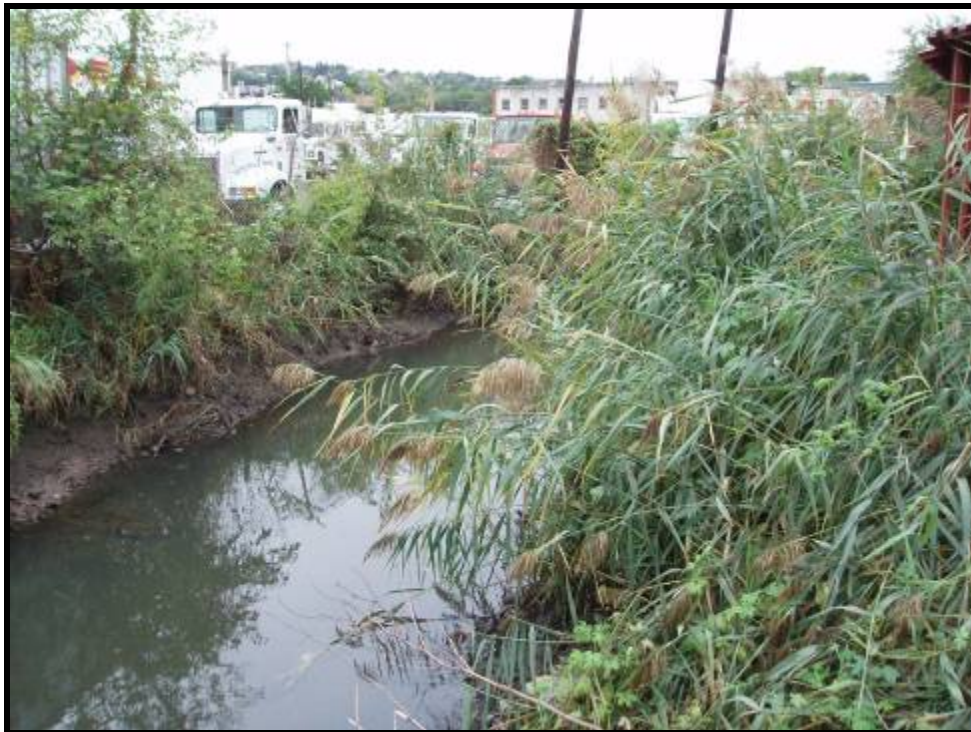
4. Looking upstream of Bellman's Creek at Fairview Avenue (10/06/05)

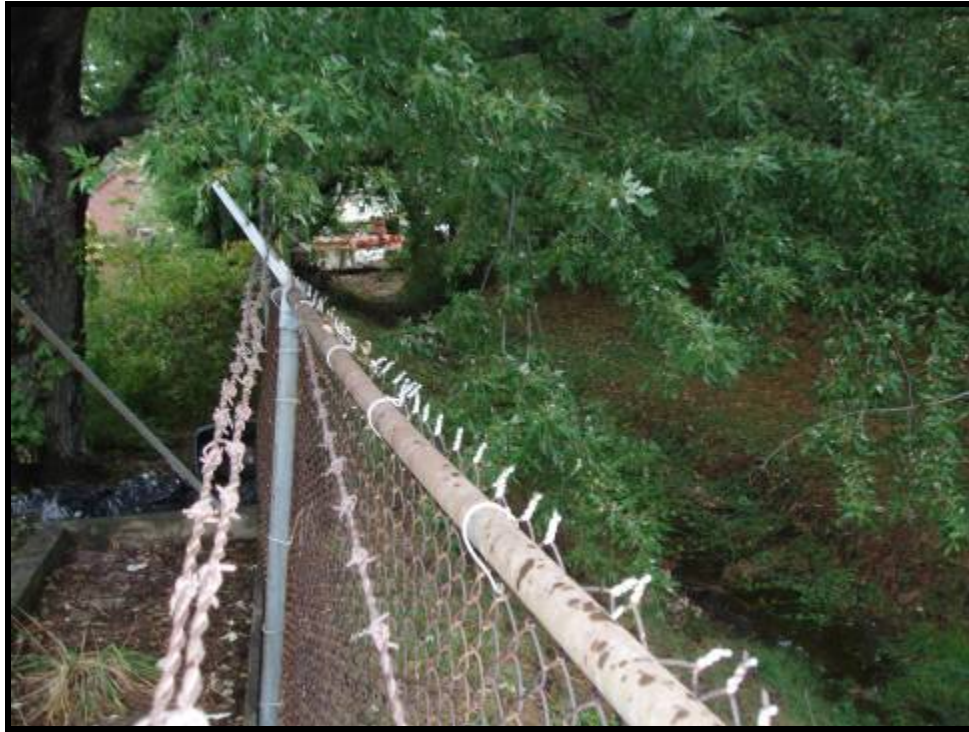
1. Looking downstream of the drainage ditch located at the end of Minnie Place South (10/11/05)

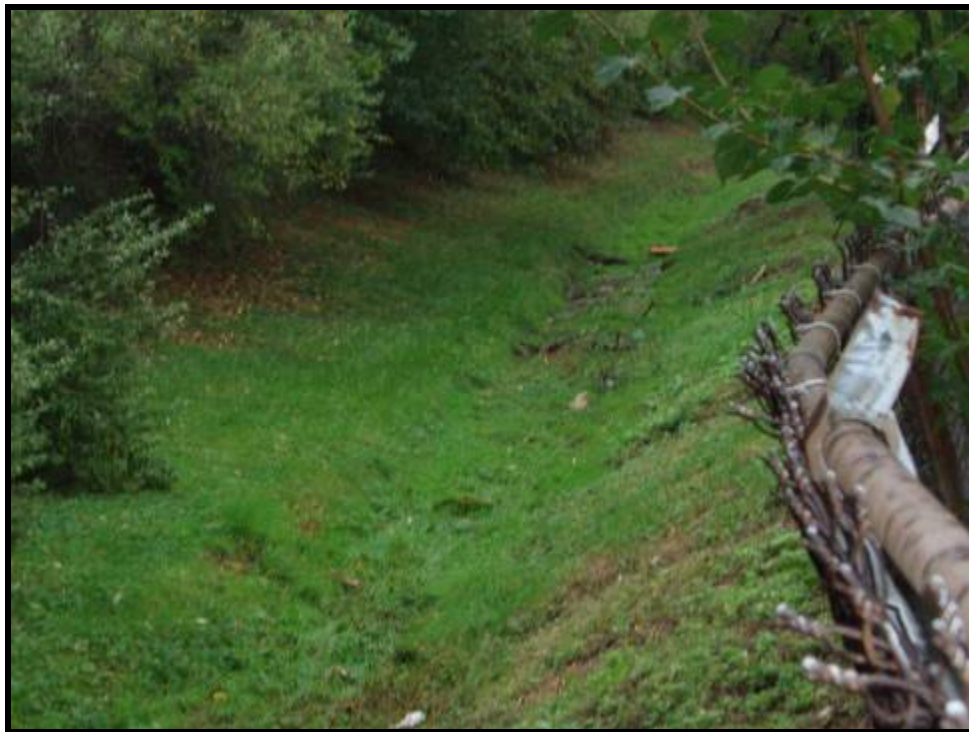
2. Looking upstream of the drainage ditch located at the end of Minnie Place South (10/11/05)

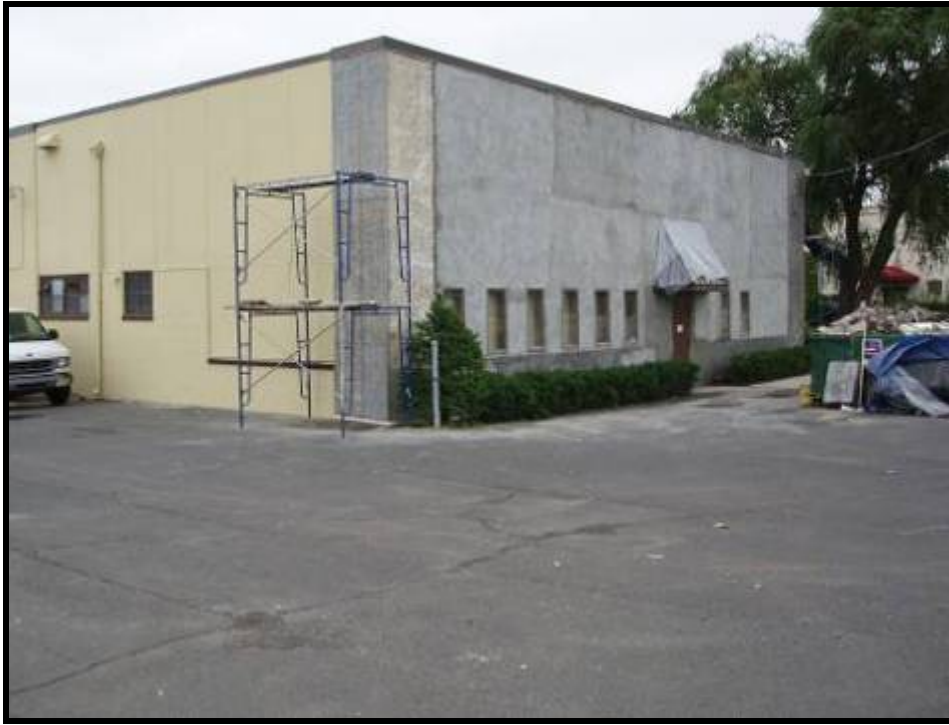
1. Looking at the front of 325 Washington Avenue (10/06/05)

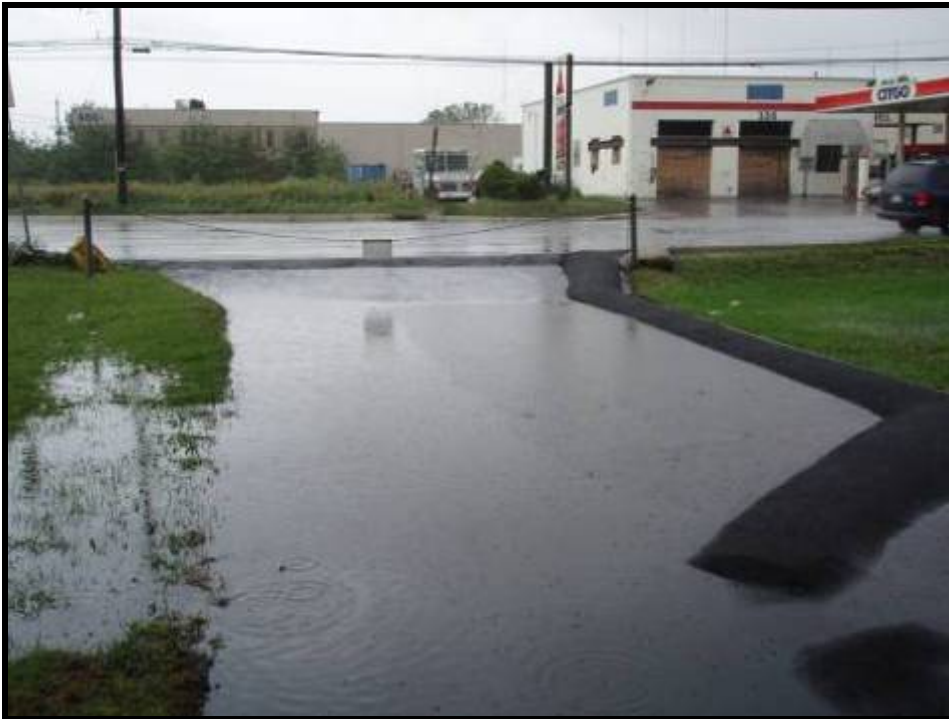
2. Looking at the raised berm and ponding of the driveway located at the south end of property (10/12/05)

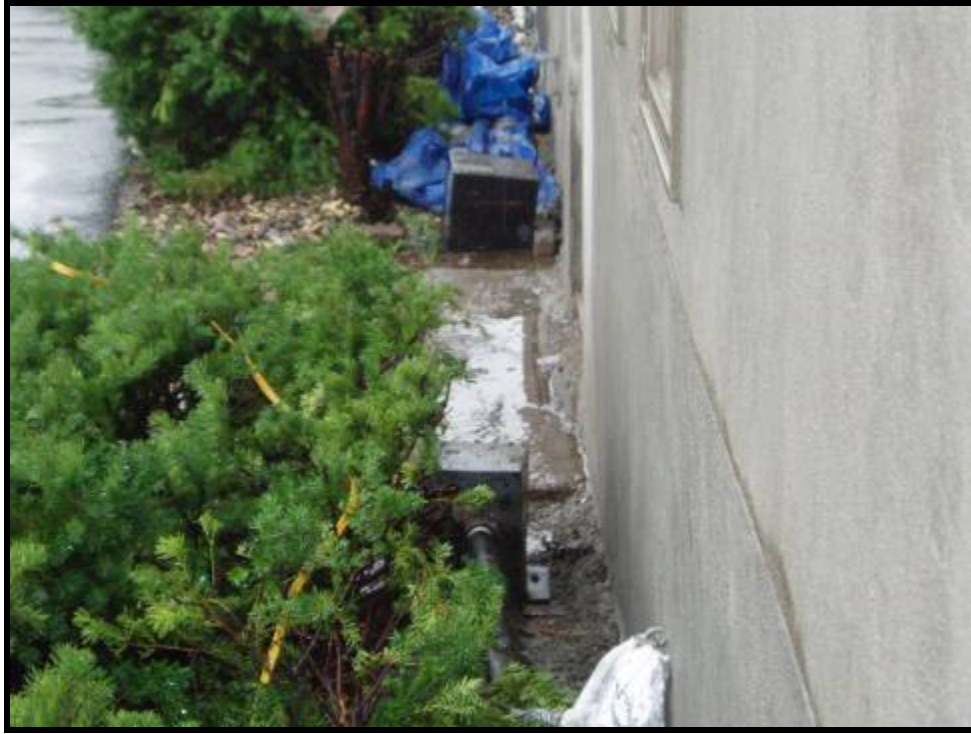
3. Two pump systems located in front of the building of 325 Washington Avenue (10/06/05)

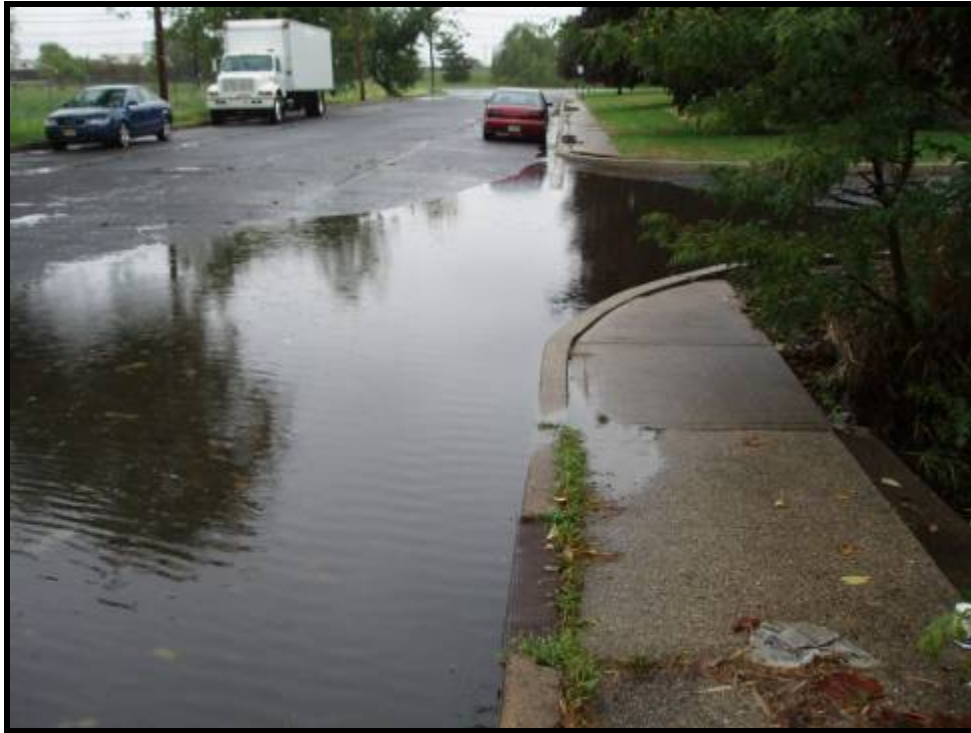
4. Looking West at the clogged inlet on the Michelle Avenue culvert (downstream on left) (10/12/05)

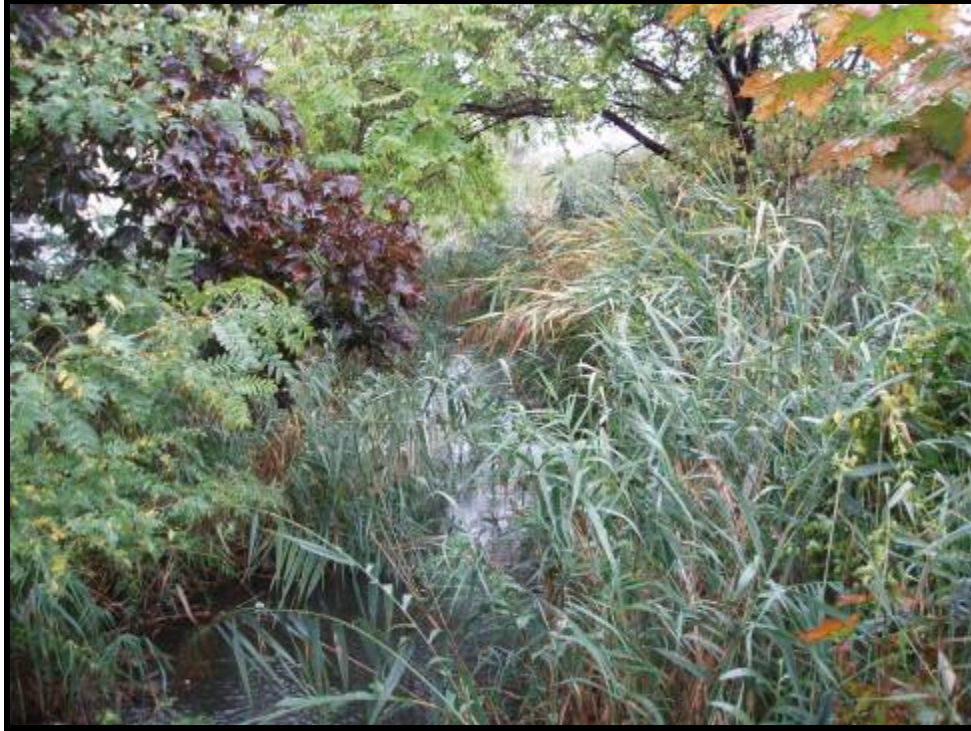
5. Looking upstream at the Michelle Avenue culvert (10/06/05)

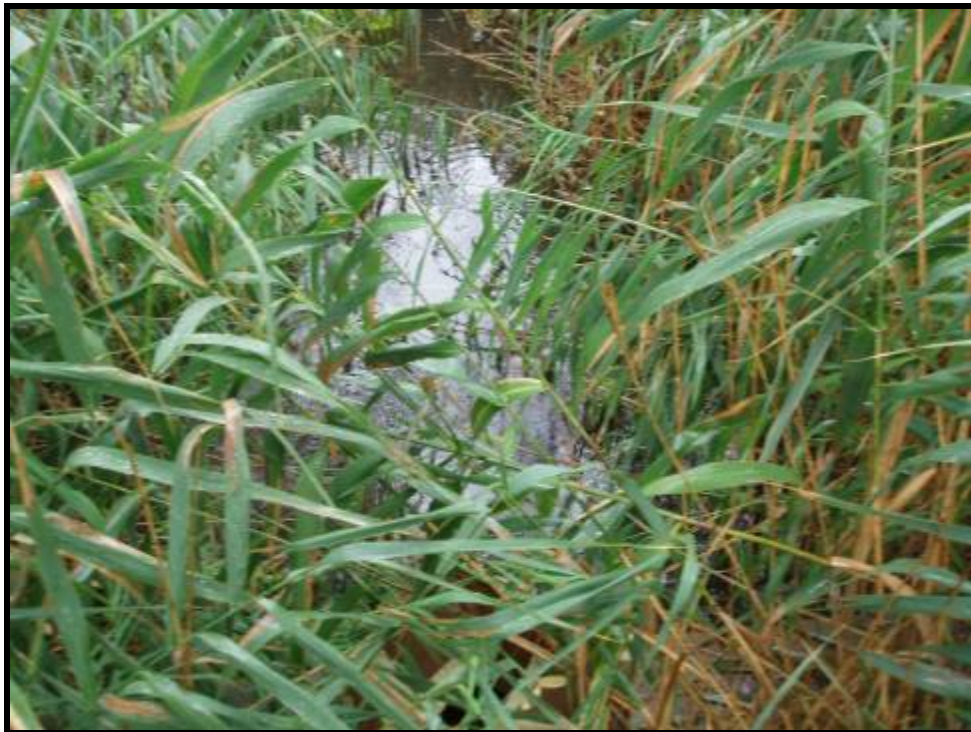
6. Looking downstream at the Michelle Avenue culvert (10/06/05)

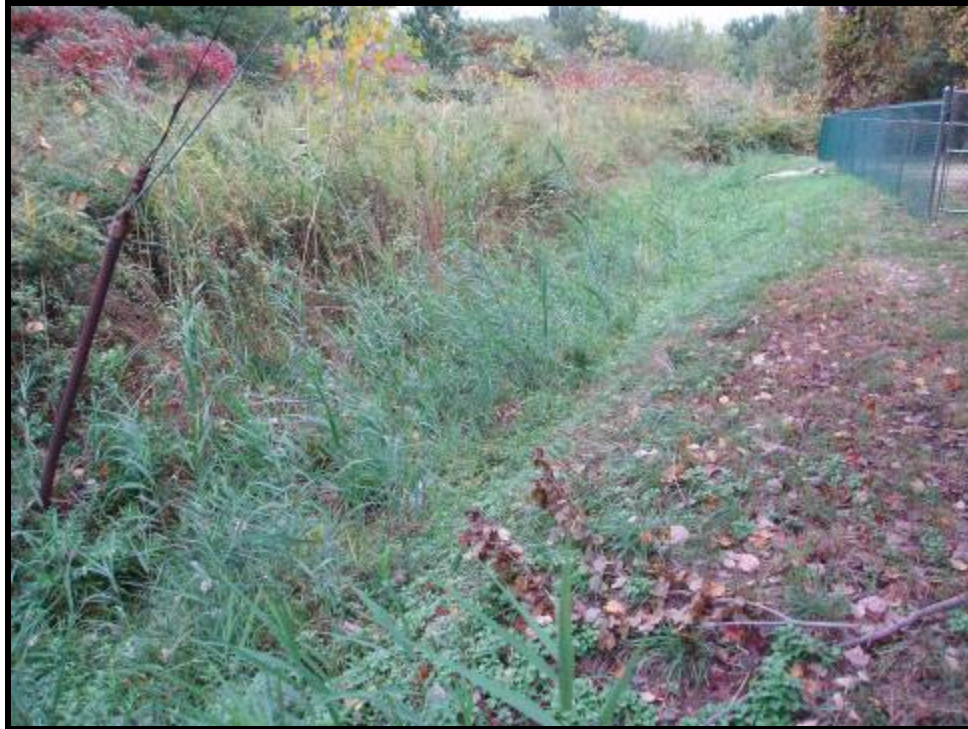
4. Looking East at the drainage ditch located next to the Chapman Drive cul-de-sac (10/12/05)

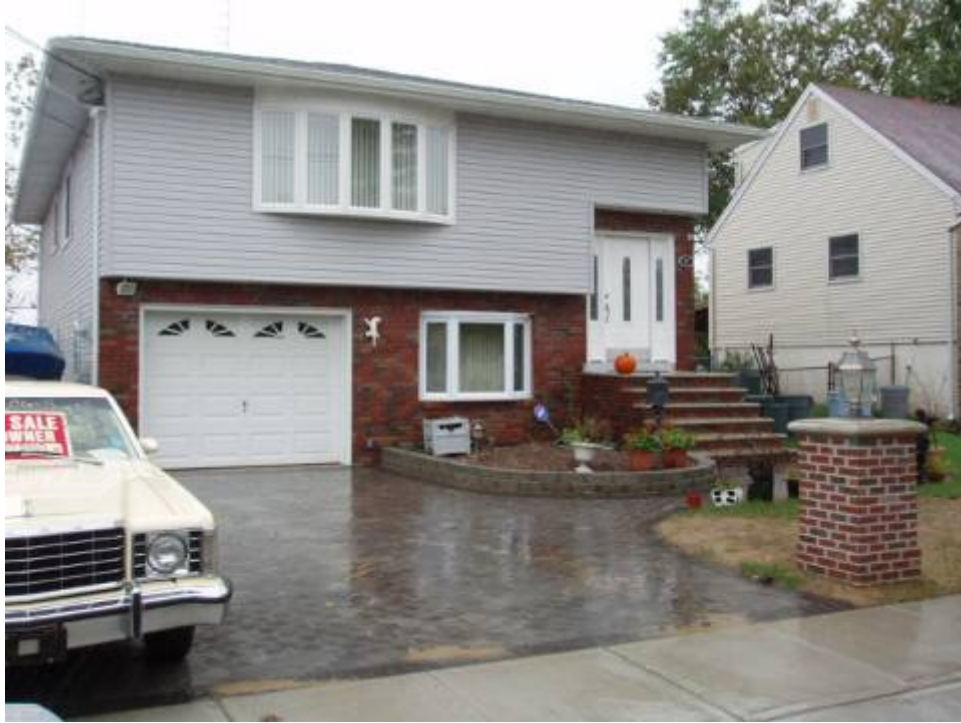
From a recent field inspection, the inlets to the Huber Street stormwater sewer system were clear. The Huber Street profile appears to have sufficient slope to carry stormwater runoff to the inlets. No ponding or flooding conditions were observed during the field inspection on Huber Street. NJMC believes this flooding complaint is not a regional stormwater problem. The NJMC staff recommends that the property owner seek a licensed Professional Engineer to survey the property to determine the origin of the excess runoff to their property and to determine whether the backyard has a proper slope away from the house.

1. Looking at the north side of the property at 67 Huber Street (10/14/05)

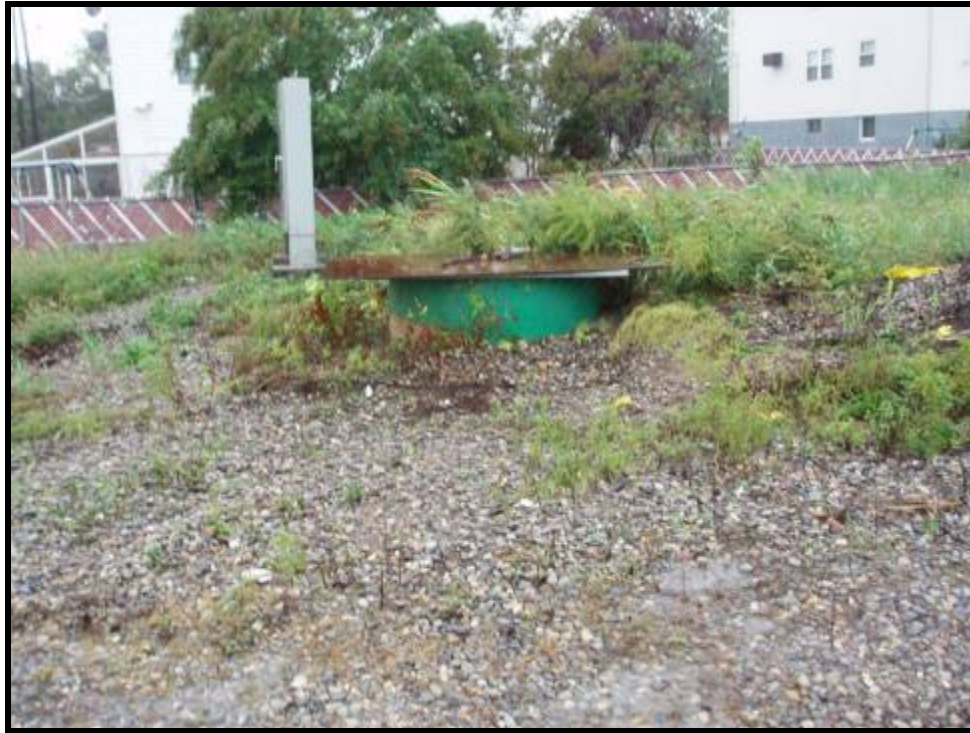
From a recent field inspection, a retaining wall was found at the rear of the property located on 64 Maiden Lane (see Photo 2). The runoff from the backyard of 64 Maiden Lane has no flow path to drain properly to a pump station that has been installed down-gradient of the property (see Photos 3 and 4). As such, the water ponds within the property.

4. View of stormwater pump system located in the lot behind 64 Maiden Lane (10/12/05)

It is recommended that the party responsible for the construction of the retaining wall modify the existing site grading to provide positive flow away from 64 Maiden Lane. This could be accomplished with a drainage ditch or pipe connection to the pump station behind the property. The NJMC will provide assistance in making the determination of ownership.

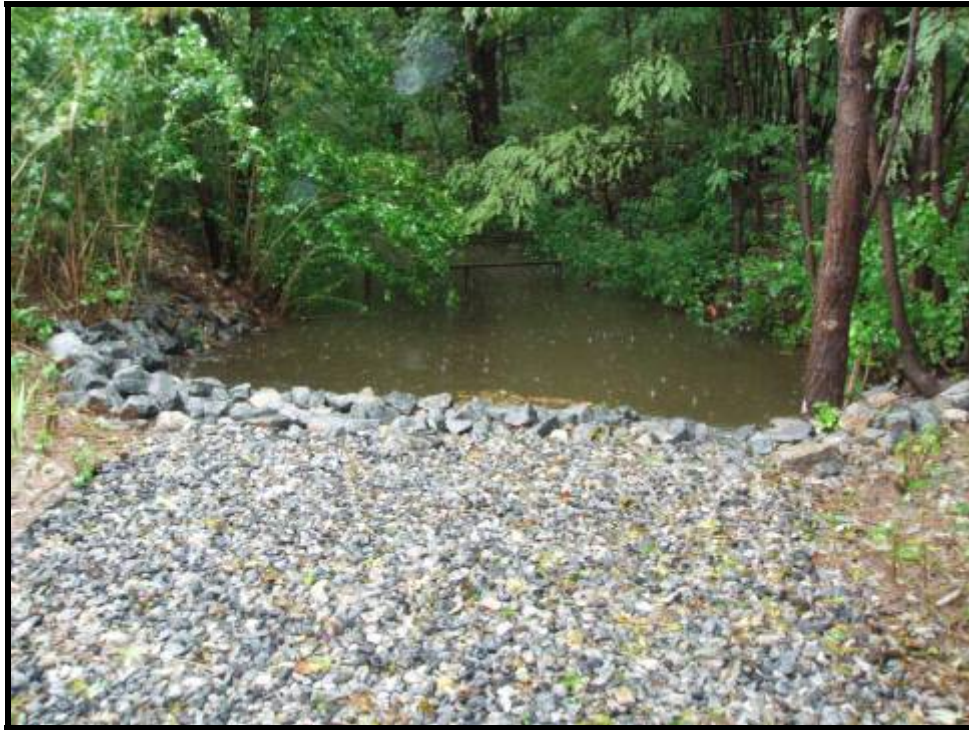
1. Looking upstream of the intake to the DePeyster Pump Station (10/11/05)

recommends that this study form the basis of the analysis of an additional pump system. The NJMC also recommends that access to the upstream trash rack be improved. A Little Ferry Department of Public Works employee should be able to clean off the rack via a pathway (see Photo 1). The NJMC has accepted the 25-year flood elevation (4.1 feet NAVD88) determined by the report. Water above this elevation leaves the watershed and enters the Losen Slote system.

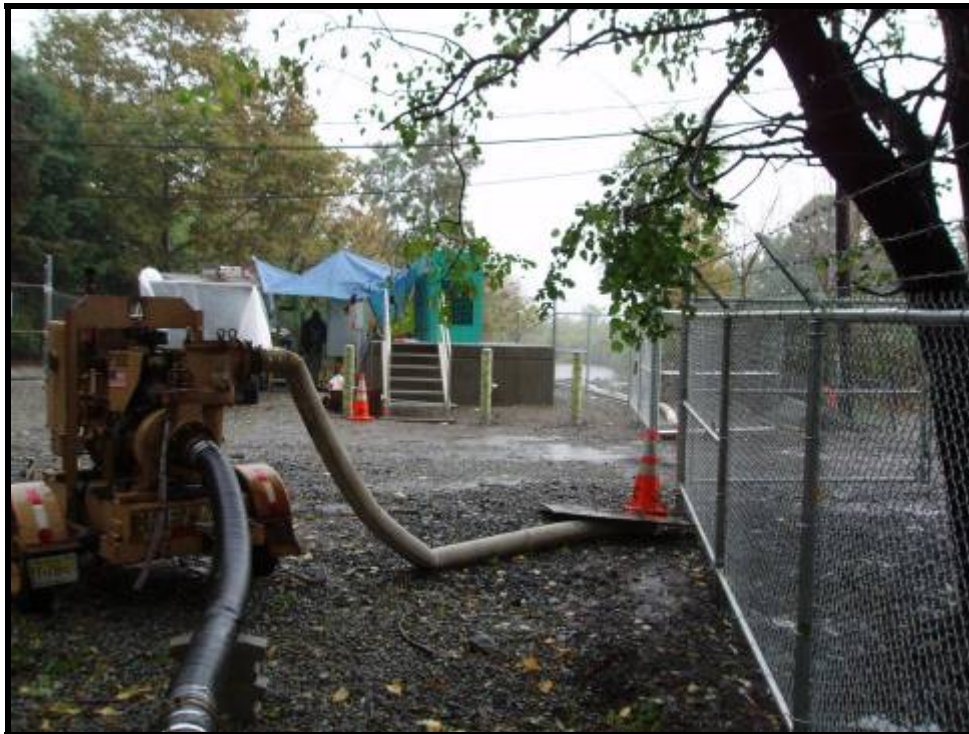
From a recent field inspection, the DePeyster Creek Pump Station is in the process of being repaired at the end of Dietrich Street. A bypass system is temporarily pumping water while the new pump station is being constructed (see Photo 2). According to a hydrologic and hydraulic analysis of the watershed completed by Mianeki Consulting Engineers, the new pump station is unable to outpace projected peak flows from a two-year storm event. During larger storm events, it is likely that the pump station will be inundated and that the upstream channel will backup into the residential neighborhood.

2. View of bypass pump system and new DePeyster Pump Station (10/11/05)

The NJMC recommends that a hydrologic and hydraulic analysis be prepared that analyzes the need for an additional pump system to adequately discharge the 25-year storm during mean high water (MHW) conditions. Note that a detailed hydrologic and hydraulic analysis of the existing and proposed pump station during the 25-year event has already been completed by Mianeki Consulting Engineers. NJMC

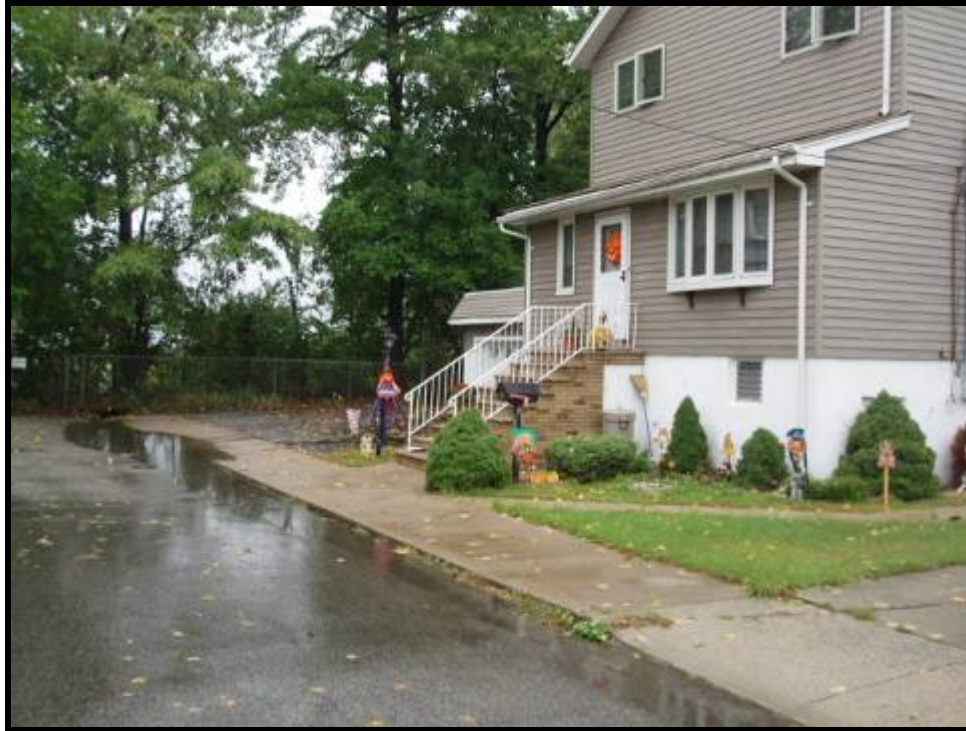
3. Front view of property at 37 Hartwick Street (10/14/05)

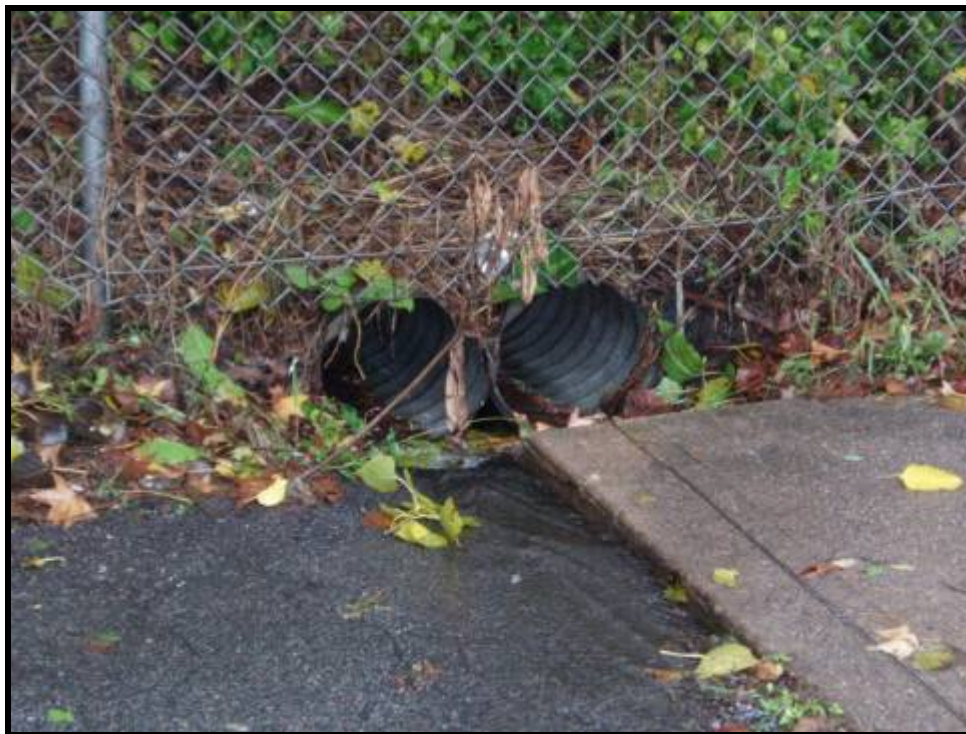
4. Hartwick Street pipe outlet flowing to drainage ditch towards DePeyster Pump Station (10/14/05)

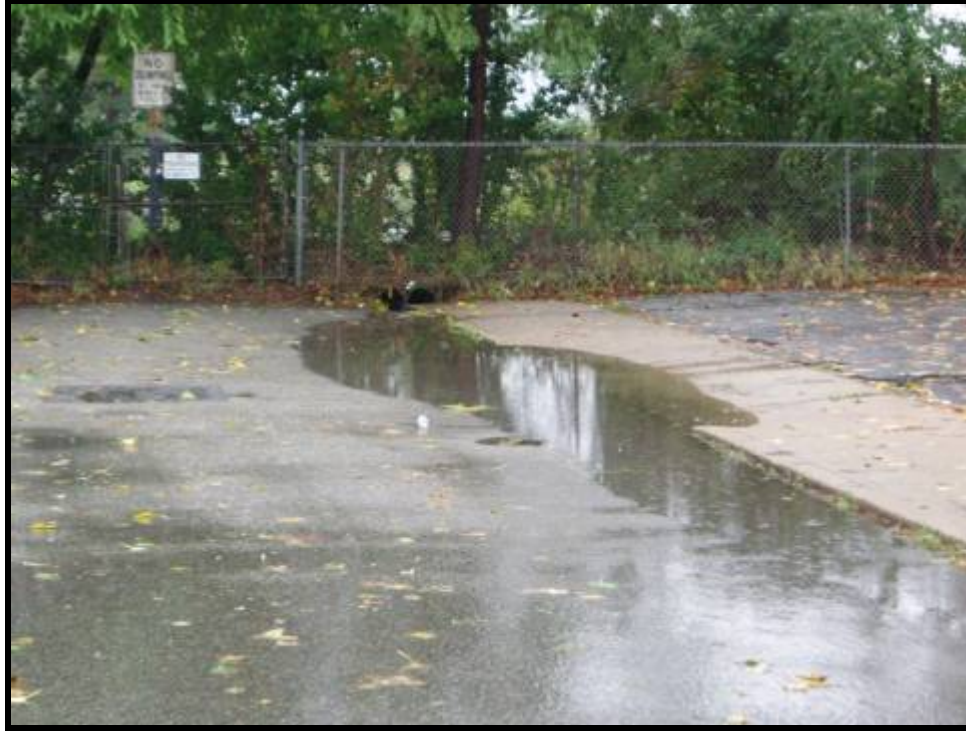
5. Ponding in front of the property at 37 Hartwick Street (10/14/05)

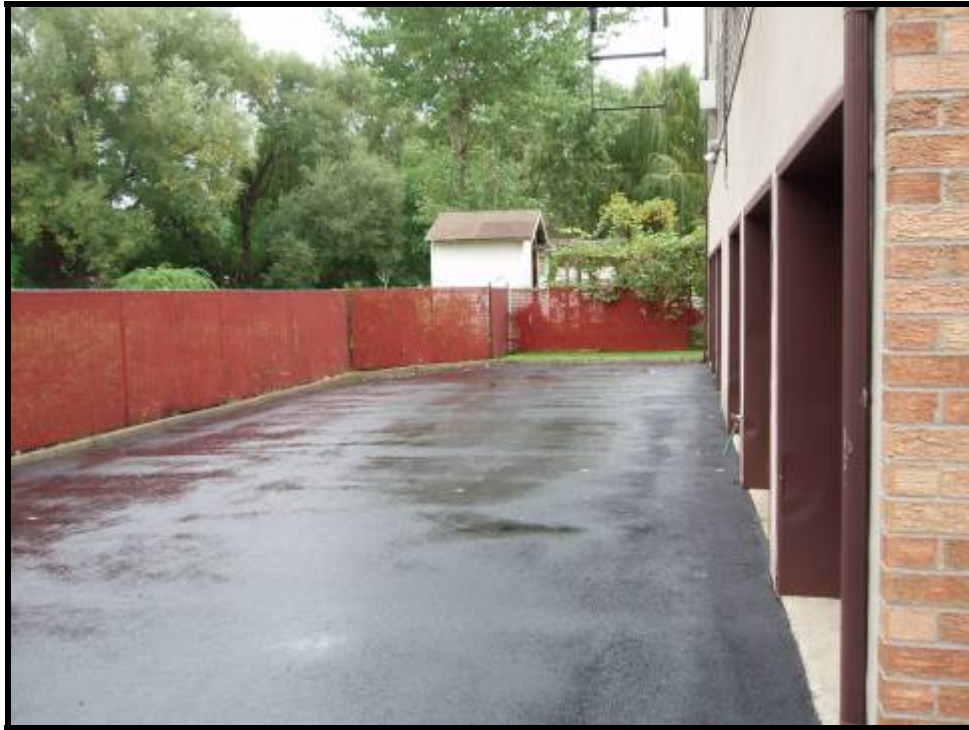
1. Parking area for the residence of 1138B Farm Road where flooding occurs (10/11/05)

The preliminary recommendation to mitigate the flood conditions in the vicinity of 1138B Farm Road is to clean out the stormwater sewer system on Farm Road and install a flap gate system at each outfall. Additionally, the slopes and elevations of the Farm Road stormwater sewer system should be verified to ensure adequate flow velocity. In conjunction with this survey, the NJMC recommends the preparation of a NJDEP Minor Stream Encroachment Permit for the maintenance cleanout of the drainage system leading to the system's outfall.

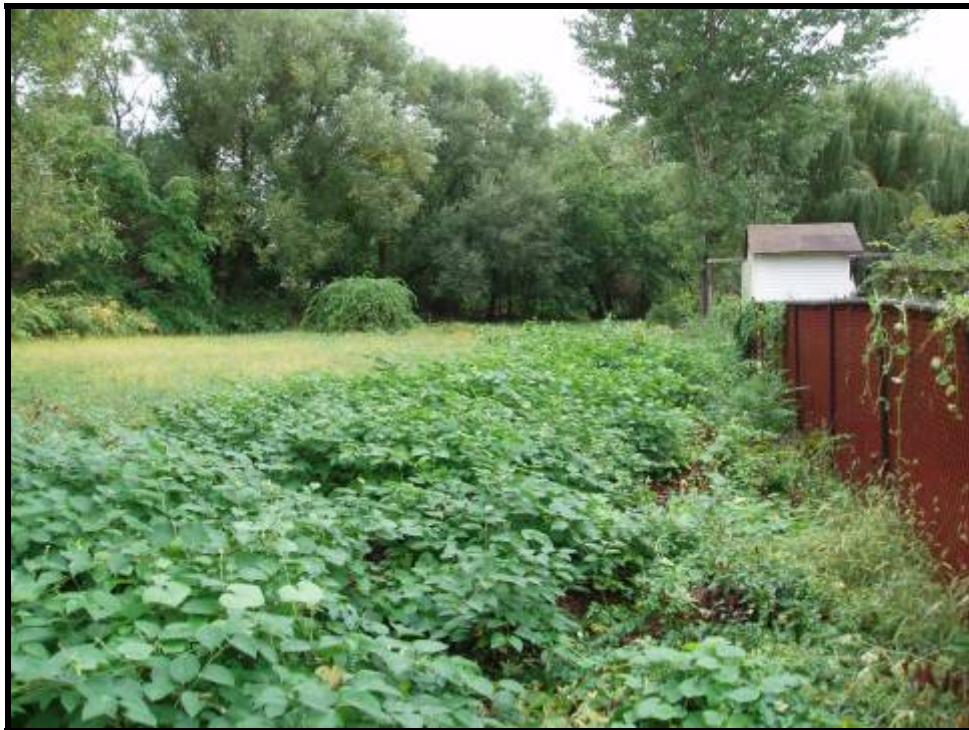
From a recent field inspection, the lot behind the flooded property appears to act as a detention basin because the drainage ditch leading to an outlet on the Hackensack River has been heavily vegetated (see Photos 2 and 3). Due to heavy vegetation, the NJMC inspection team was unable to determine whether the system outfall was the Acorn Road Tide Gates, which also discharge in the immediate area to the Hackensack River (see Photo 4). According to a Secaucus official, the outfall is not the Acorn Road Tide Gates and does not have a one-way valve. Additionally, Secaucus is recommending that a pump station be installed on its property at this location, 236 Meadow Lane, to service both the above ditch and the flow collected by the Acorn Road Tide Gates.

2. Looking south at the detention basin/drainage ditch behind 1138B Farm Road (10/11/05)

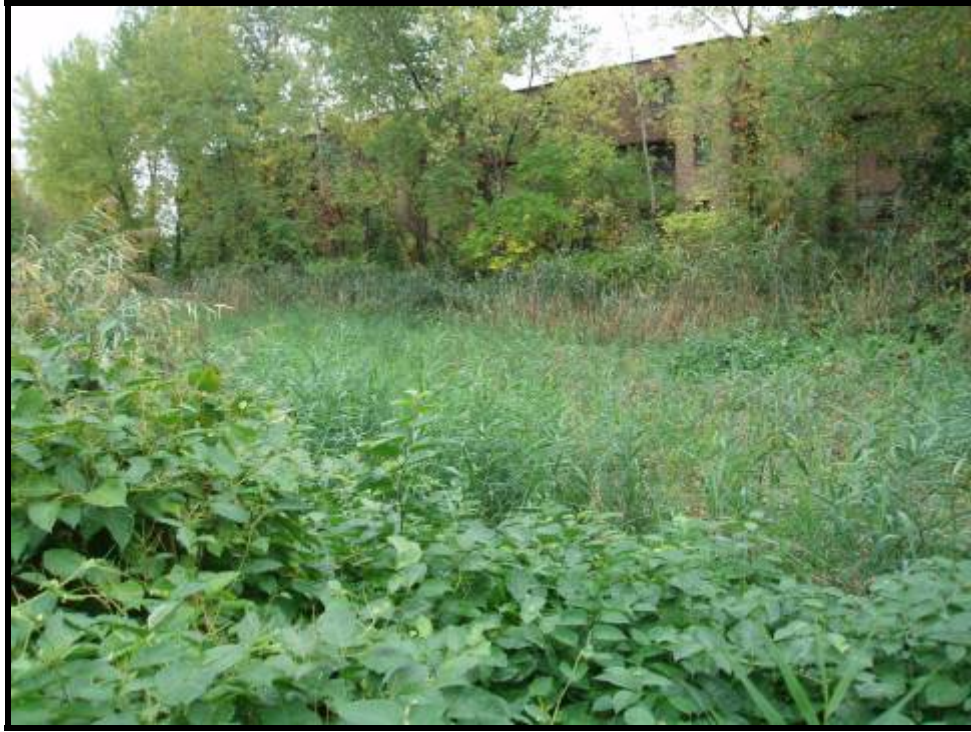
3. Looking north at the detention basin/drainage ditch behind the property of 1138B Farm Road (10/11/05)

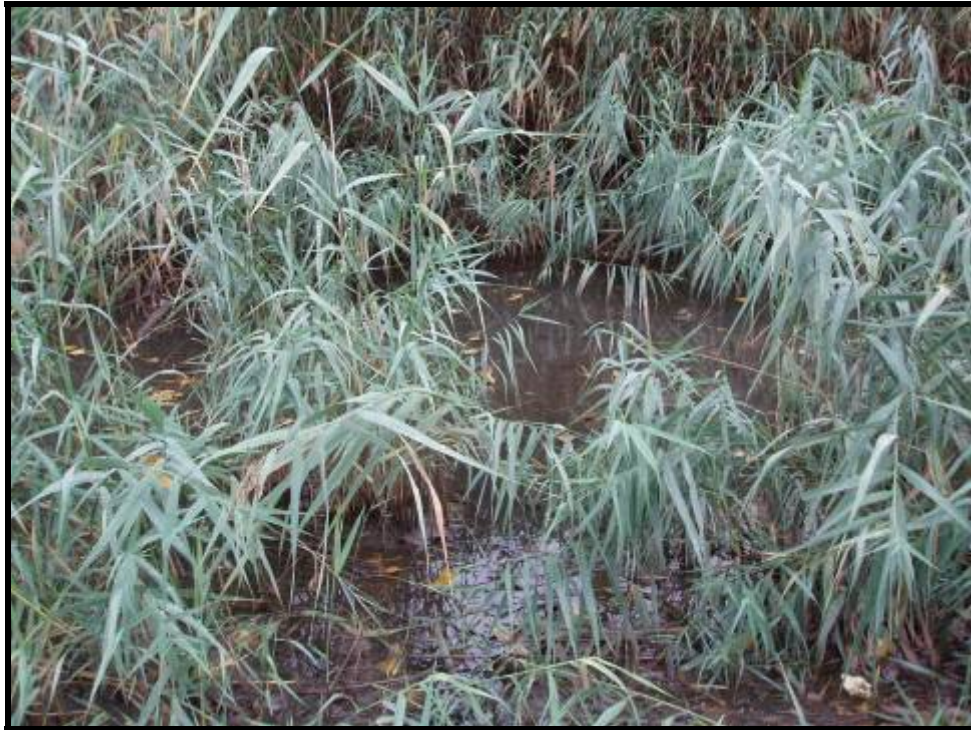
4. View upstream of the outfall to the Hackensack River (10/11/05)

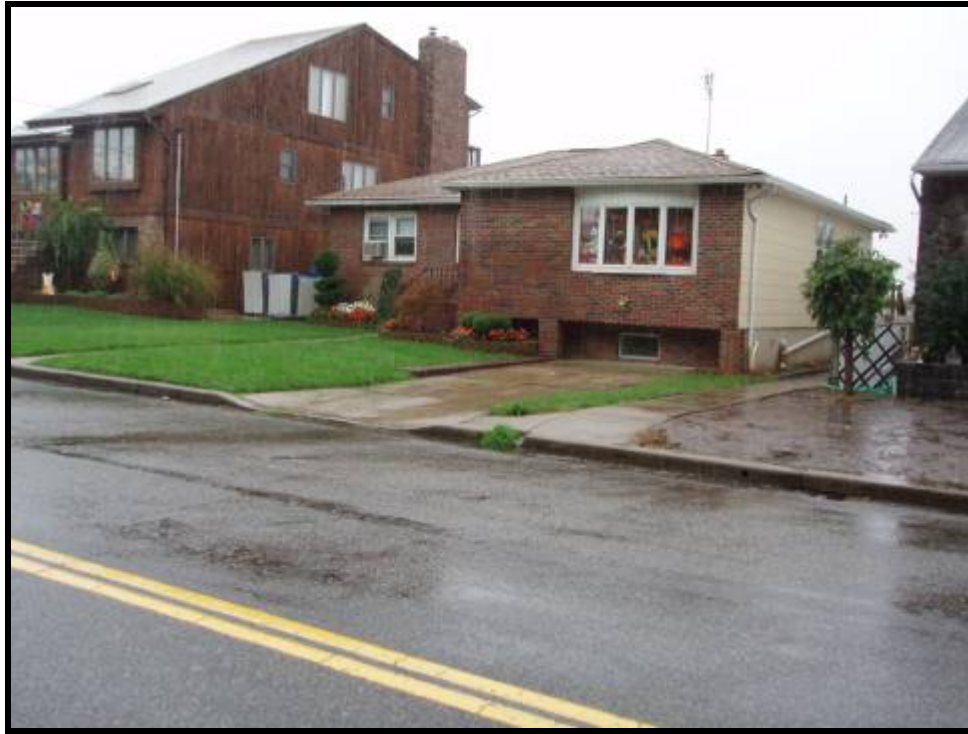
1. Front view of the property at 15 Mill Ridge Road (10/14/05)

The NJMC believes this flooding complaint is not a regional stormwater problem. The NJMC recommends that the property owner seek the services of a licensed Professional Engineer to inspect the rear of the property and to make recommendations on improvements that will keep at least the 25-year flood surge waters and the 25-year storm away from the house.

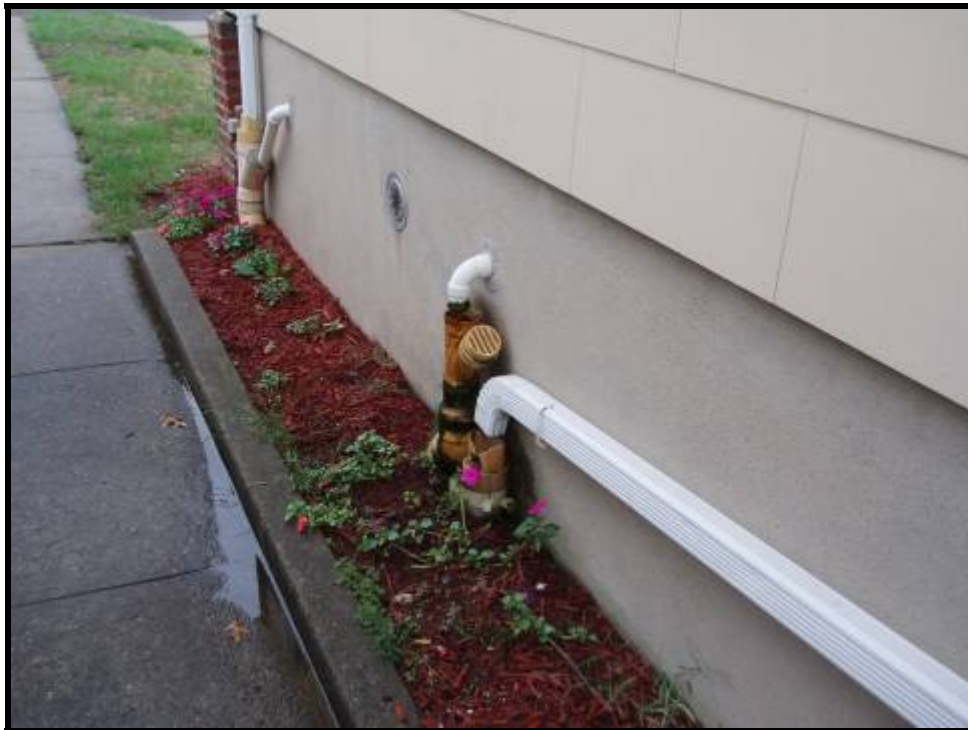
2. Side view of the property at 15 Mill Ridge Road (10/14/05)
