# Hackensack Meadowlands Floodplain Management Plan

**The National Flood Insurance Program  
Community Rating System  
Activity 510 Guidelines**

**The New Jersey Meadowlands Commission  
One DeKorte Park Plaza  
Lyndhurst, New Jersey**

**October 24, 2005**

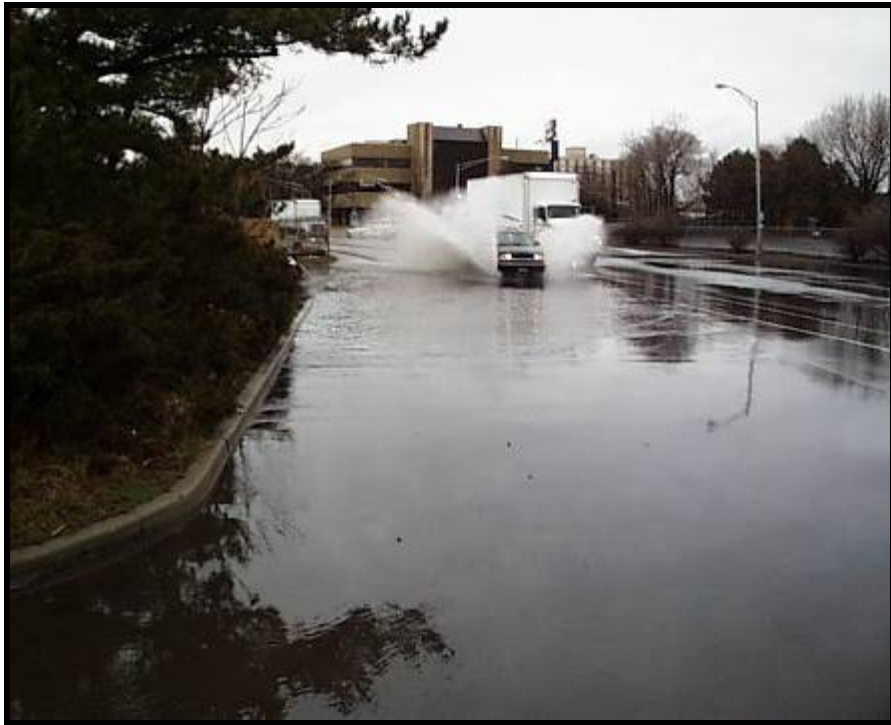
1. Looking North on Meadowlands Parkway near Broadcast Plaza (1/26/05)

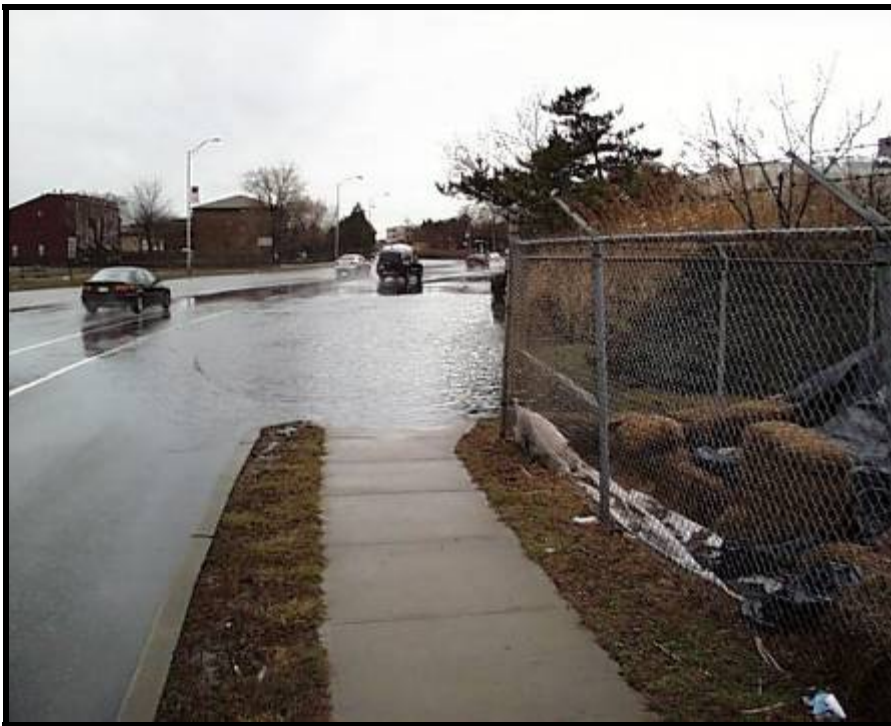
2. Looking South on Meadowlands Parkway near Broadcast Plaza (1/26/05)

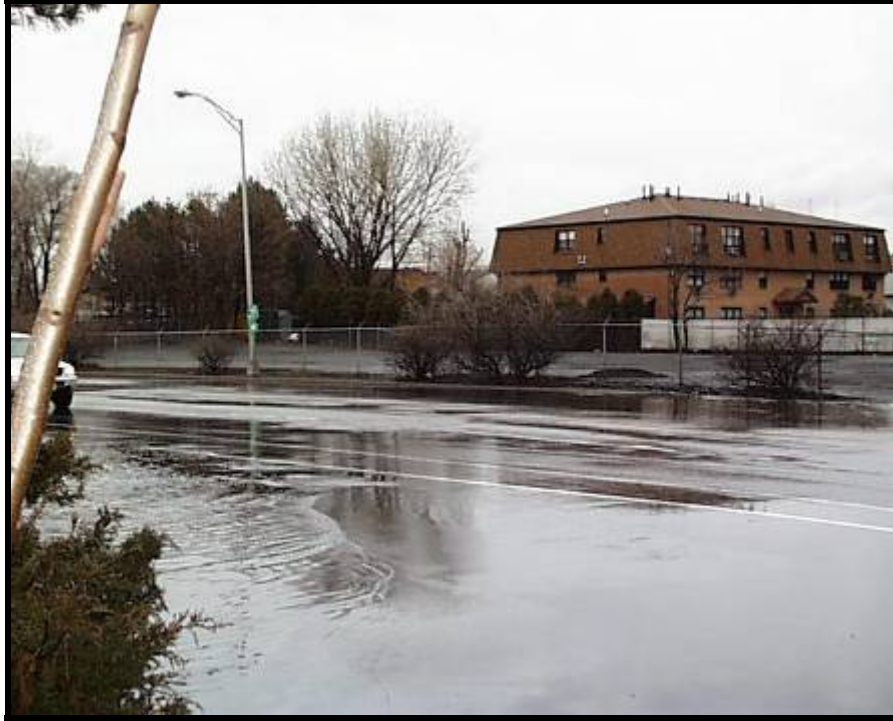
3. Looking Northeast on Meadowlands Parkway near Broadcast Plaza (1/26/05)

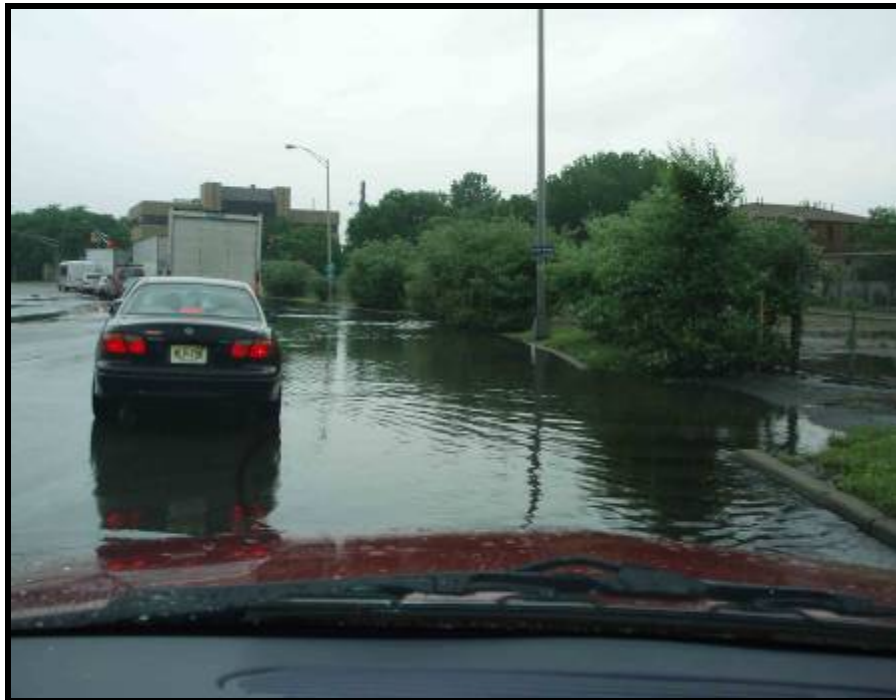
4. Looking South on Meadowlands Parkway near Broadcast Plaza (6/10/05)

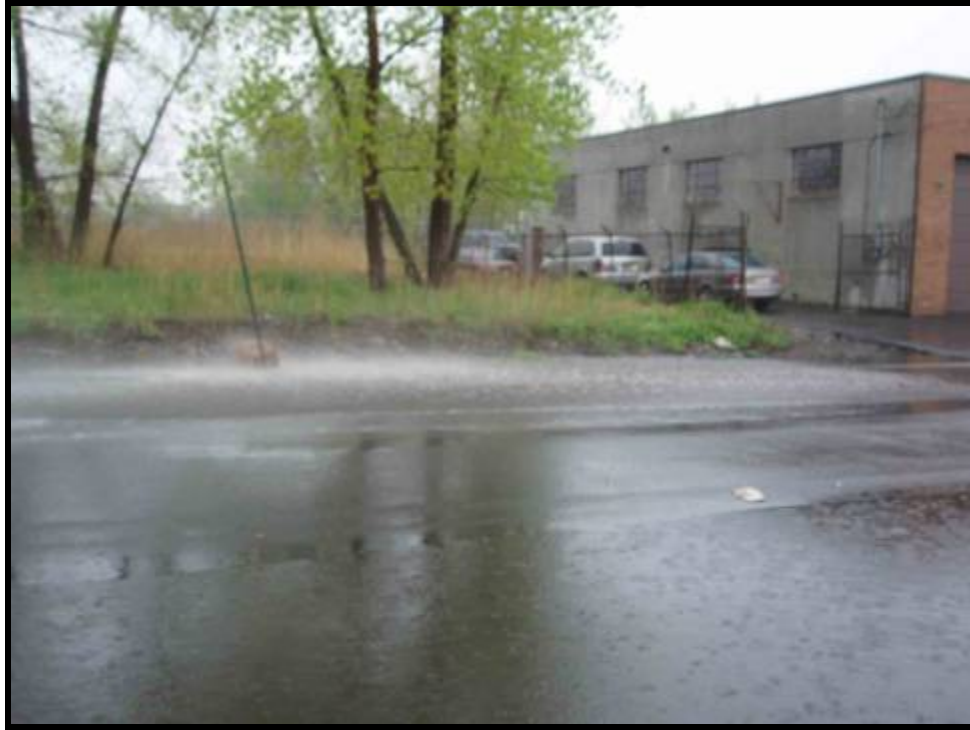
1. Looking Southeast on 16<sup>th</sup> Street in front of Block 115, Lot 1 (4/25/05)

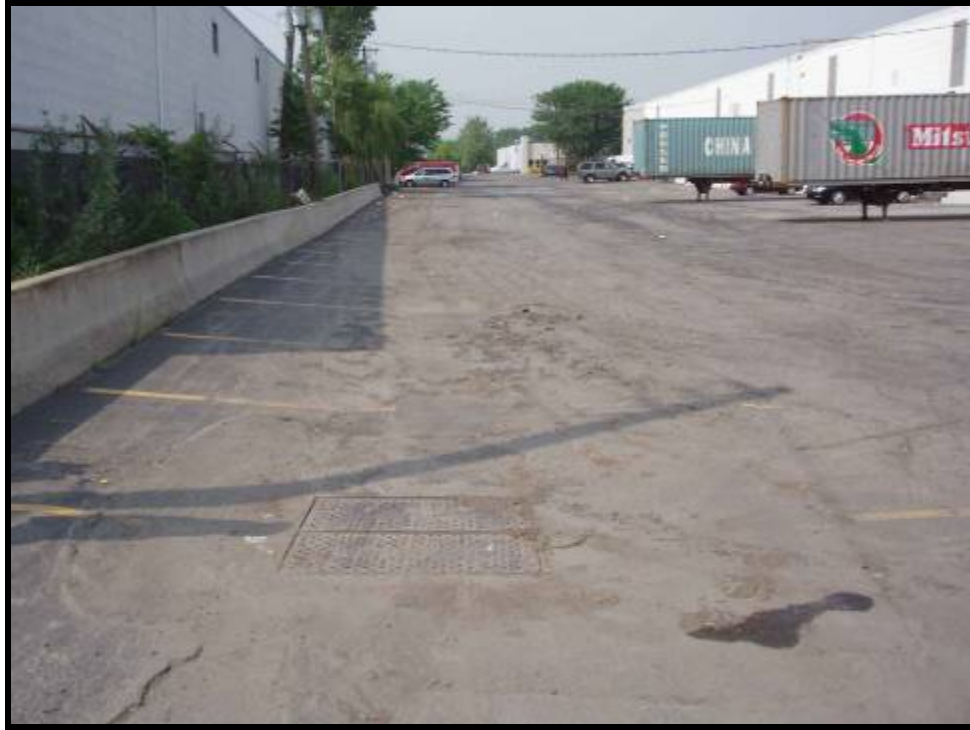
1. Looking Southwest from the back of the parking lot (6/15/05)

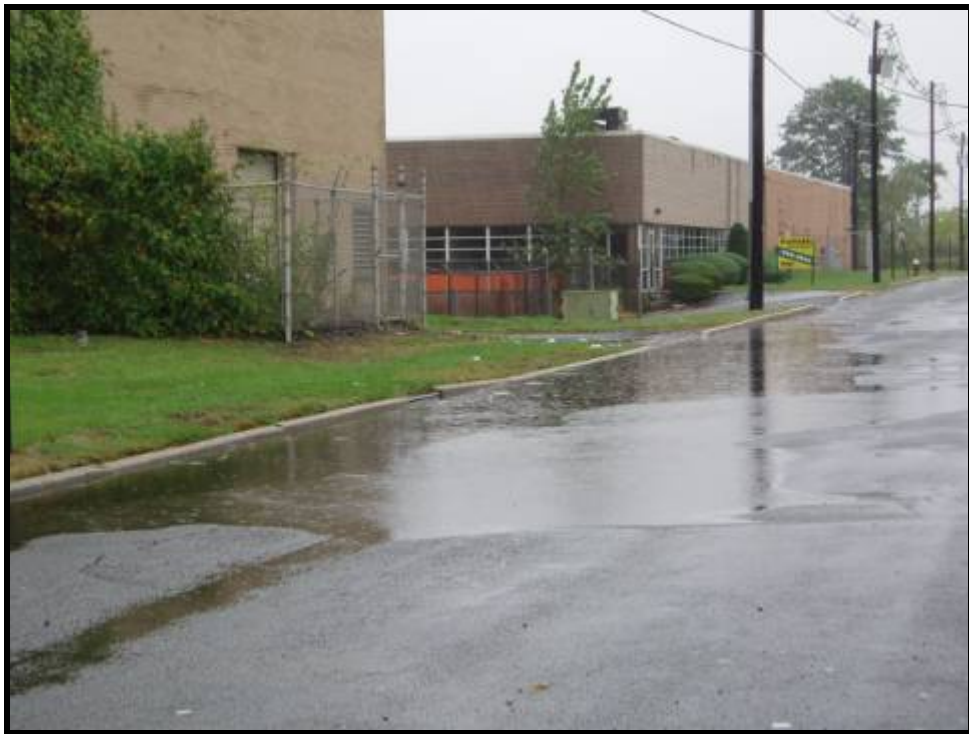
6. Looking Southeast on 472 Barell Avenue (10/14/05)

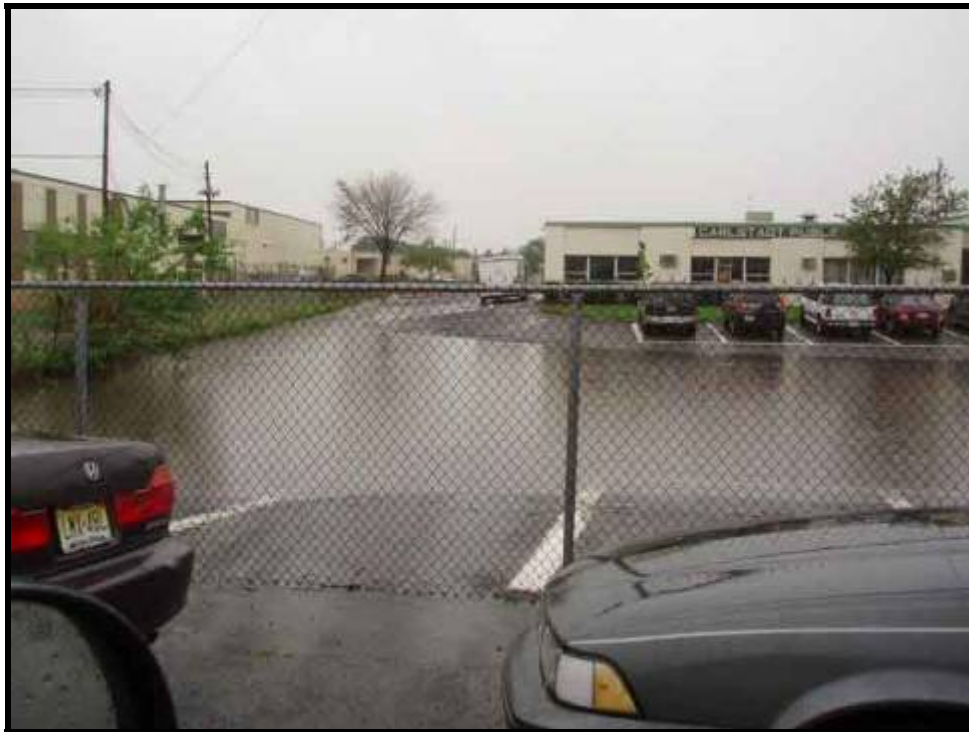
2. Looking Northeast at 105 Kero Road (7/08/05)

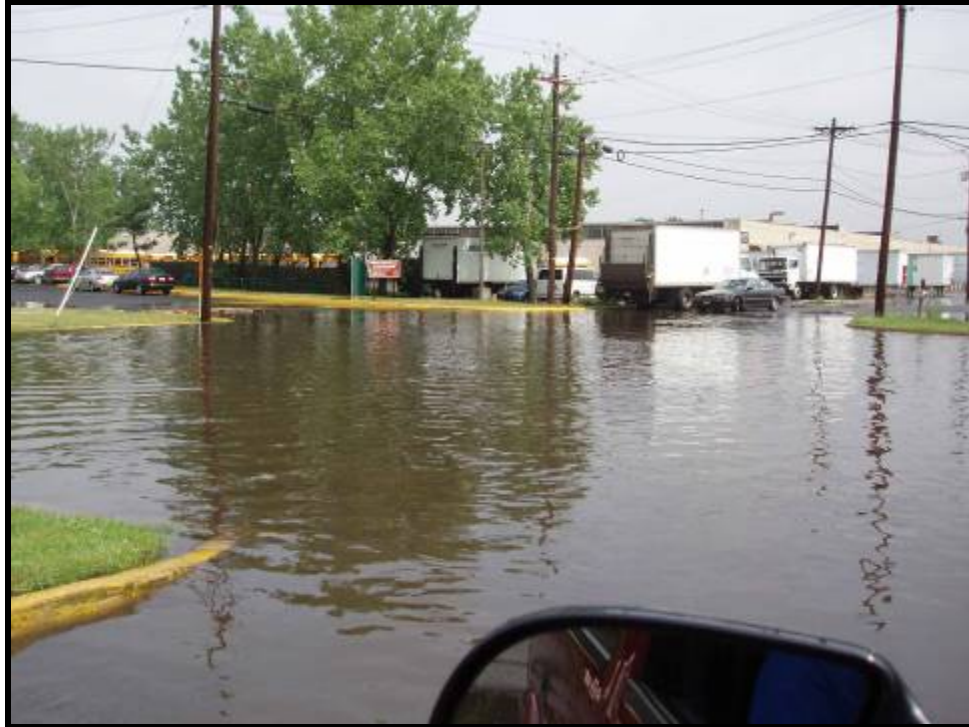
4. Looking Northeast from 140 Kero Road (7/08/05)

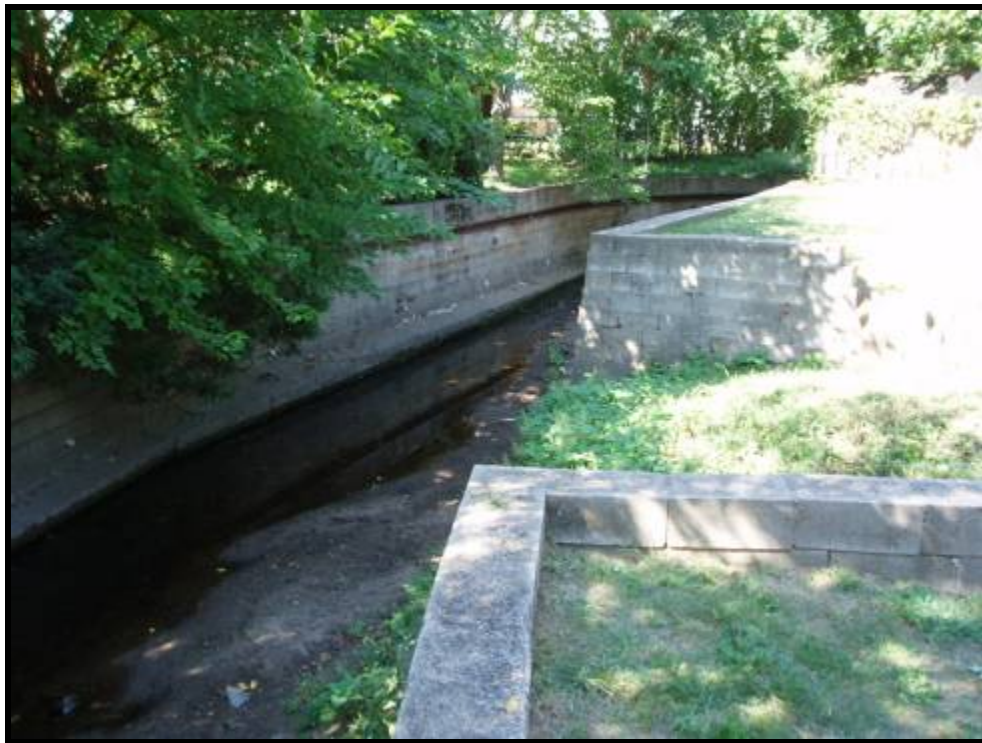
3. Wolf Creek looking Northeast from Lloyd Street (9/09/05)

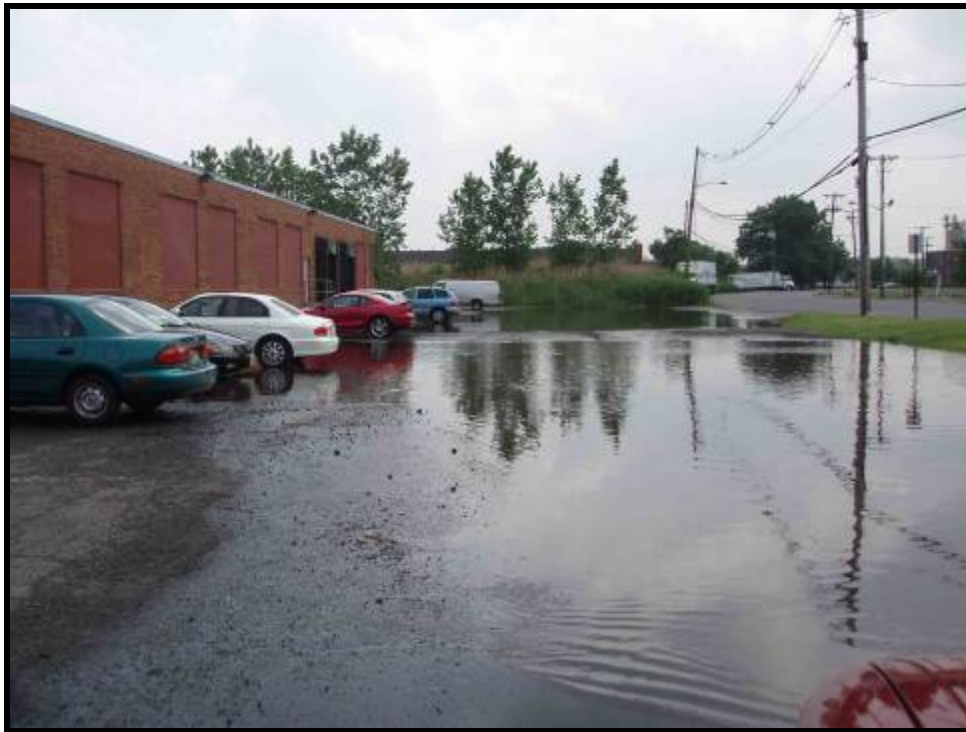
3. Looking Southeast from 140 East Union Avenue (6/10/05)

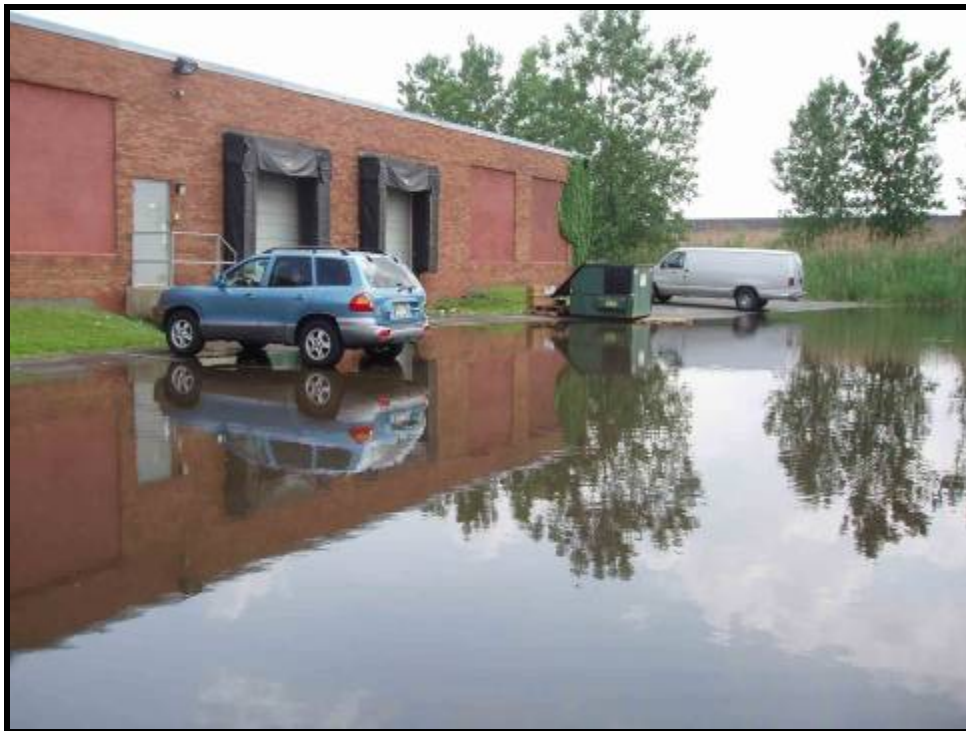
4. Looking Southeast from 140 East Union Avenue (6/10/05)

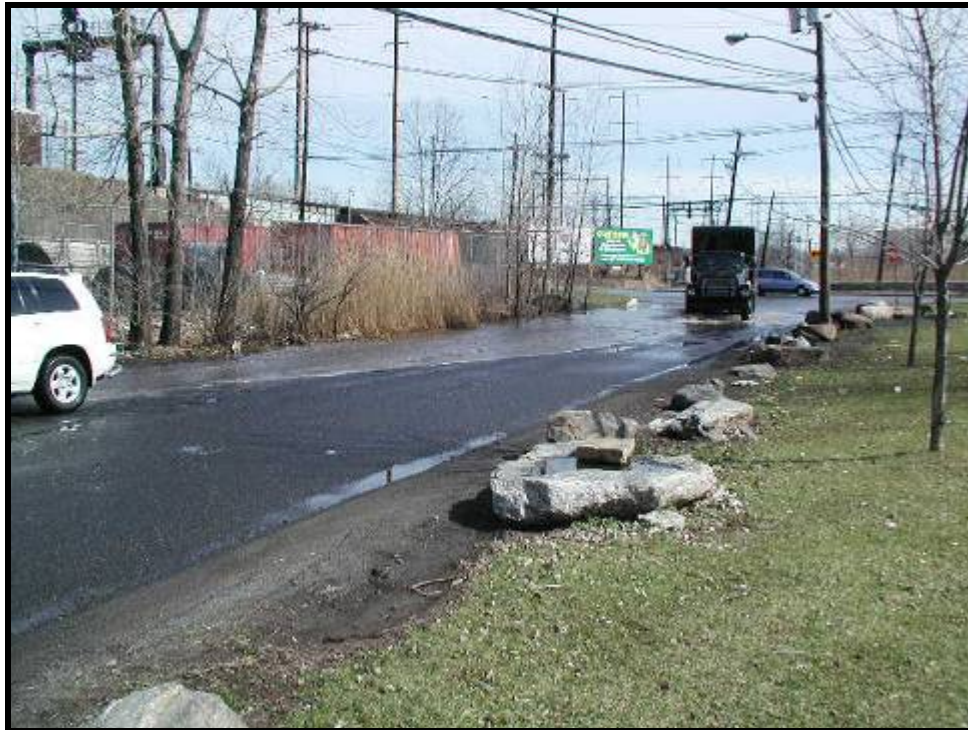
2. Looking Northeast on Penhorn Avenue (3/30/05)

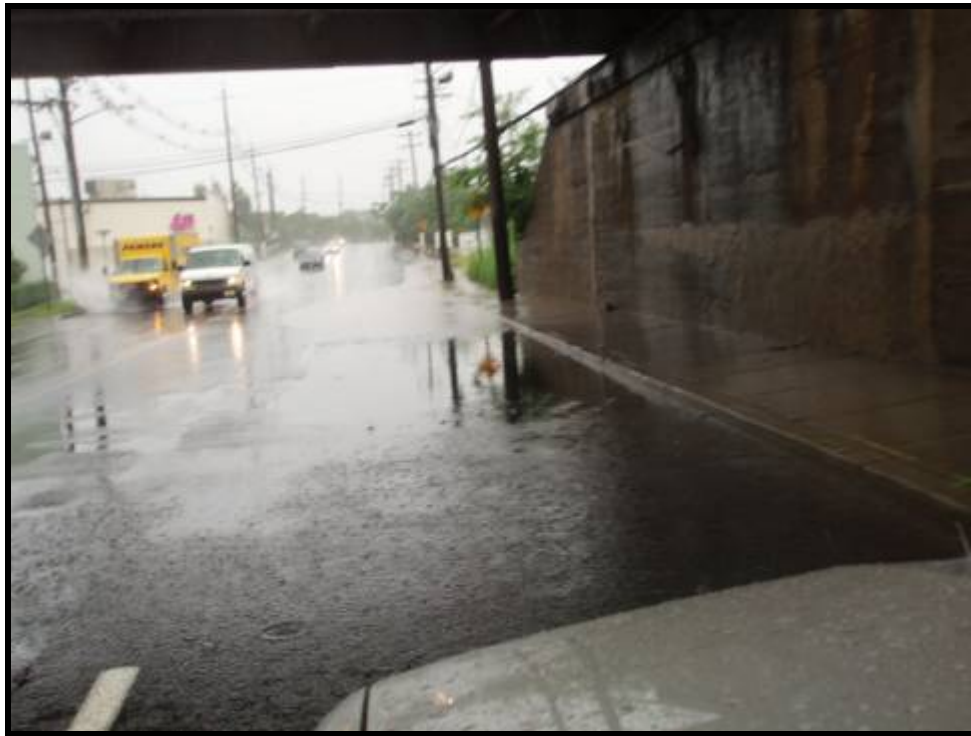
3. Looking Northwest on Secaucus Road underneath NJ Transit bridge (6/10/05)

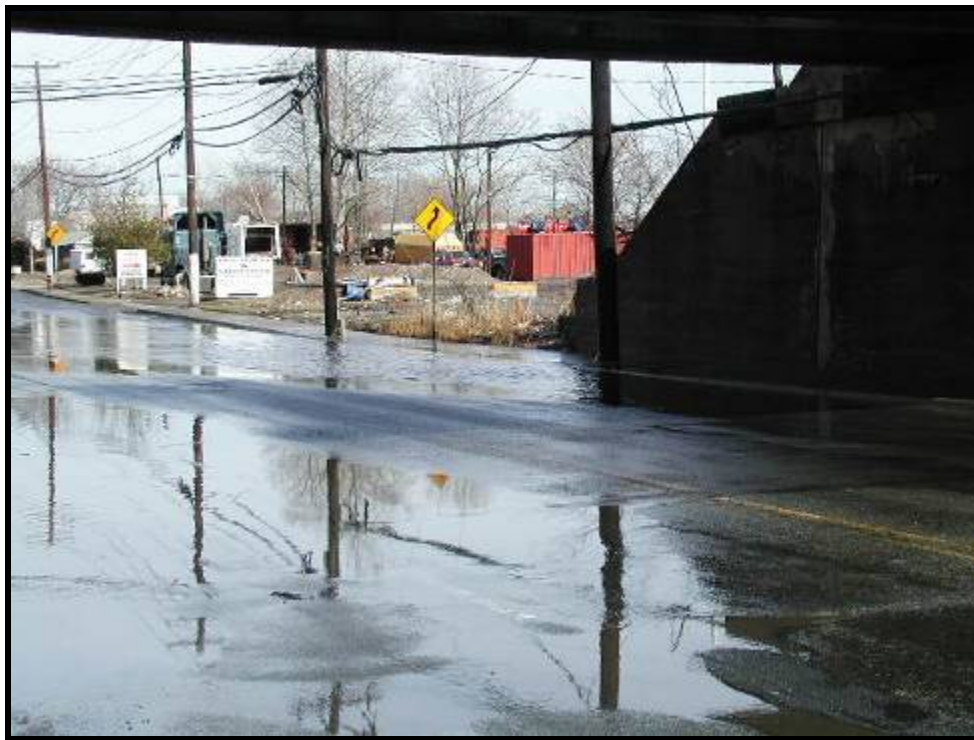
4. Looking North from Penhorn Avenue underneath NJ Transit bridge (3/30/05)

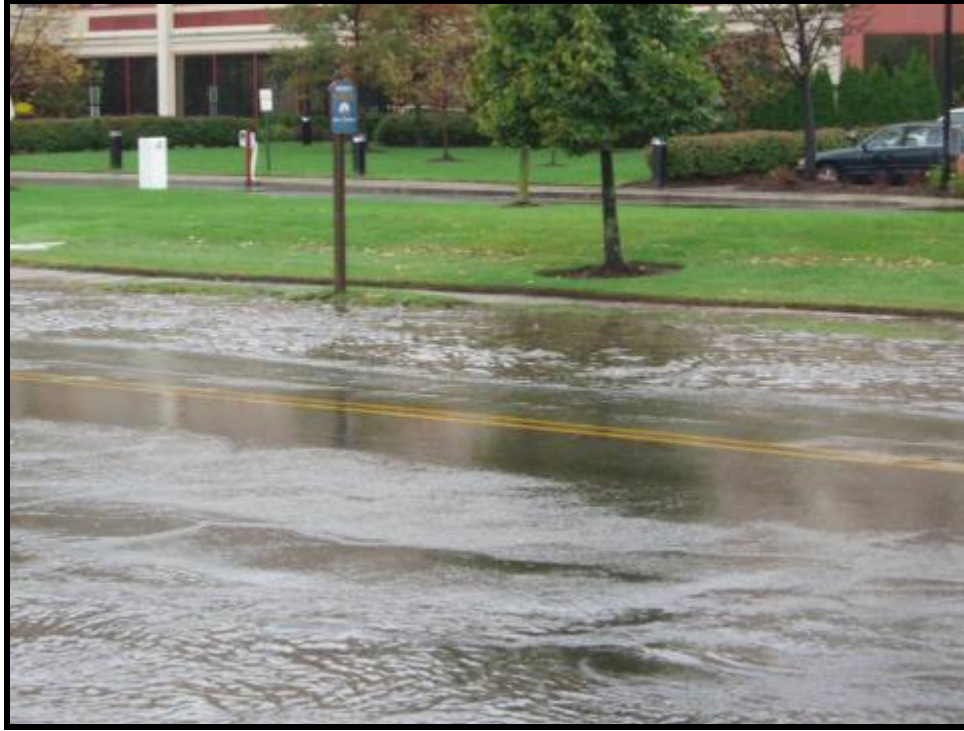
3. Looking West on Polito Avenue (10/14/05)

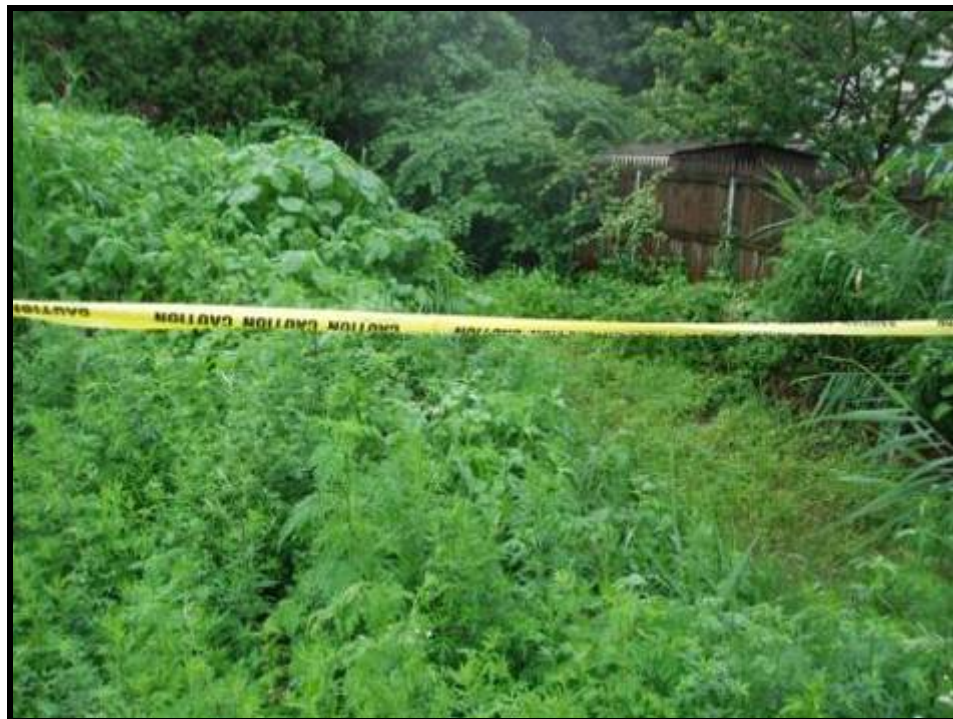
2. Same location at Photo 1, following one growing season. (7/08/05)

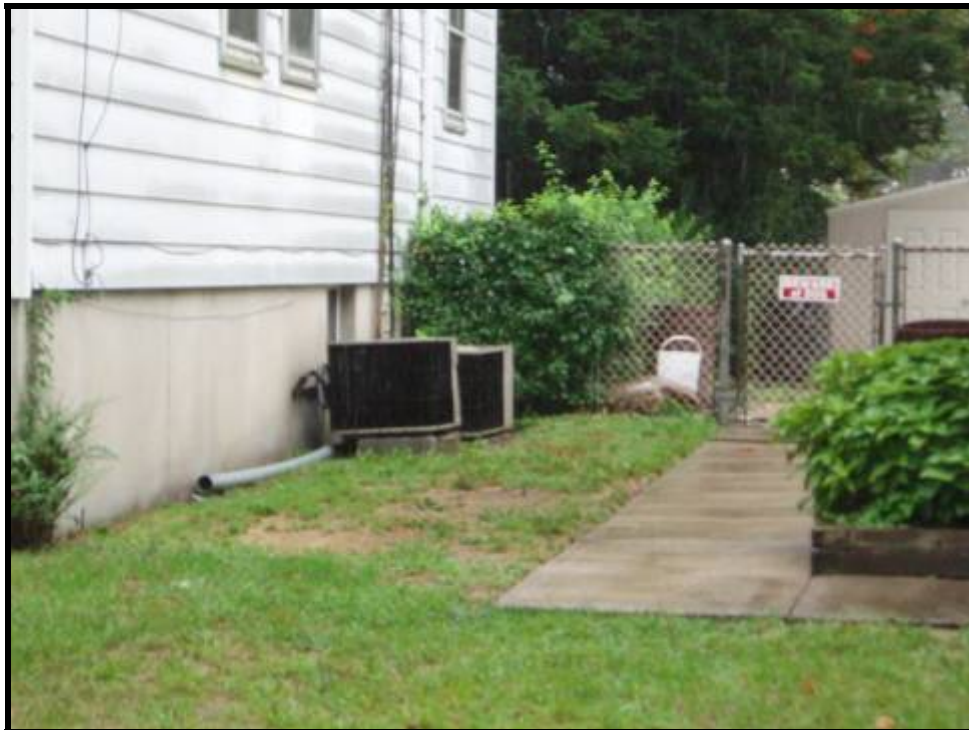
2. Looking at the east side of the property at 176 Louis Street (10/14/05)

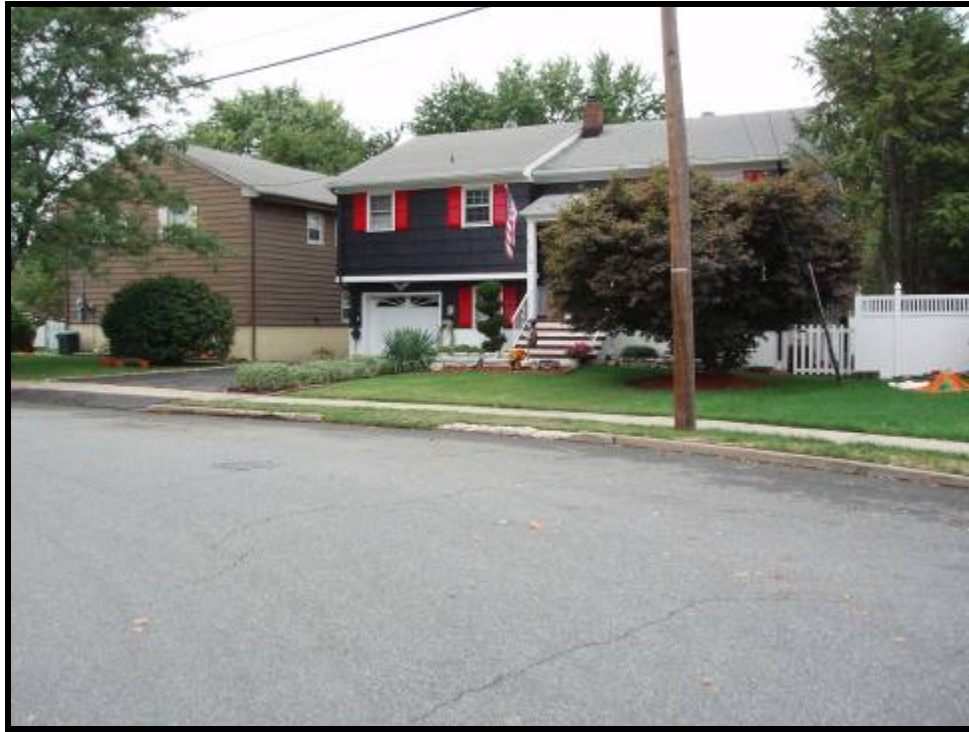
1. Looking at the front of 9 Chapman Drive (10/12/05)

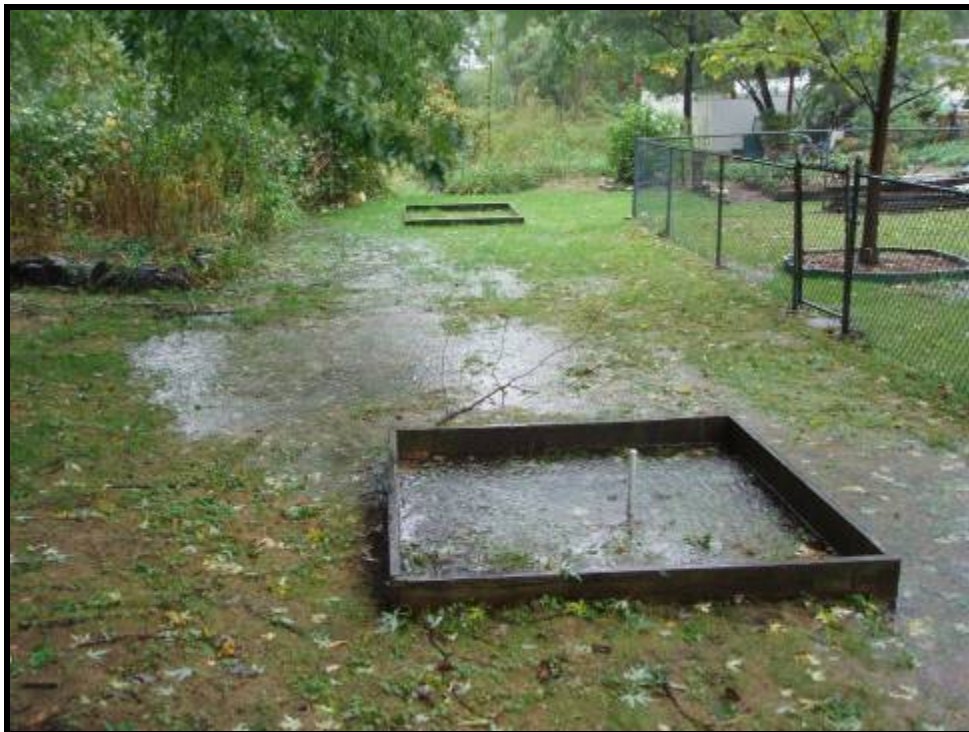
2. Looking at the area behind 9 Chapman Drive (10/12/05)

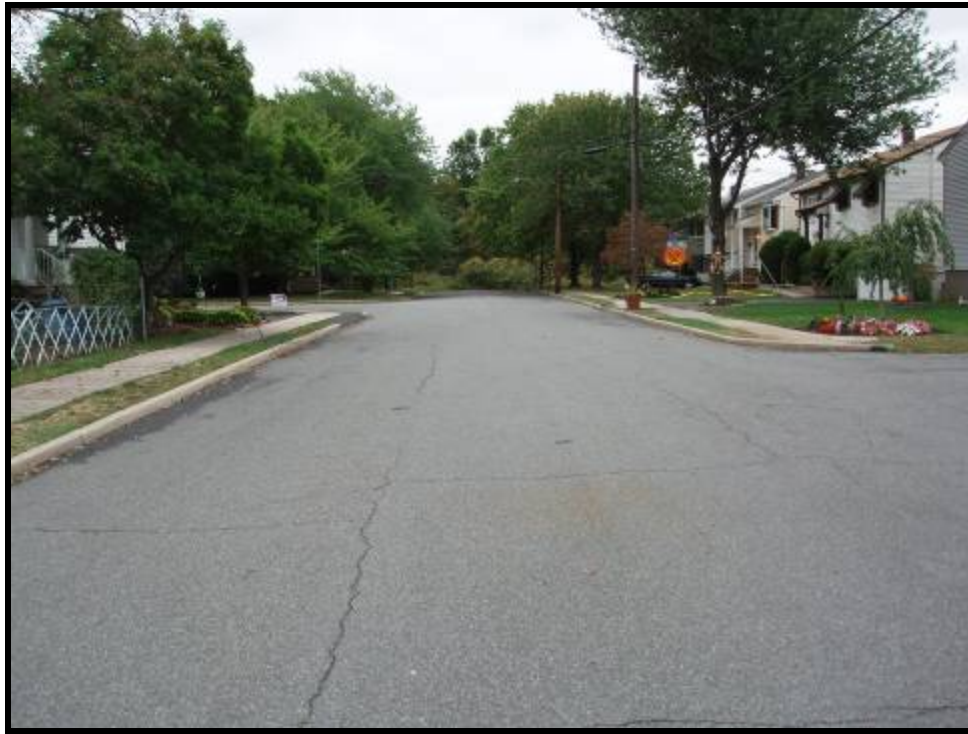
3. Looking south at 9 Chapman Drive towards the cul-de-sac (10/12/05)

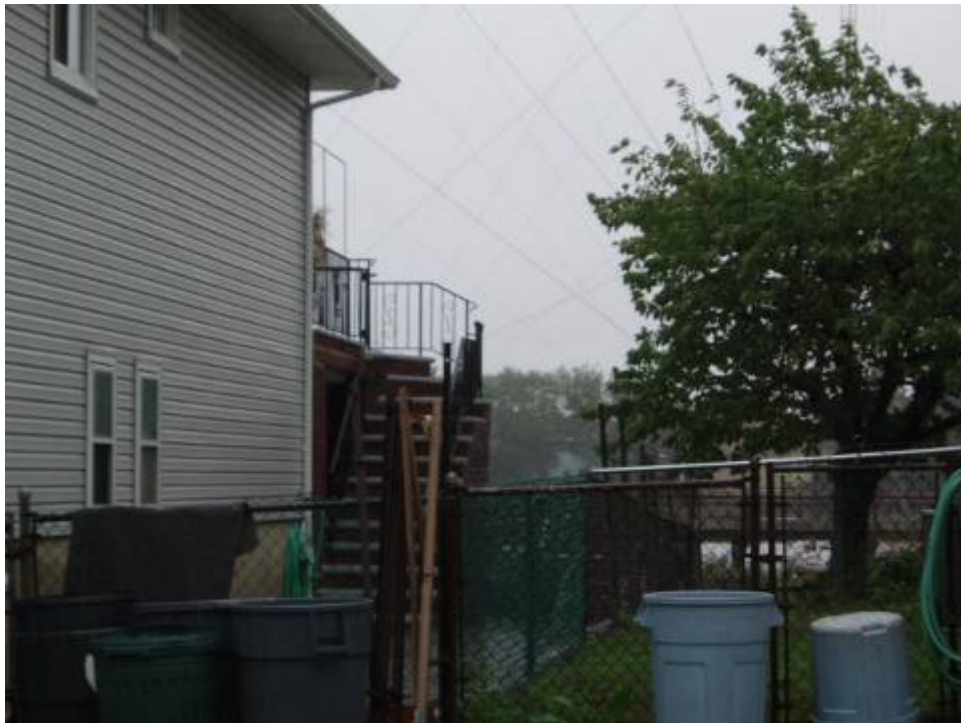
2. Looking at the west side of the property at 67 Huber Street (10/14/05)

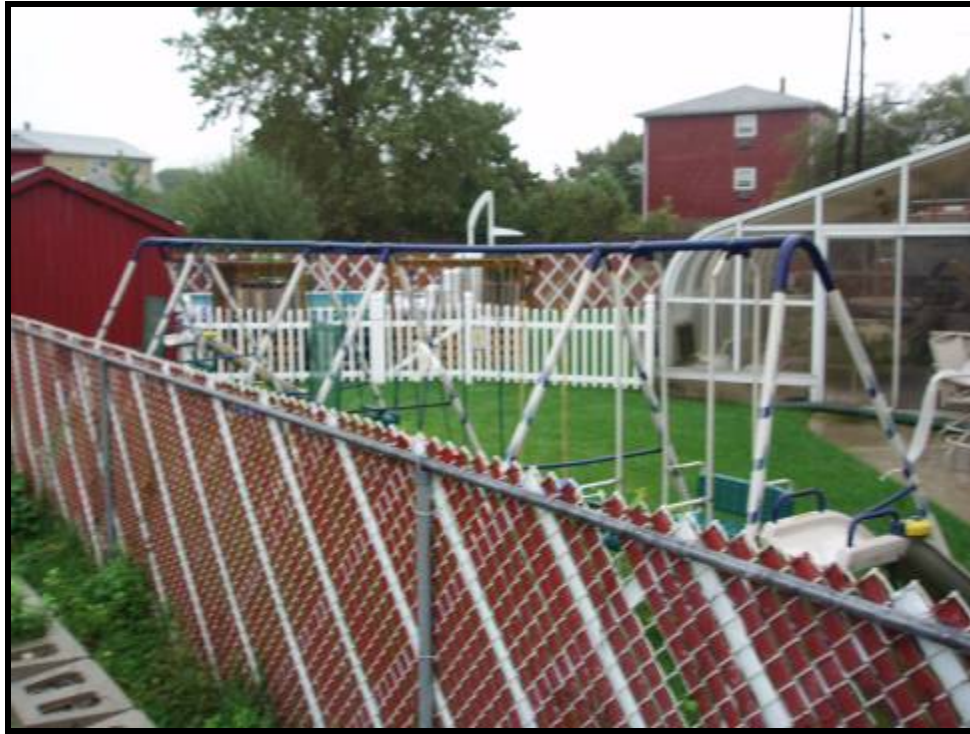
1. Looking at the backyard of 64 Maiden Lane (10/12/05)

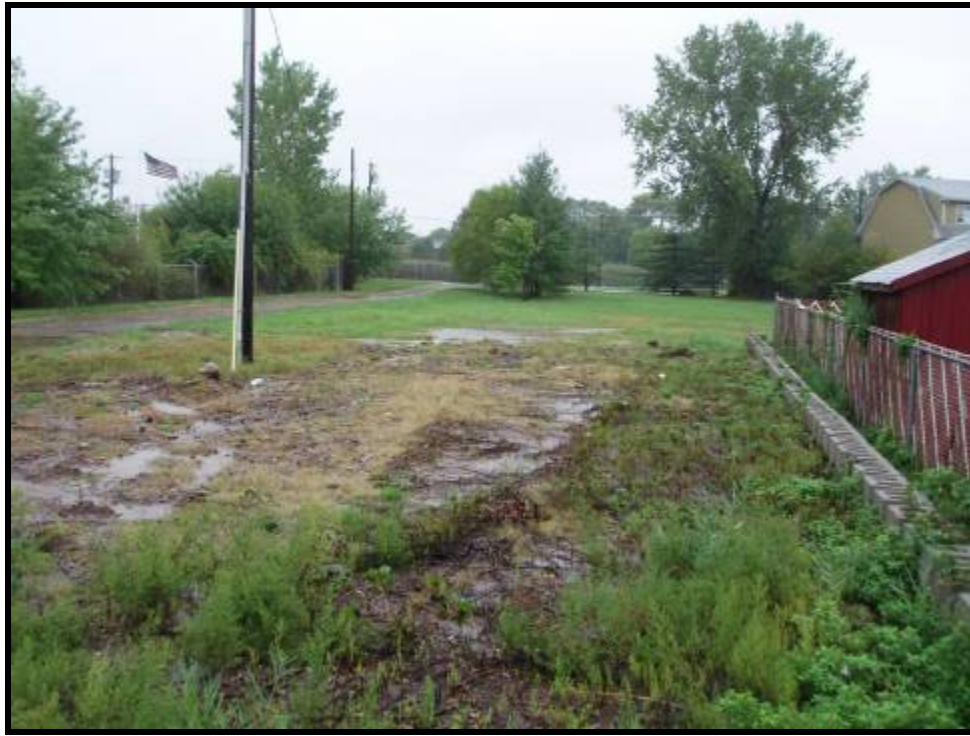
From a recent field inspection, a retaining wall was found at the rear of the property located on 64 Maiden Lane (see Photo 2). The runoff from the backyard of 64 Maiden Lane has no flow path to drain properly to a pump station that has been installed down-gradient of the property (see Photos 3 and 4). As such, the water ponds within the property.

3. View of empty lot behind 64 Maiden Lane (10/12/05)

It is recommended that the party responsible for the construction of the retaining wall modify the existing site grading to provide positive flow away from 64 Maiden Lane. This could be accomplished with a drainage ditch or pipe connection to the pump station behind the property. The NJMC will provide assistance in making the determination of ownership.

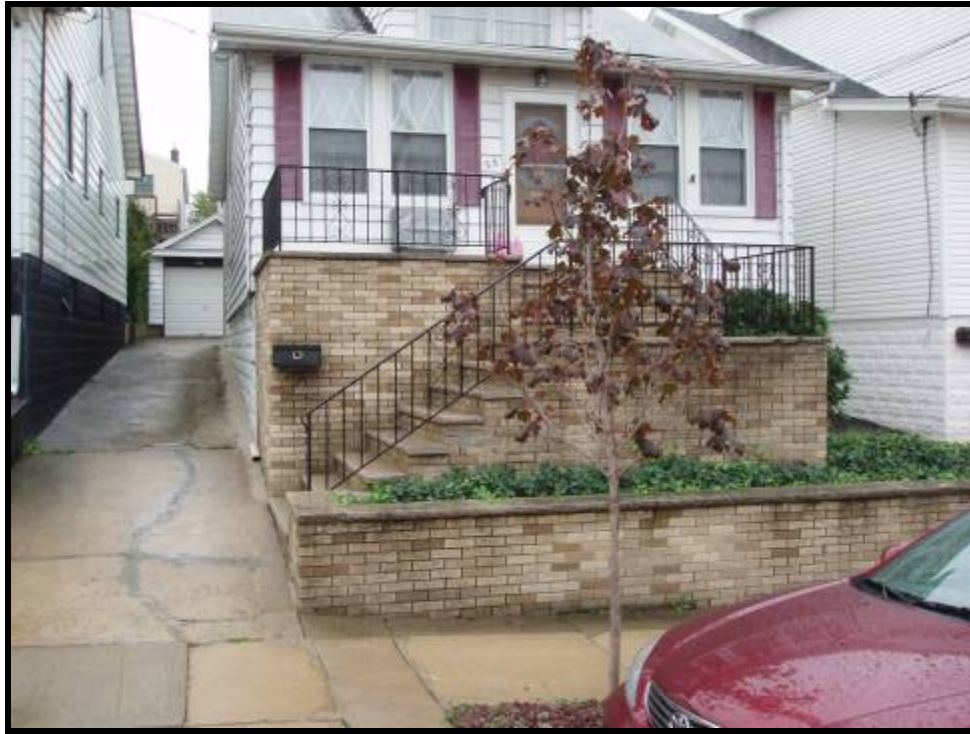
1. Front view of the property at 55 Second Avenue (10/12/05)

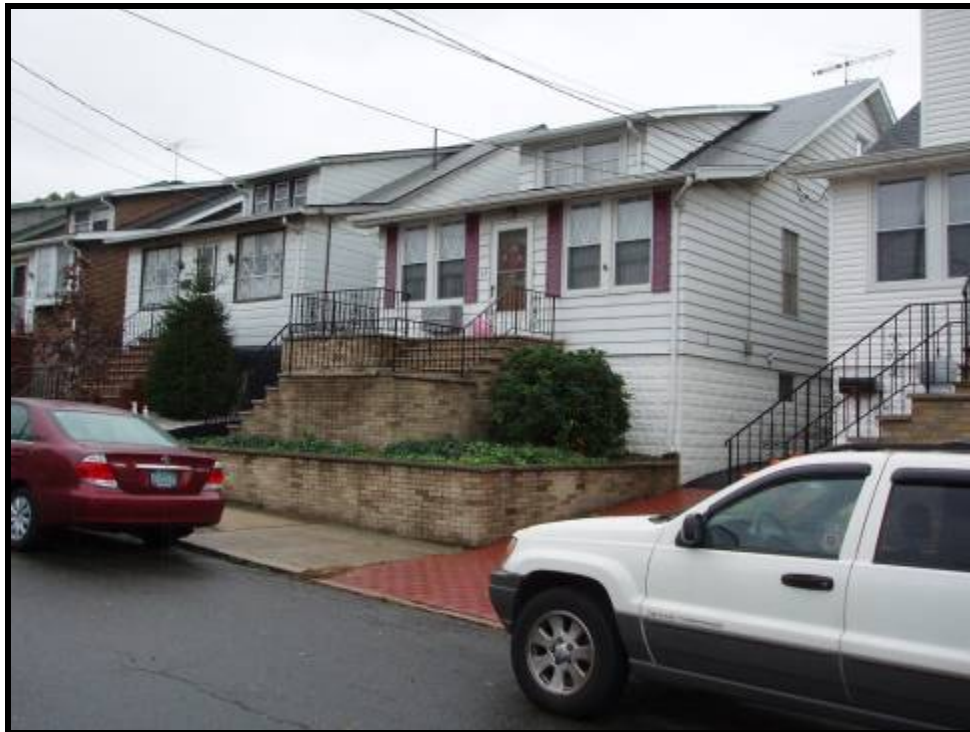
2. Front view of the property at 55 Second Avenue (10/12/05)
